Elimination of ESD Events and Optimizing Waterjet Deflash Process for Reduction of Leakage Current Failures on QFN-mr Leadframe Devices

Back-End Manufacturing & Technology, STMicroelectronics, Inc., Calamba City, Laguna 4027, Philippines

Abstract: This technical paper presents the resolution of high leakage current failures on QFN-mr (Quad-Flat No-leads Multi-Row) LF (leadframe) devices by optimizing the waterjet deflash process and eliminating the ESD (electrostatic discharge) events. ESD damage to units can cause permanent or latent product failures which results in low final test yield, and worse, possible external customer complaints. The use of CO₂ (carbon dioxide) bubbler was able to reduce the DI (deionized) water's equivalent resistivity from 17 MΩ to 0.30 MΩ, minimizing the tribocharging effect produced during the waterjet deflash process. Moreover, ESD events were eliminated by grounding the floating assembly equipment parts and installing appropriate ESD controls. It is of high importance to reduce or eliminate the leakage current failures to ensure the product quality, especially as the market becomes more demanding. After the optimization and implementation of the co

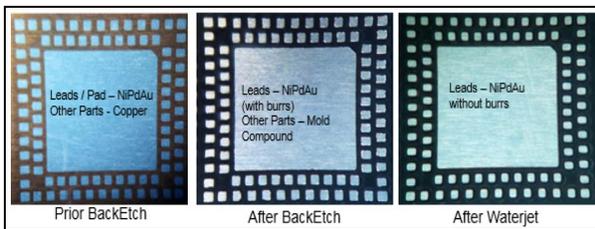
Tapeless LF has an additional backetch process to form the lead footprint and waterjet deflash process to remove the metal burrs (specifically copper burrs) induced by the etching process. During waterjet process, high speed and highly pressurized DI water is being applied to the units. A visual comparison of the LF at these processes is illustrated in Fig. 1. This high waterjet pressure creates high triboelectric charging (or simply tribocharging) and could cause ESD damage to the units.

Fig. 1 Tapeless LF bottom side visual comparison.

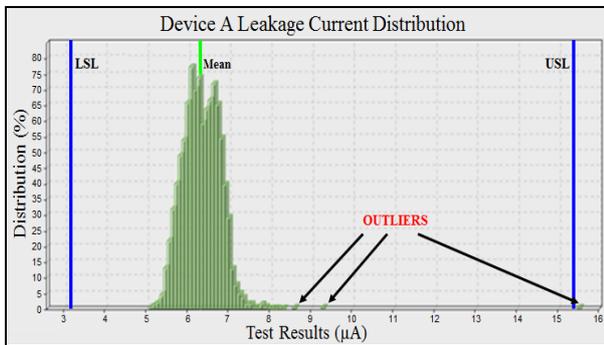
PPAT (parametric parts average testing) on leakage current response was employed at final test to screen-out or reject units that are outliers (above 5-sigma) from a reference distribution. Fig. 2 shows the outliers on 1 lot of Device A. The reference distribution is obtained on the response of the first 50 units tested.

Fig. 2 Leakage current PPAT response, showing outliers.

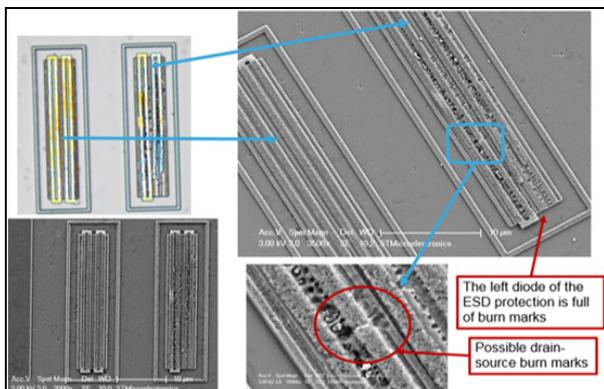
Most of the rejections do not manifest any abnormality after FA (failure analysis) since the leakage current readings are still within the defined specification limits. However, the units are considered failing since they are outliers from the PPAT testing. For units above the specification limits, FA showed burnt metallization as shown below. This defect manifestation could be brought by an EOS (electrical overstress)/ESD issue, as depicted in Fig. 3.

Fig. 3 EOS/ESD defect manifestation.

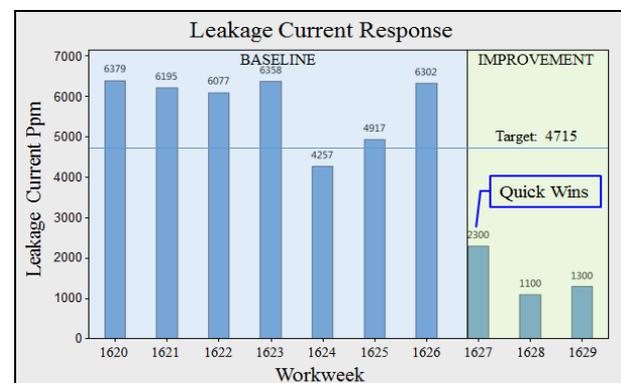
Assessment on the ESD event mapping is shown in Table 1. Investigation showed that there were ESD events on Diebonder A, causing higher leakage current occurrence.

Fig. 10 Leakage current ppm improvement.

The equipment was then subjected to health check and the ESD events were zeroed out by grounding the machine floating parts. The assessment and the corrective actions were considered quick wins, causing the leakage current occurrence significantly reduced from 5,784 ppm average to 1,567 ppm average for workweek 1627-29.

After implementation of the corrective and improvement actions, leakage current occurrence greatly reduced from a baseline of 5,784 ppm to average of 1,567 ppm last workweek 1627-29, see Fig. 10. This is significantly better than the target performance at 4,715 ppm.

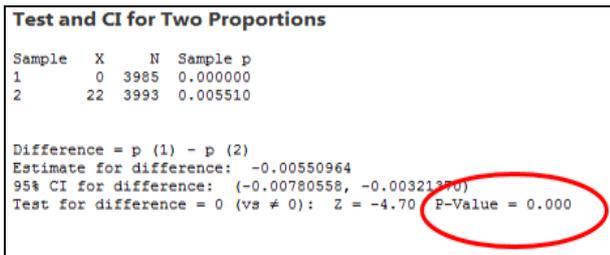
Waterjet process with varying DI water resistivity levels (high – 17 MΩ, low – 0.3 MΩ) shows significant result, with p -value < 0.05 (p -value = 0 to be exact, see Fig. 11), thus considered critical. This zero leakage current PPAT was obtained for waterjet deflash process with installed CO₂ bubbler.

Fig. 11 Proportion test on water resistivity levels.

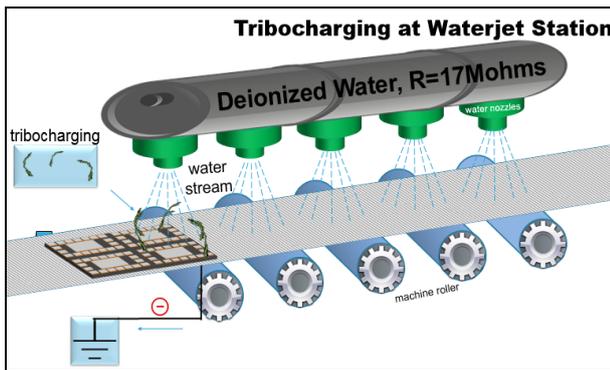
An illustration for tribocharging at waterjet station and the setup for CO₂ bubbler are shown in Fig. 12 and Fig. 13, respectively.

Fig. 12 Tribocharging at waterjet deflash process.

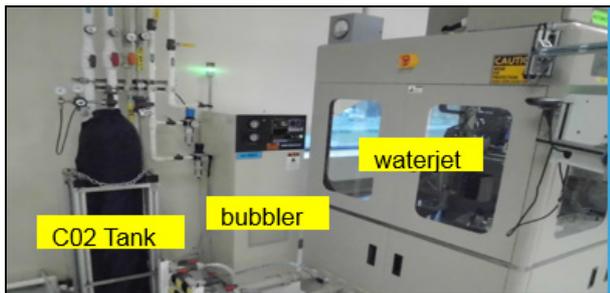
Fig. 13 Installed CO₂ bubbler at waterjet deflash process.

The CO₂ bubbler has a resistivity setting ranging from 0.2 MΩ to 0.4 MΩ. This range value is still within the static dissipative range. A static dissipative material allows slow dissipation or attenuation of charge from a charged device. The rate of discharge is slow and

Pokayoke mechanism was installed so as not to allow the waterjet machine to proceed when the water resistivity is above the limit, brought by depleted CO₂ tank or defective bubbler.

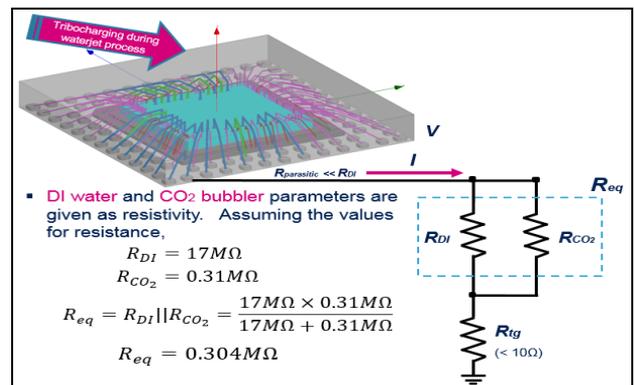
controlled such that no damage is done to an ESD sensitive device. The equivalent model representation is shown in Fig. 14. With the addition of CO₂ bubbler to lower the resistivity (and resistance) of DI water, the equivalent resistance of the discharge path becomes $R_{eq} = R_{DI} // R_{CO_2}$.

With lower R_{eq} , but still within the static dissipative range, higher current I could flow to the

ground. Hence more amount of charge Q of the device could be discharged at a period of time t .

Fig. 14 ESD model, equivalent resistance of discharge path.

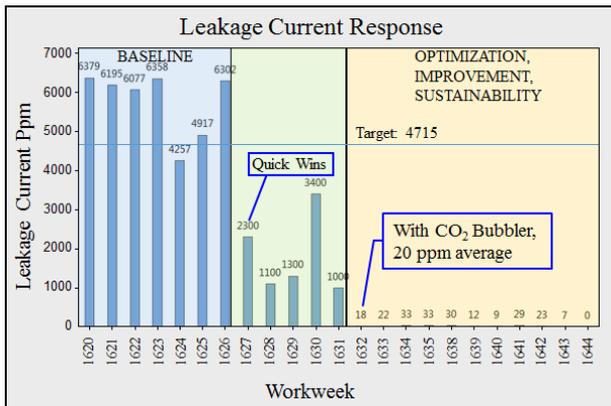
Fig. 15 Leakage current ppm improvement after optimization and implementation of all improvement and corrective actions.

After optimization of the waterjet deflash process and implementation of all corrective and improvement actions, leakage current occurrence greatly reduced from a baseline of 5,784 ppm to just 20 ppm for workweek 1632-44, as highlighted in Fig. 15.
