Mosul Dam: Geology and Safety Concerns

Abstract: Mosul Dam is an earth fill dam located on the River Tigris northern part of Iraq. The capacity of its reservoir is 11.11 billion cubic meters which makes it the fourth biggest dam in the Middle East. From geological perspective, the dam is located on double plunging anticlines. The rocks of the site are mainly composed of highly jointed and karstified alternating beds of limestones, gypsum and marls, since the impoundment of the reservoir seepage of water was recognized under the foundation of the dam. To stop or minimize the seepage, intensive grouting operations were conducted. Recent investigations and evaluation of the conditions of the dam indicate that it is in a critical situation. In this paper, consequences of the dam failure are discussed and possible solutions are given.

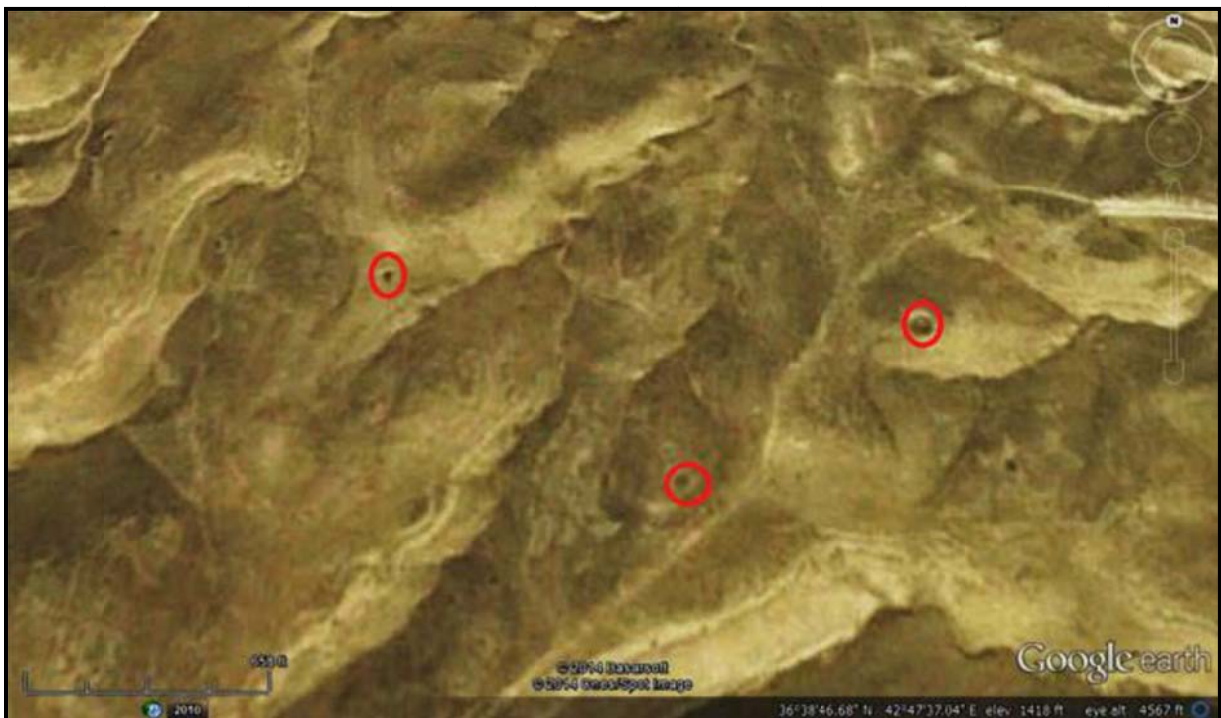
Fig. 9 Enlarged Google Earth image showing many sinkholes (dark spots encircled by red color), in the upstream area of the dam site [5].

Figs. 9 and 10 shown already indicate the extent of the karsts phenomena in the form of sinkholes upstream area of the dam and in the reservoir.

The continual development of such sinkholes will open new connections with the groundwater aquifer running below and around the dam site causing more dissolution problems.

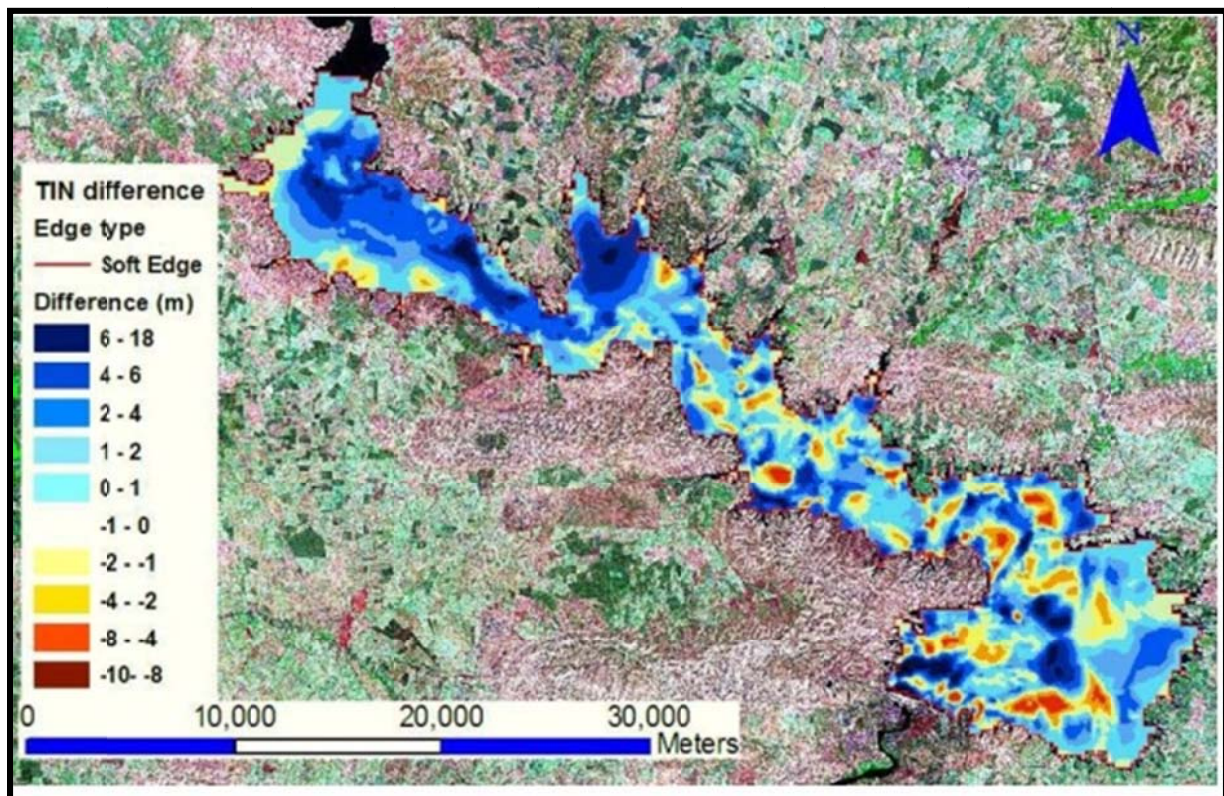
Fig. 10 Results of bathymetric survey of Mosul Dam reservoir carried out in 2011 by a Luleå university PhD student [7].

Another significant morphological aspect in the area is karstification in the area and in the dam site [5, 6]. Typical dissolution karstification phenomena close to the dam site and sinkholes are shown in Figs. 6-9. While sinkholes have developed very close to the dam during and after operation, and similarly sinkholes were discovered in the reservoir later on as shown in Fig. 10 [7].

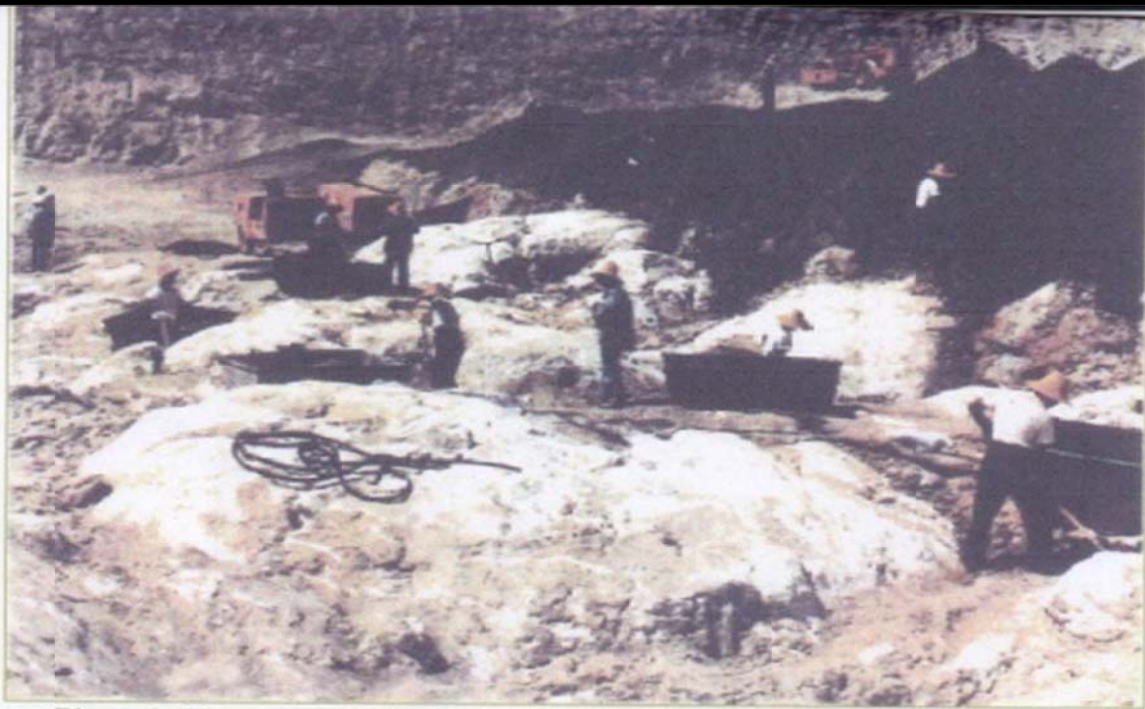
During the excavation works of the spillway chute and flip bucket the GB3 layer was exposed showing spectacular cavities and open joints and cracks. These are shown in the photographs in Fig. 13.

Photo 1. Chute area of the spillway, top of GB3 layer; subrounded boulders of gypsum/anhydrite and brecciated marls.

Fig. 13 Cracks and cavities in the GB3 layer below spillway's chute and flip bucket [9].

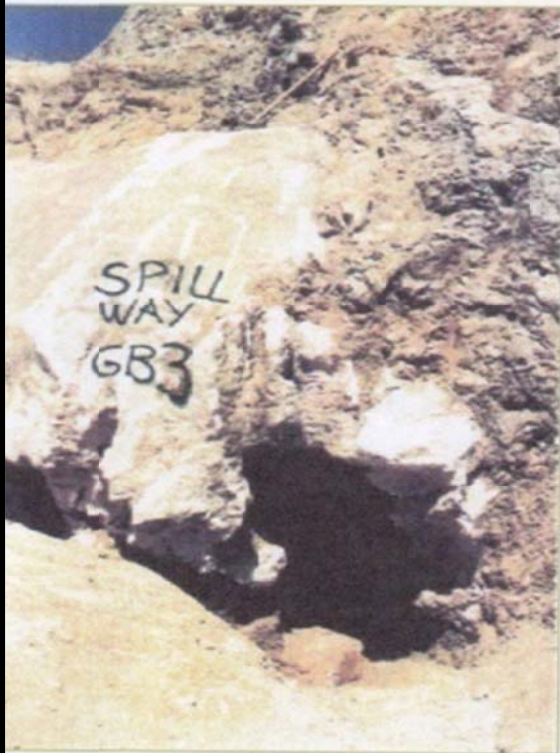
Photo 2. Cavity in GB3 layer.

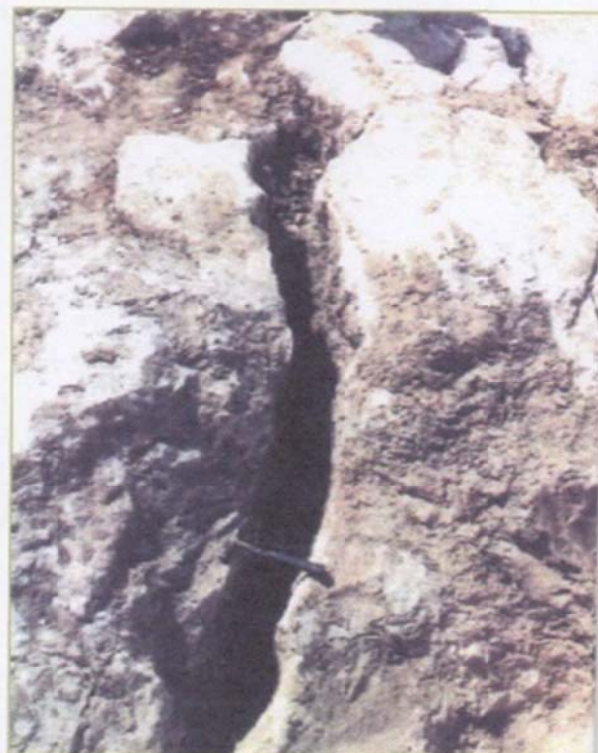
Photo 3. Open crack in gypsum layer.

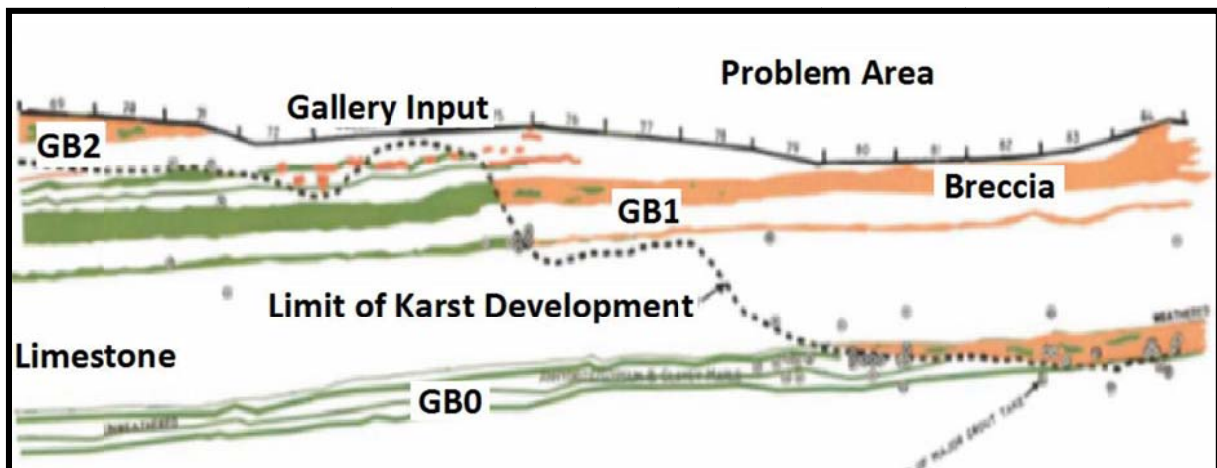
Fig. 14 Estimated karsts line in the problem area (sections 69-87) (The black spots show locations of some of the major grout take locations) [9].

In Fig. 14 the dotted line is the estimated karsts line development in sections 69-87 which is the most problematic area as visualized by the designers, the estimation of this line was based on the results of boring and field permeability testing. The black spots in this figure indicate some of the points of major grout take. Below this line according to the designer's judgment karsts cease to exist and this depth should define the end of the deep grout curtain. The design criteria of the grout curtain, however, called for extending the curtain 20 meters below this line for more safety. In actual fact the depth of dissolution extended below this line after impounding the reservoir. The design criteria and full details of the grouting works are given in Ref. [8].

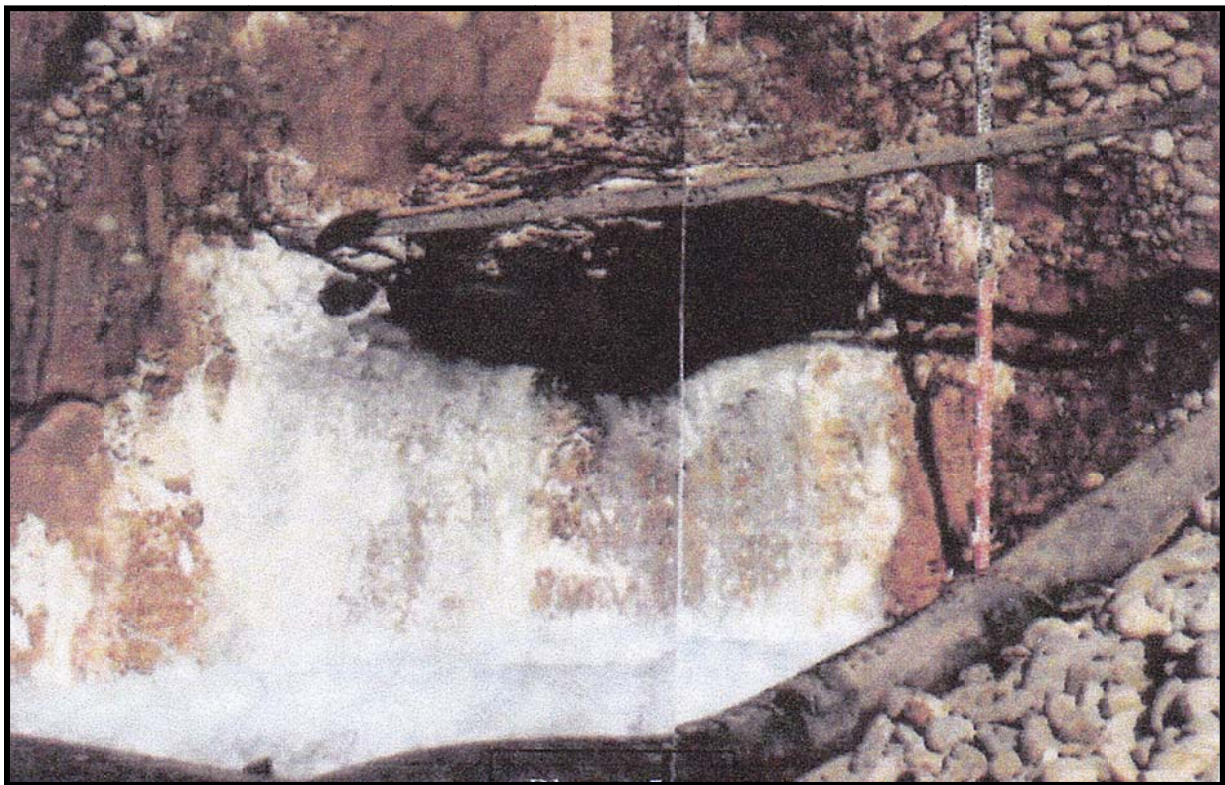
Fig. 16 The flow (360/sec) from underground aquifer into the intake/tailrace tunnel of the pump storage scheme originating from Wadi Der Malih aquifer [9].

aquifer was also fed directly from the reservoir after impounding. Fig. 16 is a photograph of the water flow of one spring which had erupted during the excavation of the tunnel and could only be stopped after performing much grouting works. The Importance of the Wadi Der Malih aquifer is not only due to the great difficulties it had caused during the construction of the pump storage scheme, but it is also believed it contributed to the formation of a series of sinkholes at the right bank downstream of the main dam as explained later on.

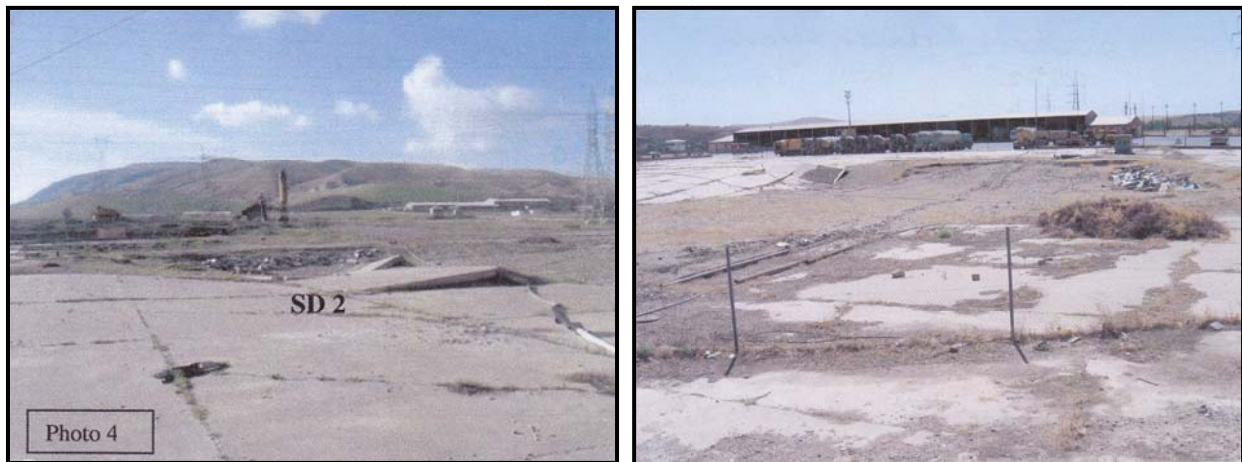
Fig. 20 Two views of sinkhole SD2 at the initial stage and final stages of development [9].

sinkholes showed dramatic solution of the gypsum layers which were exposed on the shore line. During the operation years of the dam and specifically from 1991 to 1998 new series of sinkholes began to form in the downstream area of the dam. These sinkholes followed a straight line alignment parallel to the axis of the dam and at about 400 meters away. These sinkholes were indication of an active process of rock dissolution. Careful observations and measurements indicated that the ground surfaces at the sinkholes locations had settled gradually and collapsed in enlarged underground cavities which were formed partly by the fluctuation of the water level resulting from the operation of the reregulating dam 8 kilometers to the south of the main dam and partly due to the connection to Der Maleh underground aquifer which runs under the dam area and being charged from the right rim of the reservoir through the gypsum layers day lighting at the right rim. The location of these sinkholes is shown in Fig. 19, and the photographs of sinkhole (SD2) given in Fig. 20 show the initial phase of its formation in the

contractor's concrete paved work area and the final shape after full development.

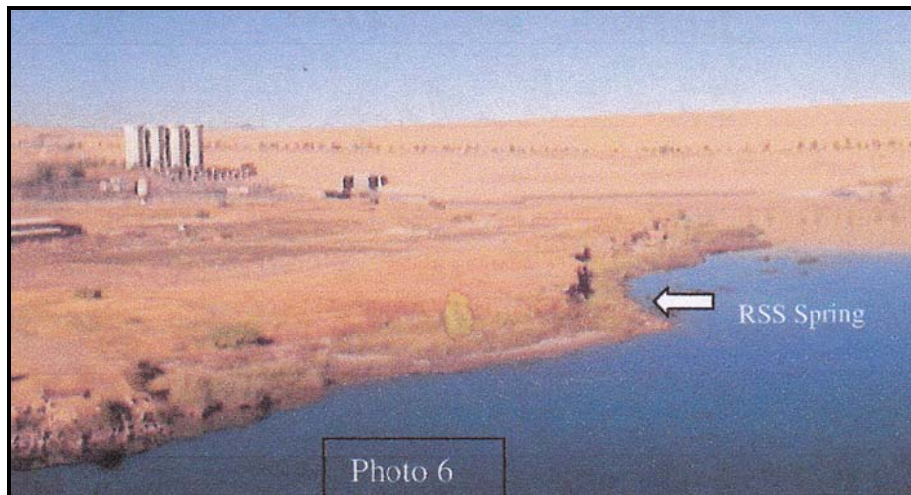
Fig. 21 Spring downstream of dam [9].

The chemical composition of the water in the sinkhole gave the same results as those from Der Maleh aquifer encountered during the excavation of the pump storage scheme tailrace tunnel not very far from the sinkholes location. Further from this area on the same alignment at the river bank one spring was discovered after the erosion of the alluvium cover due to spillway operation. This spring seems to follow the same sinkhole phenomena and its water has same composition of Der Maleh aquifer (Fig. 21).

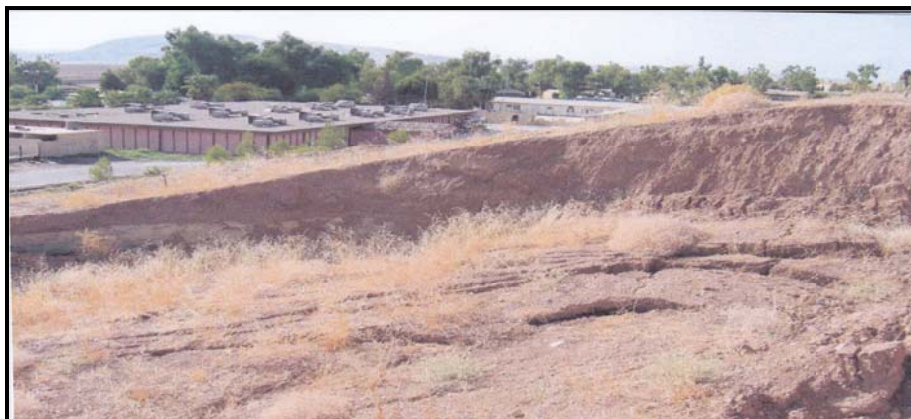
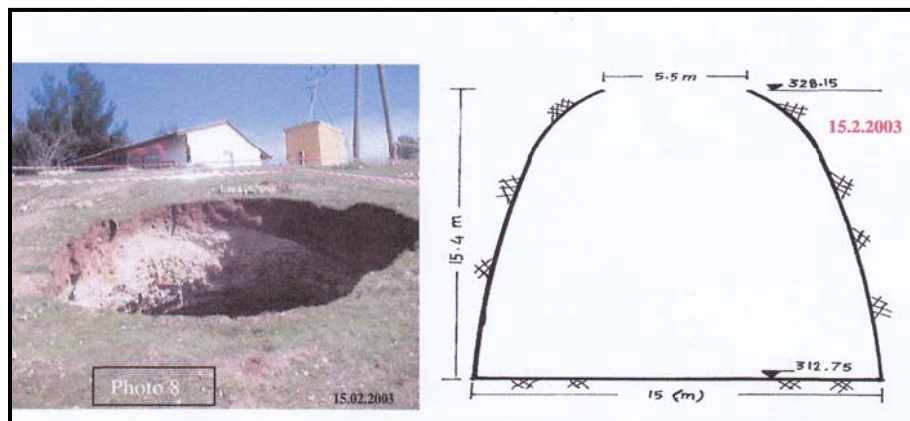
Fig. 22 Photographs of the right bank sinkhole showing development stages and sketch indicating mapped dimensions [9].

By contrast to the right bank sinkholes which began by ground surface cracking followed by ground surface settlement until the occurrence of the full collapse, one sinkhole at the left bank very close downstream of the dam of dam shown in Fig. 22 occurred suddenly in February 2002 without previous warning. It was situated close to housing colony 150 meters downstream of the left flank

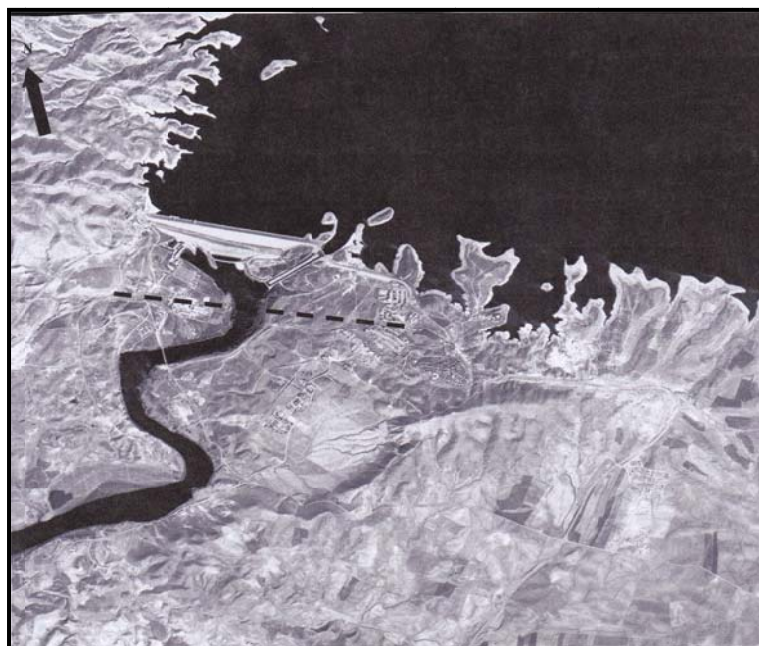
Fig. 23 Aerial view of the Dam area showing alignment of downstream sinkholes [9].

In Fig. 23, this sinkhole seems to be located on the

same line of the other sinkholes on the right bank. One suggestion to the sudden collapse of this sinkholes is the possible infiltration of

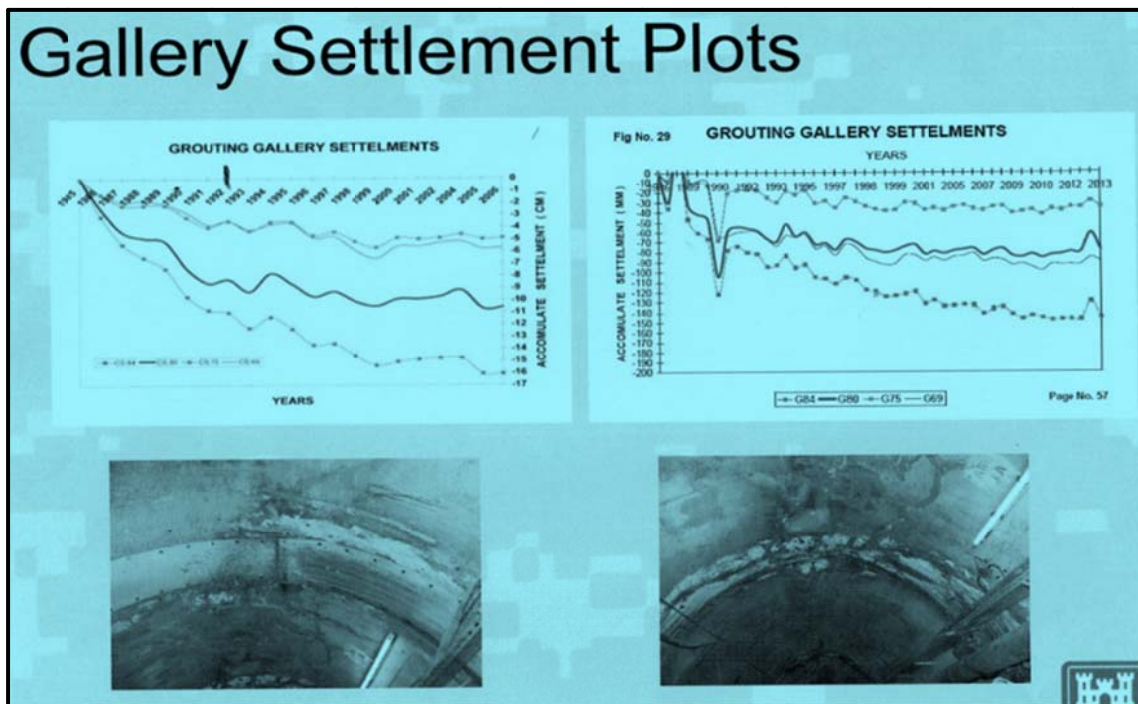
Fig. 26 Cumulative settlements in the grouting gallery recorded in sections 69, 75, 80, and 84 from 1986 till end of 2015.

(3) Signs of increased monolith movement in the grouting gallery and cracks opening were observed and measured. It was concluded that they were direct results of settlement in the gallery and hence in the foundations. The cumulative record of settlement in the grouting gallery which was kept from 1986 and extended to the end of 2015 showed sharp increase in settlement in the last year which indicates a worsening situation in the dam foundations.
