# Discussion on Maintenance Cases of Wind Turbine Components

Huang Ren-Jen

Central Branch, Department of Power Equipment Repair and Maintenance, Taiwan Power Company, No. 643, Sec.2, Jinma Rd. Changhua city, Taiwan, Email address: u592749@gmail.com

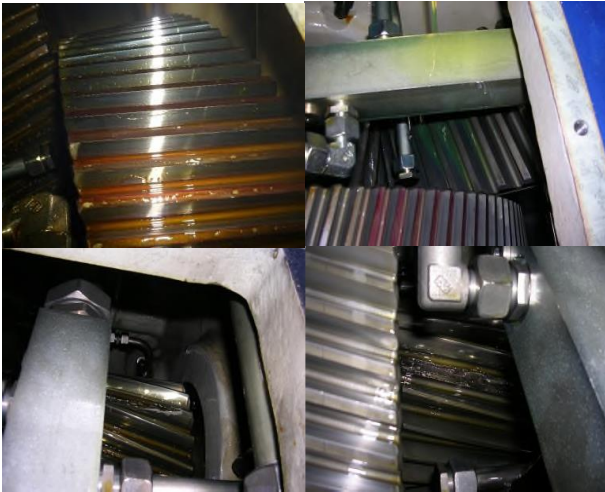
Fig. 5 Visual inspection of gear body and gear teeth.

During each regular inspection, open the observation hole of the gear box and use the endoscope or auxiliary tools to perform the gear body and gear teeth inspection., as shown in Fig. 5. When the gear teeth are found to be cracked, use penetrant testing to check the position and length of the defect, as shown in Fig. 6. Since the gear is immersed in lubricating oil during operation, the oil in the cracks should be removed with a cleaner before the penetrant testing.

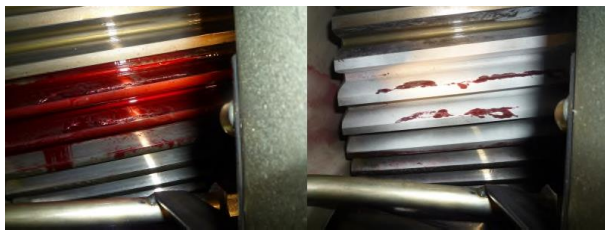
Fig. 6 Gear PT detection.

In addition, in order to prevent the PT material from contaminating the untested area it should be covered before application.

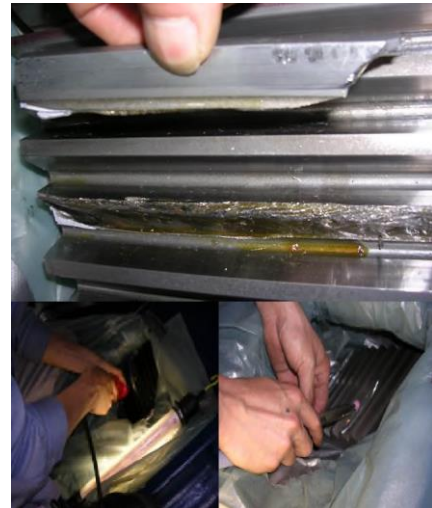
Fig. 7 Remove cracked teeth and grind.

Due to the long time for the purchase of gearbox spare parts, in order to ensure that the wind turbine can to generate electricity, after consolation and evaluation by the wind turbine team of our department, the cracked gear teeth are first ground and repaired as shown in Fig. 7, then, use PT to detect the abrasion

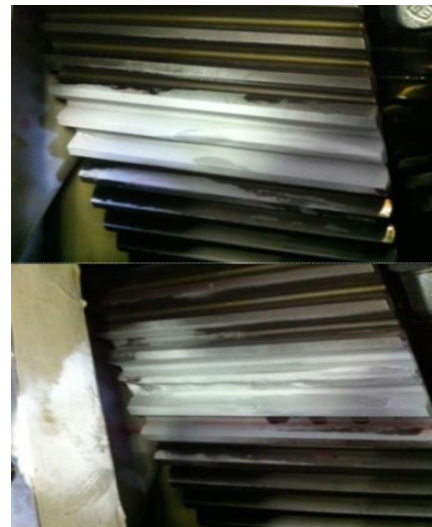
Fig. 8 PT detection.

area, as shown in Fig. 8, remove the cover, then use a magnetic rod to remove the iron chip, and complete the reassembly work. In order to ensure that the gear can run safely in the case of missing teeth, first run at 1/4 load, and then stop for inspection after a week. After observing that there is no abnormality around the missing teeth area, then increase the load to 1/2 load operation. This treatment method has been tested by Zhanggong Wind Farm for many times, and a standard operating procedure has been formulated as a basis for handling when the gear teeth are found to be cracked and there are no replacement parts. This approach not only increases the availability of wind turbines in the wind farm, but also increases its capacity

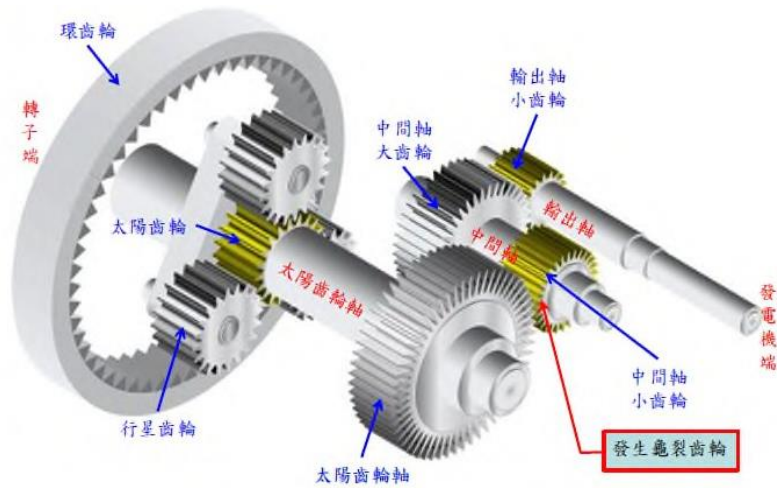
Usually the location of the tooth cracks is mostly on the big and pinion gears of the intermediate, as shown in Figs. 9 and 10. In addition, it can be seen from Fig. 11 that the position of the maximum stress point is also the easiest initial point for cracks and can be used as an area to strengthen weak point detection later.

Fig. 10 Big broken tooth.

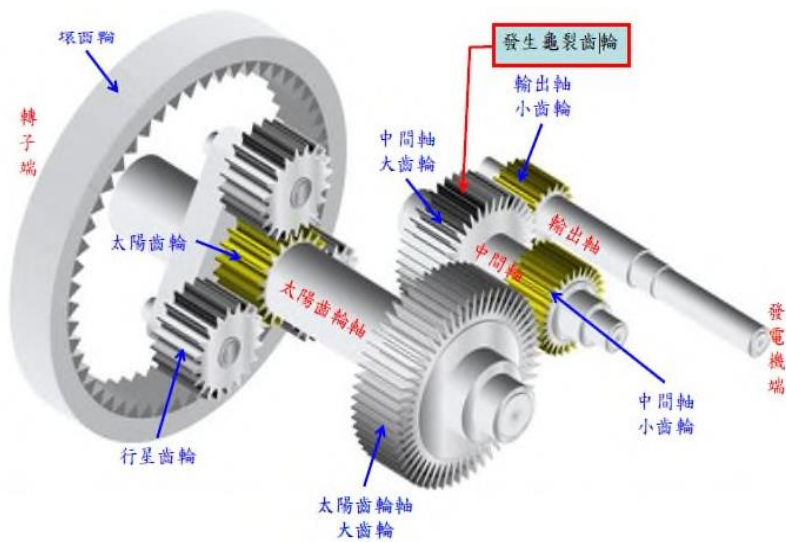
Fig. 11 Pinion broken tooth.

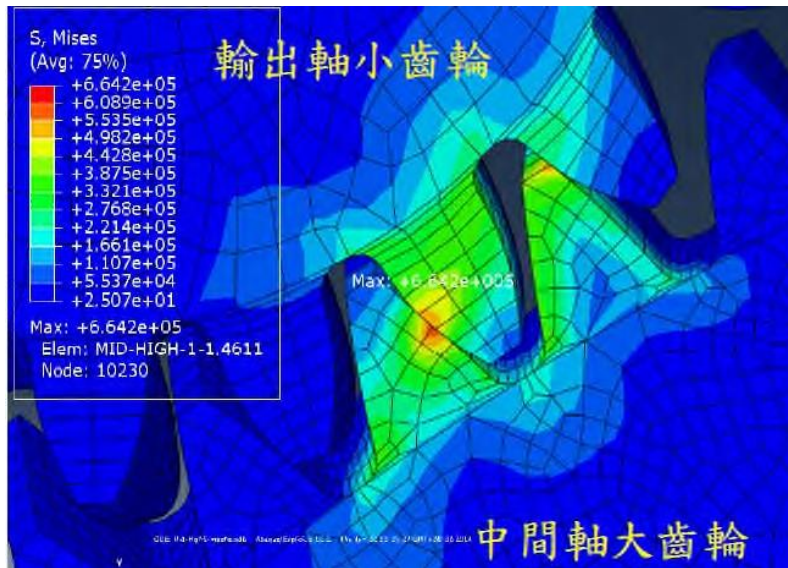
Fig. 12 Maximum stress point of tooth surface.

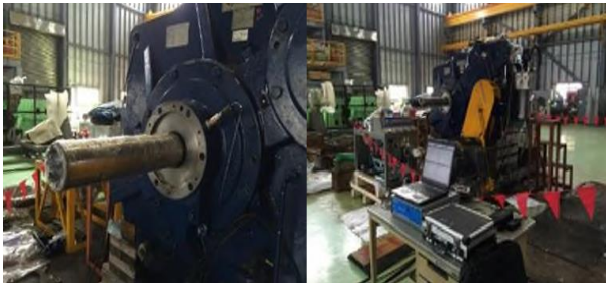
**Fig. 16 Non-load test after gearbox overhaul.**

The repair of the gearbox includes the replacement of broken gears and the replacement of damaged bearings, as shown in Fig. 16. After the assembly is completed, the gear lubricant should be filtered and monitored, and perform 30% (600 rpm), 65% (1,300 rpm), 100% (2,000 rpm).

Non-load running tests, measure the vibration and temperature of the bearing, as shown in Fig. 16. The test results must meet the acceptance standards of the before they can be sent back to the wind farm for reinstallation work.

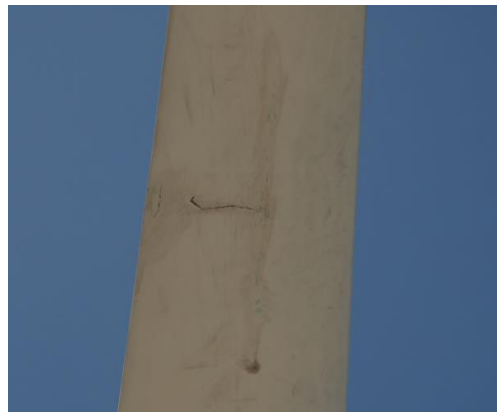
m, and the names of the various parts of the blade are shown in Fig. 17. Telescopes are used to detect and record the abnormal phenomena found in photos, as shown in Fig. 18. In addition to visual inspection, when the wind turbine is in operation, people can stand under the wind turbine and listen to whether there is any abnormal sound. If the surface of the blade is peeled off, the abnormal sound can be heard.

**Fig. 18 Defective blade.**

When the blade inspection finds cracks or peeling of the surface layer, the repair work can be carried out after the assessment does not affect the structural strength. This work needs to be performed by qualified personnel. Fig. 19 is a certificate of conformity. The repair also needs to be executed in accordance with the original factory’s SOP, the execution process is shown in Fig. 20.

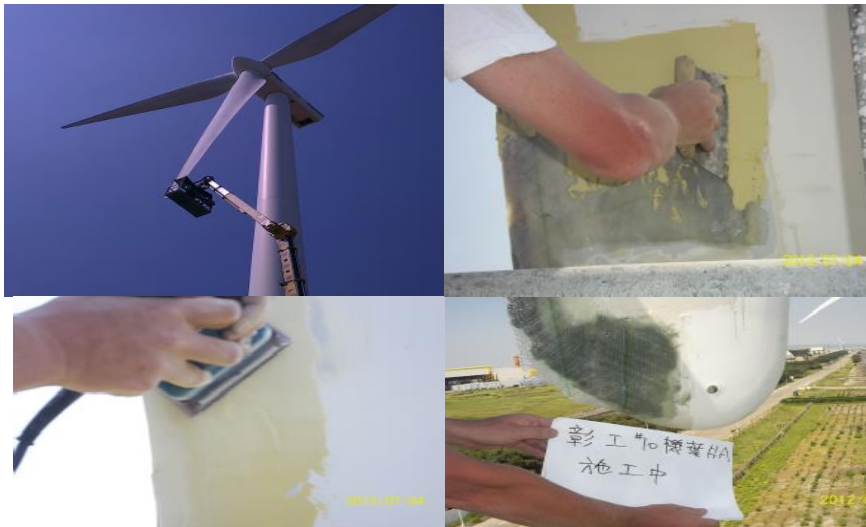
Fig. 20 Wind turbine blade repair project.

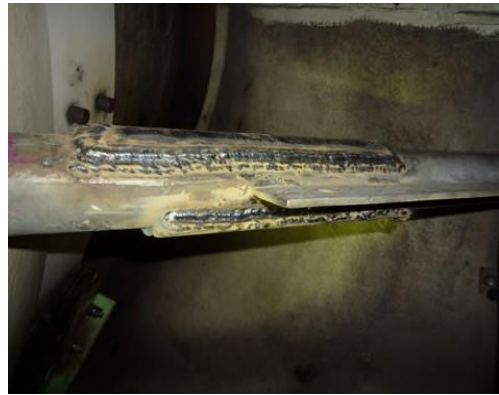
**Fig. 25** Welding is complete.

Regarding the repair of cracks or breaks in supporting members, firstly remove the defects, fix them with stiffening plates, and then repair them by welding. Since the wind turbine nacelle and blades are made of flammable FRB, the surrounding area must be covered with a fire-resistant blanket before welding. The welding process must avoid welding slag splashing, and all safety protection measures must be taken. The whole process is shown in Figs. 22-25. Because the wind turbine is in operation, its related components are subjected to an amplitude stress, so the wind turbine components often suffer from fatigue. As fatigue is a failure mode without warning,

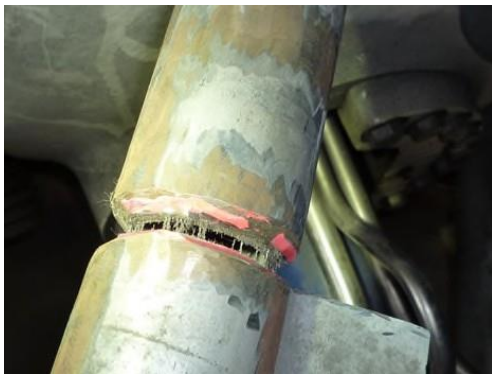
The function of hub is to join the structure of three blades, as shown in Fig. 21. The failure situation is that the support frame used to fix the component is broken. Therefore, in the routine inspection, the integrity of all supporting members must be checked in detail. If cracks or fractures are found in the supporting members, a repair plan shall be adopted, because the entire hub has to support the dynamic and static loads of the three blades, if the support frame breaks, it will cause soft feet, resulting in unbalanced support and affecting operational safety.

**Fig. 22** Weld preparation.

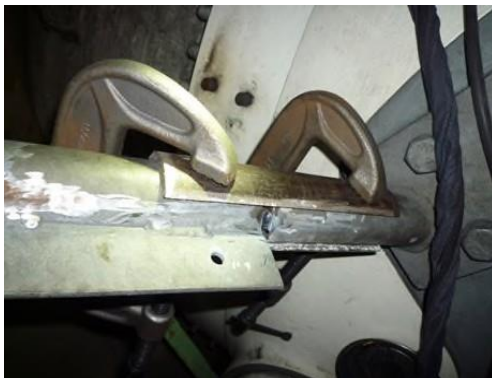
**Fig. 23** Fixed with stiffer.

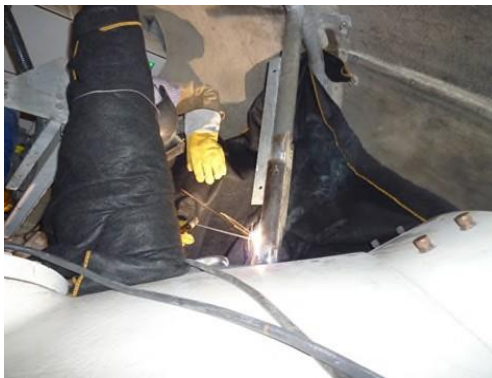
**Fig. 24** Welding work.
