# Evaluation and Repair of a Reinforced Concrete Structure: A Case Study

Fábio Giovanni Xavier de Oliveira<sup>1</sup> and Flávio Roberto Xavier de Oliveira<sup>2</sup>

1. Department of Engineering, Rehabilitar Engenharia Ltda., João Pessoa, Paraíba 58051-127, Brasil

2. Design Department, FR Projetos e Consultoria Ltda., João Pessoa, Paraíba 58051-840, Brasil

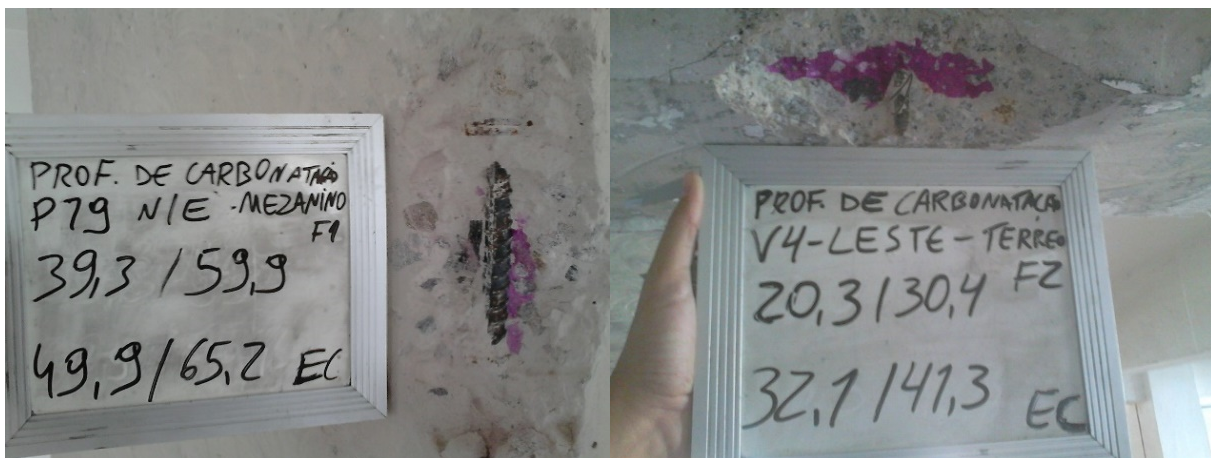
The carbonation thickness measurement test was done by sprinkling a solution of ethanol ( $C_2H_5OH$  or  $C_2H_6O$ ) with 1% pure phenolphthalein ( $C_{20}H_{14}O_4$ ) [15]. When meeting some medium or substance with a pH above approximately 9.5, this solution turns red, while at a lower pH it remains colorless, as can be seen in Fig. 2.

Fig. 2 Concrete carbonation/cover thickness test.

The qualitative test for the presence of chlorides indicated that the free chloride content in the region around the reinforcement was not sufficient to allow for steel depassivation, a fact confirmed by the concrete carbonation test, which showed that in all corroded regions, the carbonation front was deeper than the concrete cover's thickness.

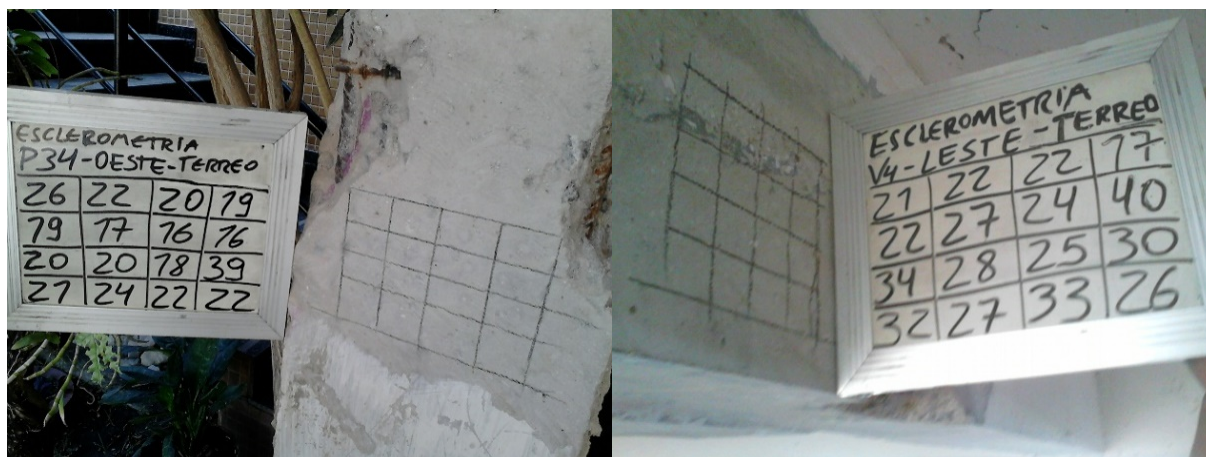
Fig. 3 Sclerometry test detail.

To guarantee the absence of reinforcement in the concrete, a James Instruments model HR-7500 analog rebar locator was used, and this verification was carried out at all points where the Rebound Hammer tests were done. Some results are seen in Fig. 3.
