# The Inspection of Level Crossing Rails Using Guided Waves

Mark Evans

*Guided Ultrasonic Ltd, Brentford TW8 8HQ, UK*

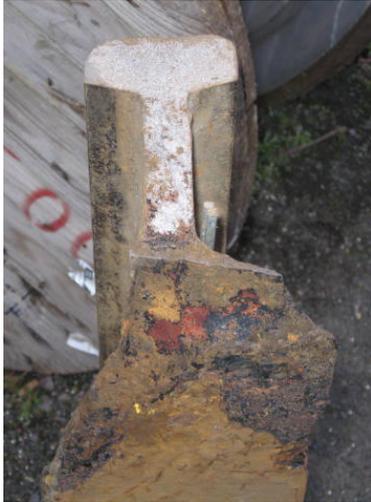
Level crossings allow road traffic to cross railway lines at track level by means of a set of removable roadway panels (often referred to as the 'deck'), which fit between the rails. The deck panels vary in materials and geometry but fit tightly between the rails with the minimum gap required to allow the passage of trains. This inevitably means that the rail within the crossing is not visible (apart from the top of the head and gauge-face). Additionally, the deck panels tend to trap moisture and road-salt around the rail causing accelerated corrosion of the lower sections of the rail, especially the toe, see Fig. 1.

**Fig. 1** Corrosion of the rail foot commonly found within level crossings with little or no loss in rail depth.

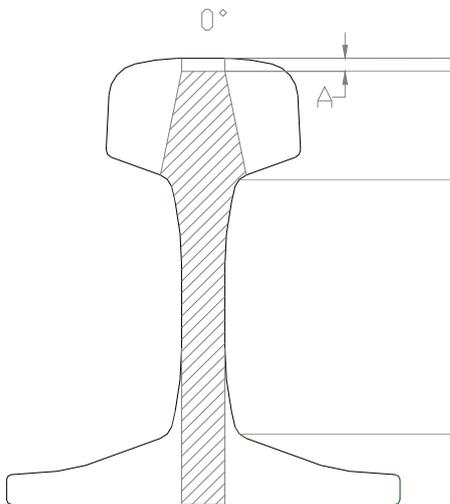
**Fig. 2** The tested area of the rail using the zero degree ultrasonic rail depth measurement is limited to the centre-line only.

The main ultrasonic test method which is most applicable to level crossings is known as U15 in which the depth of the rail at the centre-line is measured using a vertically oriented (zero degree) transducer, as shown Fig. 2 [1]. The corrosion found at level crossings typically does not affect the centreline but is concentrated at the toe sections of the rail as shown in Fig. 1, therefore, the result of the U15 inspection often does not correlate with the rail condition within the crossing and potentially catastrophic defects can go undetected. Additionally, some crossings cannot be ultrasonically inspected with the manual inspection trolley as the flanges on the inspection wheel will not fit between the rail and the deck.

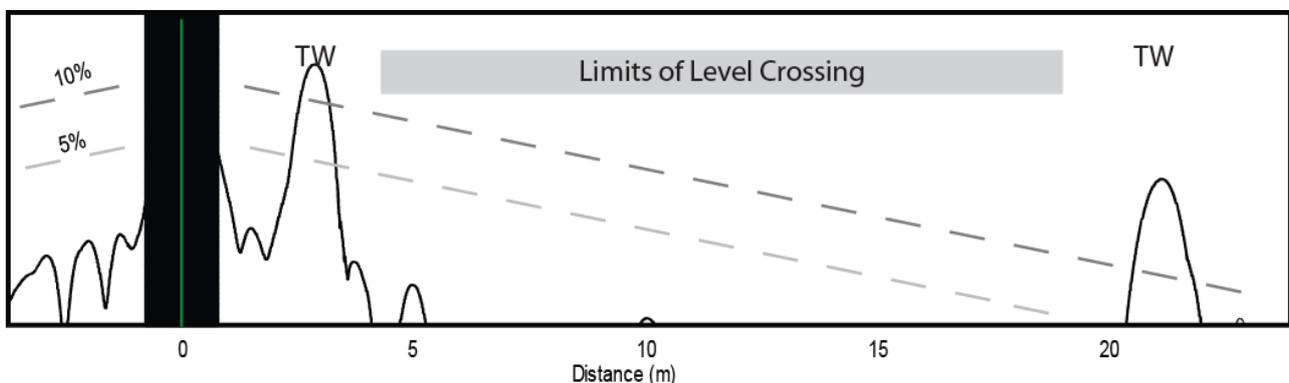
This was one of the first level crossings to be tested for the trials. The A-Scan result for one of the rails is shown in Fig. 6 where the limits of the crossing are indicated by the grey shaded area. The 5% DAC curve is the lowest intervention level and the results clearly indicate that no indications of concern were detected anywhere within the crossing. This was later verified visually; see Fig. 7, which shows only light surface scaling and no measureable loss of cross section.

Fig. 6 GWT result from Mansfield Road level crossing showing no significant indications.

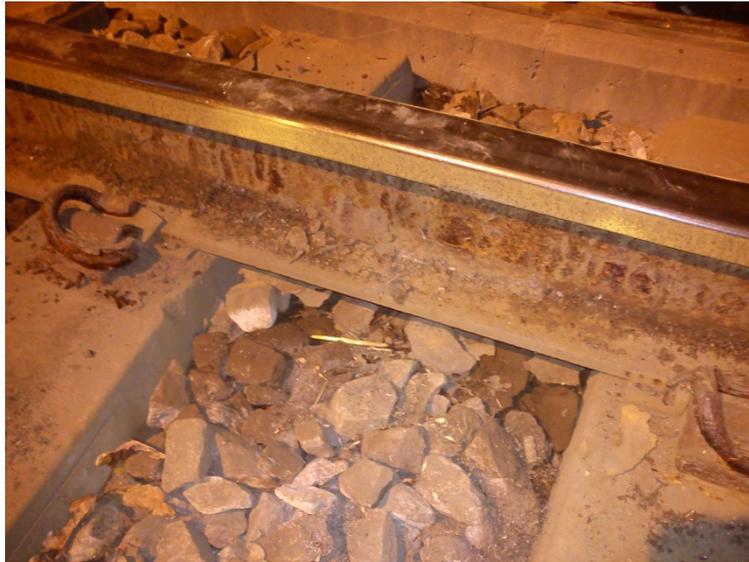
Fig. 7 No significant corrosion of the rail at Mansfield Road level crossing.

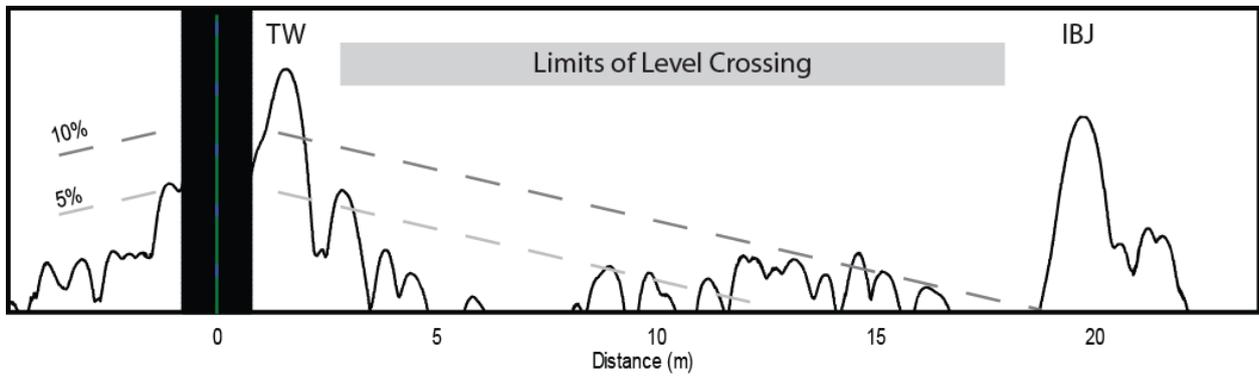
The Belmont Forest level crossing was inspected and the A-Scan result for one of the rails is shown in Fig. 8. Severe indications of between 10% and 15% cross sectional loss were detected between 8.9m and 16.5m section. Subsequent lifting of the crossing revealed extensive corrosion of the rail foot causing large reductions in the cross section of the rail which required immediate emergency action.

Fig. 8 A-Scan result for Belmont Forest showing severe indications of between 10% and 15% cross sectional loss.

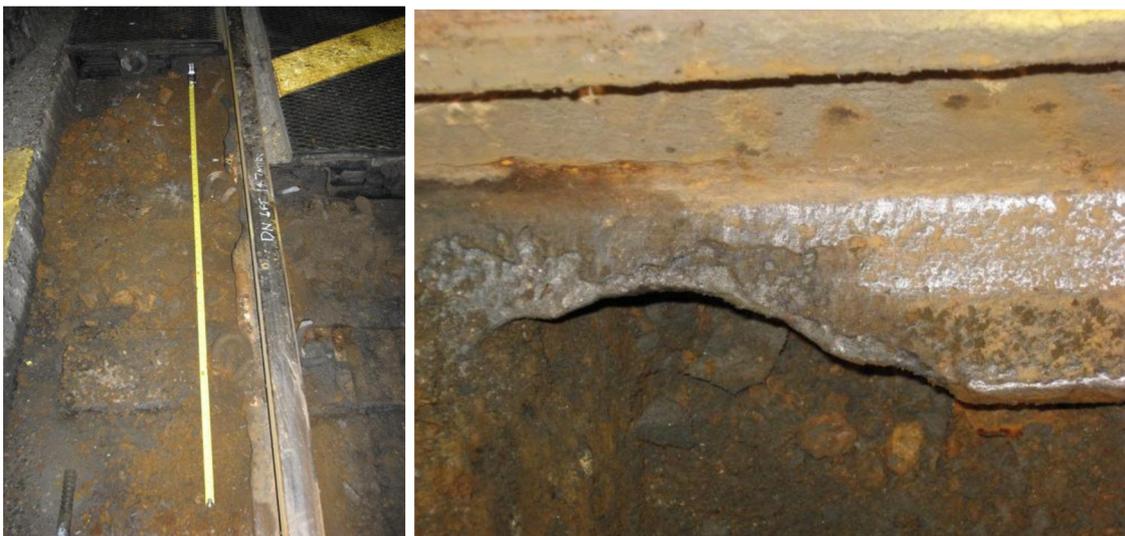
The case-study for Belmont Forest, shown in the results section of this paper, is good example which highlights the limitations of UT inspection at level crossings. In this case a recent UT inspection had not detected any significant problem with the rail shown in Fig. 9 which required emergency replacement.

It is important to emphasize at this point that the regular UT inspections of the rails at this crossing, one of which was carried out a less than 4 weeks prior, did not indicate any significant corrosion of this rail.

Fig. 9 The corroded section, at between 8.9m and 16.5m on the A-Scan result shown in Fig. 8, was then verified using VT showing severe corrosion of the toe section of the rail.
