## A Case Study on Construction Dewatering-Induced Settlement Damage: Could This Have Been Avoided?

Key words: Consolidation, de-watering, construction claim, geotechnical uncertainties.

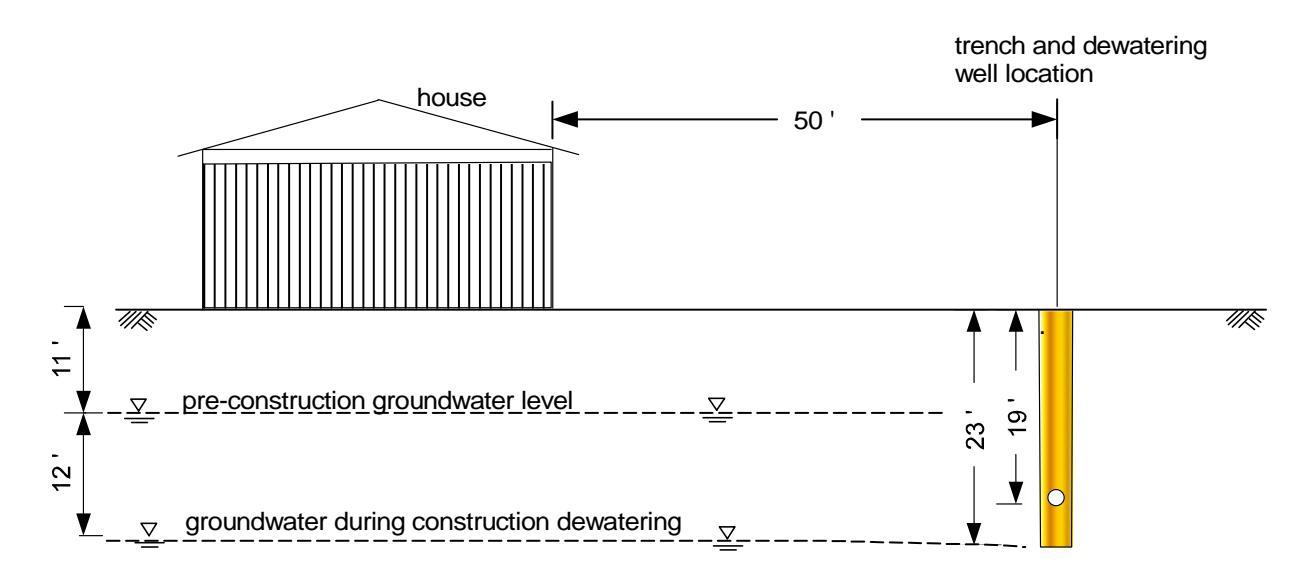
Fig. 1 Subsurface cross-section at the site (Note: dimensions shown are to the nearest foot).

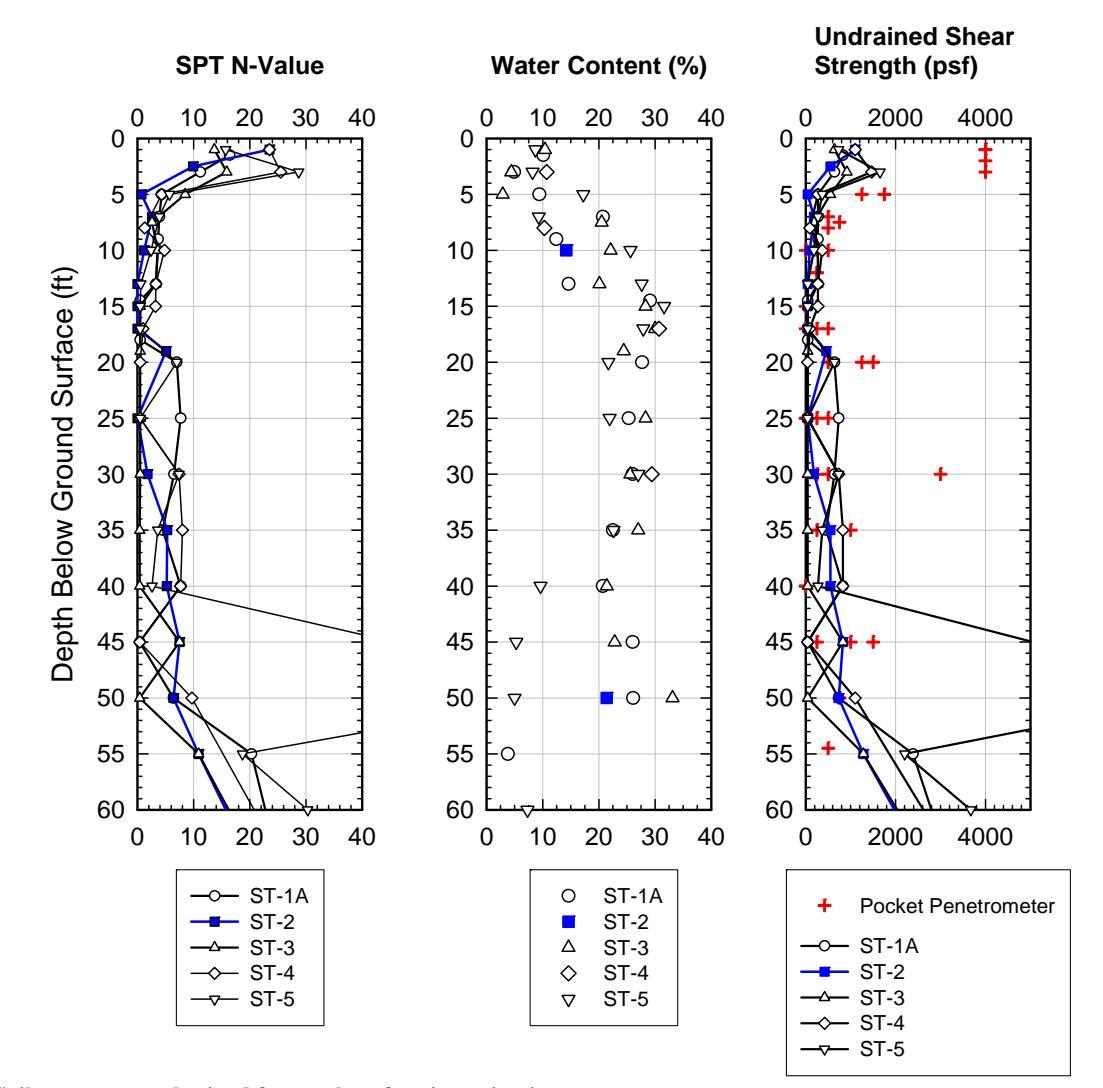
Geotechnical reports compiled for the project site indicate that subsurface conditions in the vicinity of the residence consist of fine-grained alluvial soils underlain by coarse-grained alluvium over shale bedrock. Fig. 2 contains plots of field-corrected SPT N-values, laboratory water content measurements, and undrained shear strength estimates for soils encountered in five investigative borings labeled ST-1A through ST-5. Data points representing soils in boring ST-2 are shown as bold blue squares in Fig. 2. This boring was closest to the subject residence (approximately 300 ft from the house), and is probably most representative of the soil conditions at the house.

Data and information from the geotechnical reports indicate soils at the site generally consist of a stiff surficial crust underlain by soft compressible fine-grained soils to a depth of about 50 ft below the ground surface. Data from the five soil borings plotted in Fig. 2 show the presence of a stiff layer from the ground surface to a depth of about 5 ft. Corrected SPT N-values in this region generally range between 10 and 30, and the estimated average undrained shear strength

Fig. 2 Soil parameters obtained from subsurface investigation.

is about 1100 psf. The SPT N-values and estimated undrained shear strength values decrease markedly below this layer. The reported N-values are quite low from a depth of 5 ft down to the top of the sand and gravel layer, which was encountered at a depth of about 50 ft in soil boring ST-2. Static groundwater was reported at a depth of about 15 ft in soil boring ST-2 on the date of drilling.

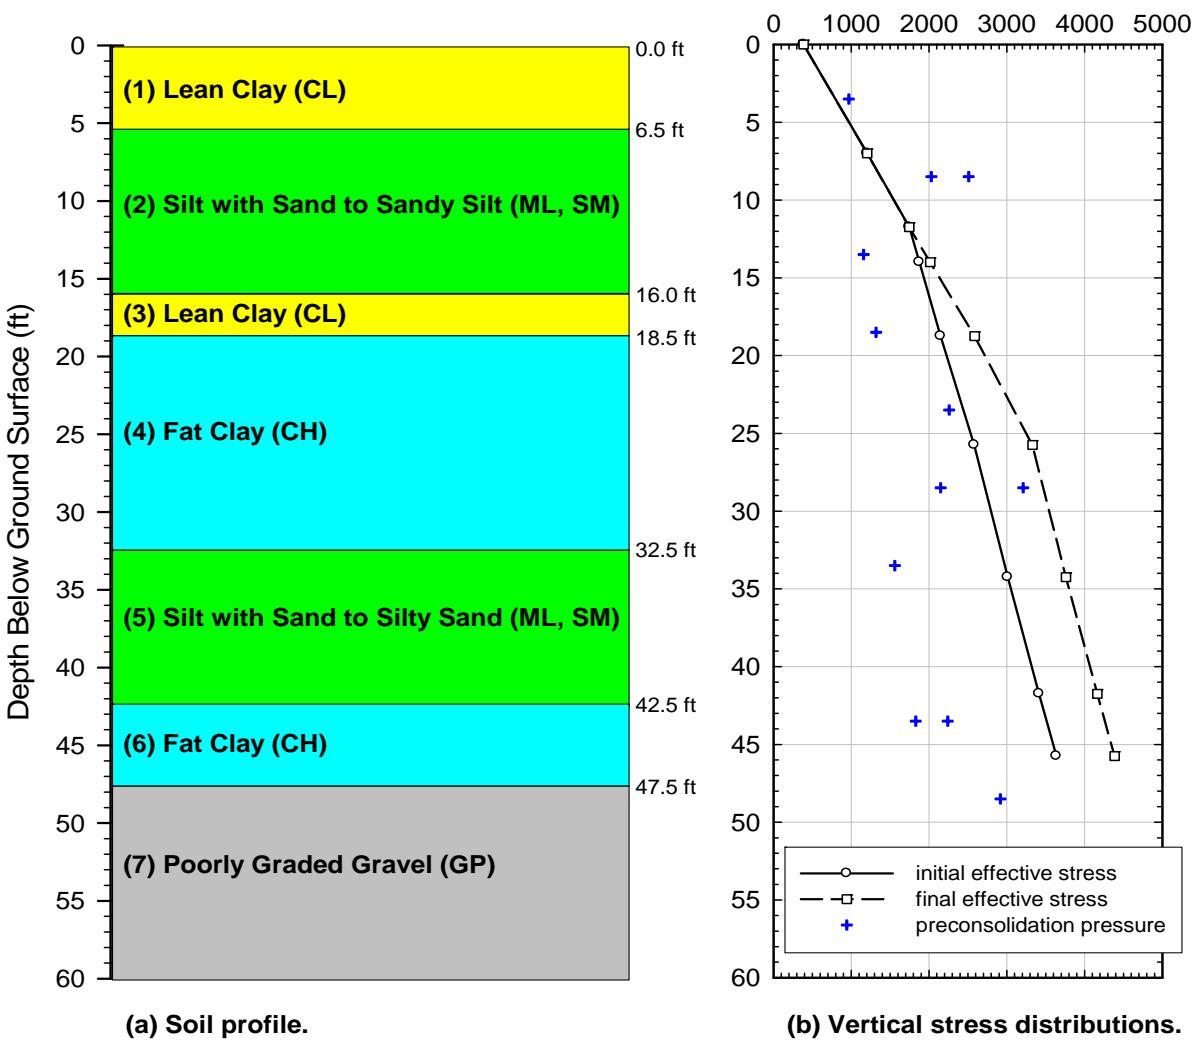
Fig. 3 Representative soil model for settlement analyses.

A consolidation analysis was conducted using laboratory test results generated during the claim investigation in conjunction with the subsurface model shown in Fig. 3. A computer program that uses a numerical analysis procedure was employed to calculate the magnitude and rate of consolidation settlement. Conventional Terzaghi consolidation equations were used to determine the magnitude of the ultimate consolidation settlement, after the excess pore pressures are dissipated. A finite difference approximation was used to calculate the rate of consolidation settlement and the rate of dissipation of excess pore pressures. Time rate values of soil consolidation are represented by the coefficient of consolidation, cv. Values of cv obtained from consolidation tests are plotted in Fig. 4a. The assumed

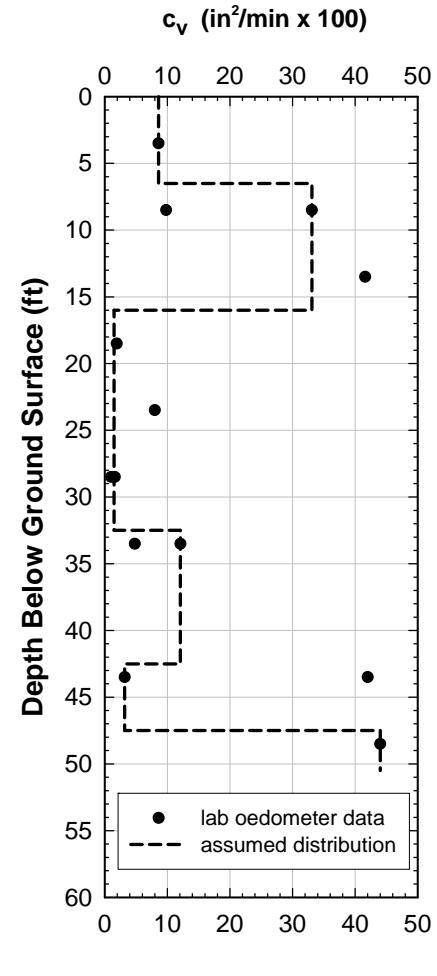
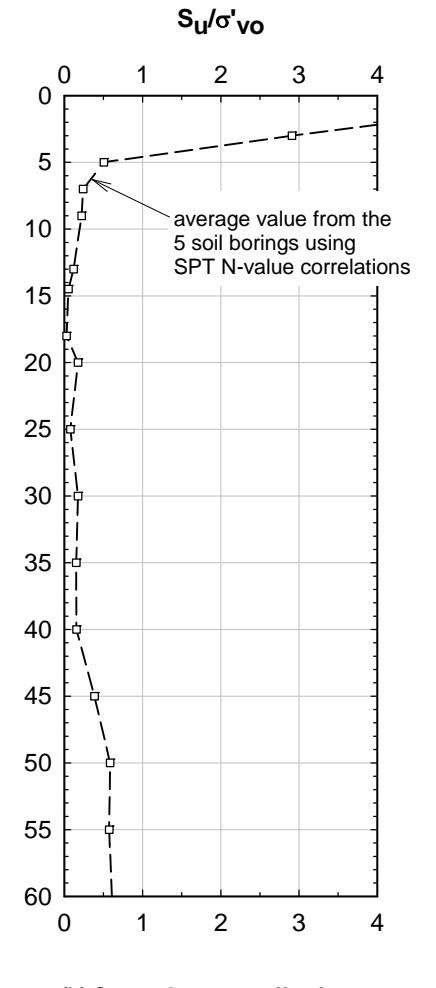
Laboratory consolidation tests indicate the soils are likely normally consolidated. This observation is further supported by the estimated distribution of  $S_u/\sigma'_{vo}$  with depth that is shown in Fig. 4b. Published data in the technical literature [2-4] indicates that  $S_u/\sigma'_{vo}$  ratios less than about 0.45 are indicative of normally consolidated soils. As shown in Fig. 4b, the fine-grained soils underlying the desiccated crust would be considered normally consolidated based on the calculated  $S_u/\sigma'_{vo}$  distribution, which is generally less than 0.2 from about 6 to 40 ft below the ground surface.

(a) Data for time-rate analyses. Fig. 4 Soil compressibility and strength data.

(b) Strength versus effective stress.

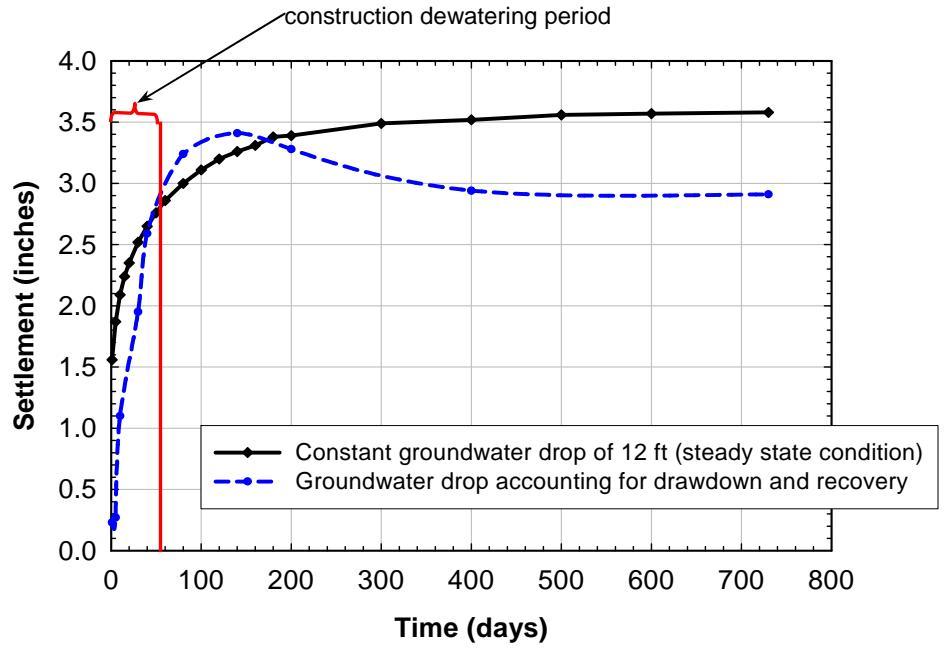
Consequently, the available geotechnical data (including both consolidation and strength tests) indicates the soil deposit is normally consolidated. Using from the defendant's measured data geotechnical report, the calculated primary consolidation settlement amounts range from about 3 to 3.5 inches, as shown in Fig. 5. The solid line in Fig. 5 was calculated using a constant groundwater drawdown level of 12 ft, while the dashed line was calculated using the drawdown and recovery curve obtained from a dewatering test adjacent to the site. The magnitudes of settlement shown in Fig. 5 are consistent with the settlement damage that was observed and documented at the residence.

A report produced by the defendants presents a calculated settlement estimate approximately 75% less than the amount shown in Fig. 5. The discrepancy is believed to occur in the assumptions used to evaluate the data and inconsistencies in the data itself. As with most analyses involving the prediction of soil response, there is seldom a single "correct" answer, but rather a predictive range or probable outcome. Variability introduced in calculations as a result of inaccurate assumptions or erroneous data can decrease the

Fig. 5 Calculated settlement assuming soil is normally consolidated.

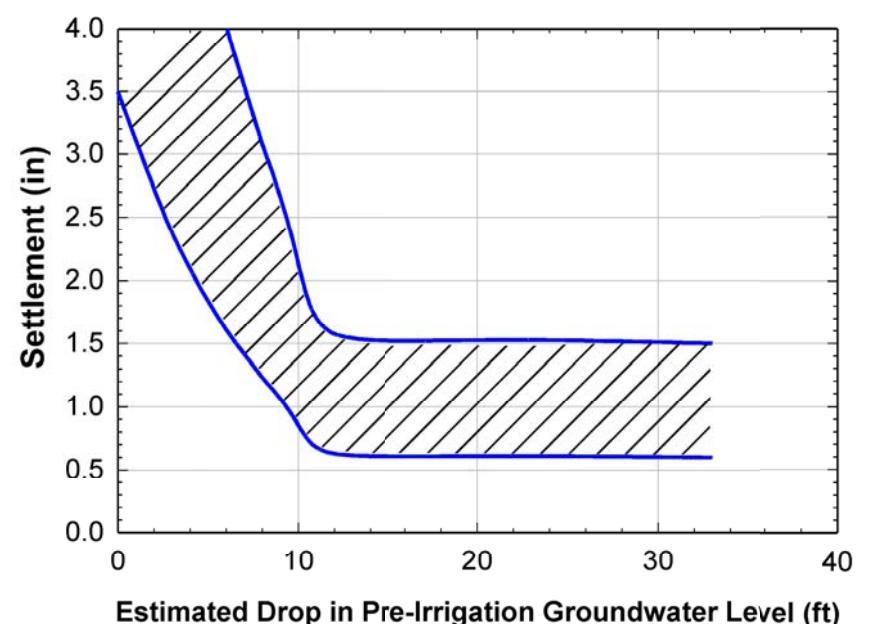
Fig. 6 shows the variation in calculated settlement in relation to the assumed historic water level. Uncertainty in the settlement prediction increases as additional variables are examined. In this case, the assumption regarding historic water levels is superimposed with the error factor in the  $C_r$  soil parameter. Considering these two parameters, the variability in the settlement prediction (or margin of error) now increases from 1.2 in to 3.4 in. The high end of this range corresponds to a condition in which the pre-irrigation groundwater level is similar to the current groundwater level, in which case the soil deposit would be normally consolidated.

This parametric analysis indicates that damaging settlements would have been possible whether the historic pre-irrigation groundwater level was 33 ft or 46 ft below current levels.

Fig. 6 Variation in calculated settlement as a function of historic groundwater levels.
