# Analysis of the Influence of New Usages on the State of Conservation of Historical Buildings through Microclimate Characterization

**Abstract:** Recycling is an alternative for preserving historical heritage buildings. Through such process, buildings are occupied by new usages that assure they are not abandoned. However, conservation issues, like pathological manifestations by filamentous fungi, are common even in buildings receiving new uses. Thus, it is extremely important to know the microclimate behavior of these buildings and analyze if there are usages that favor the appearance of filamentous fungi or not. This study aims to verify if new usages modify the microclimate in historical buildings and if such possible change favors the appearance of pathological manifestations by filamentous fungi in some specific use. To achieve the results, three buildings that have gone through recycling processes were chosen in the city of Pelotas, in Southernmost Brazil. The city possesses a large number of buildings with historical value and its climate conditions are propitious for appearance of filamentous fungi. For 12 months, microclimate was monitored, the environments *modus operand

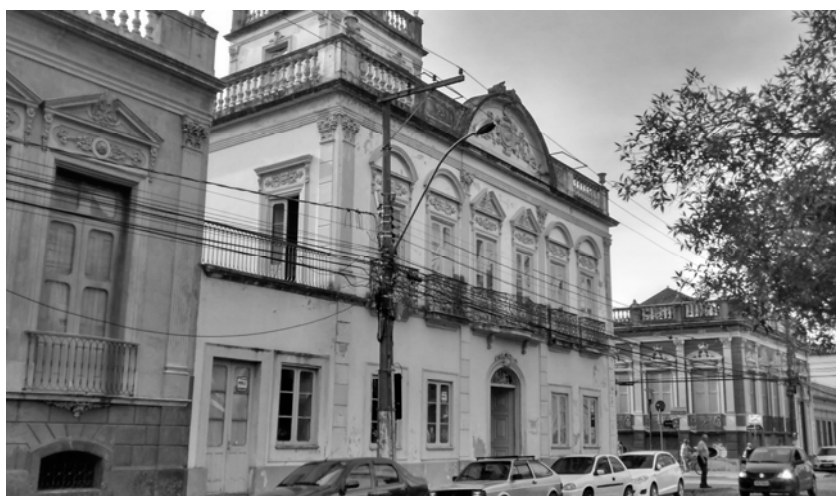
**Fig. 2 Casarão 2.**  
Source: the authors.

The three buildings in the case study were built in the 19th century and their ensemble was registered by the National Historic and Artistic Heritage Institute, highlighting their historical value [3]. They all present the same construction system: masonry of solid bricks and lime-based plaster. Because it was built before the others, Casarão 2 does not have a high cellar, which

means its ground floor is not ventilated like the others. A common feature at the three houses is the great thickness of their walls': 60 to 90 cm in the external walls, providing high thermal inertia. The three mansions are presented in Figs. 2-4.

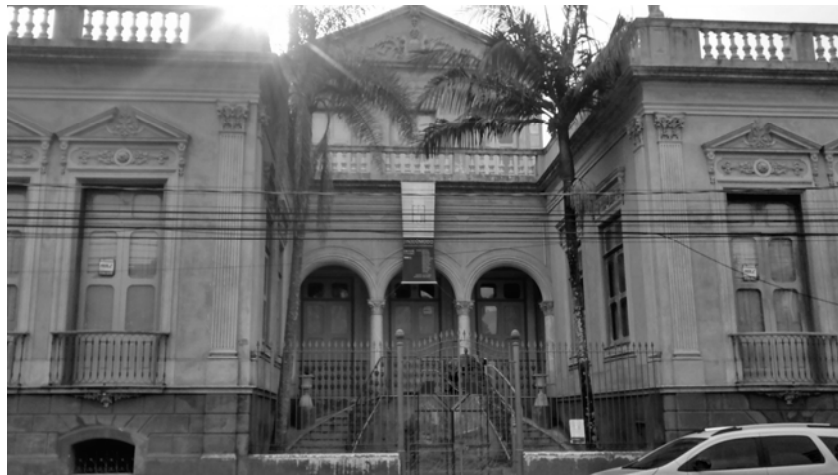
**Fig. 3 Casarão 6.**  
Source: the authors.

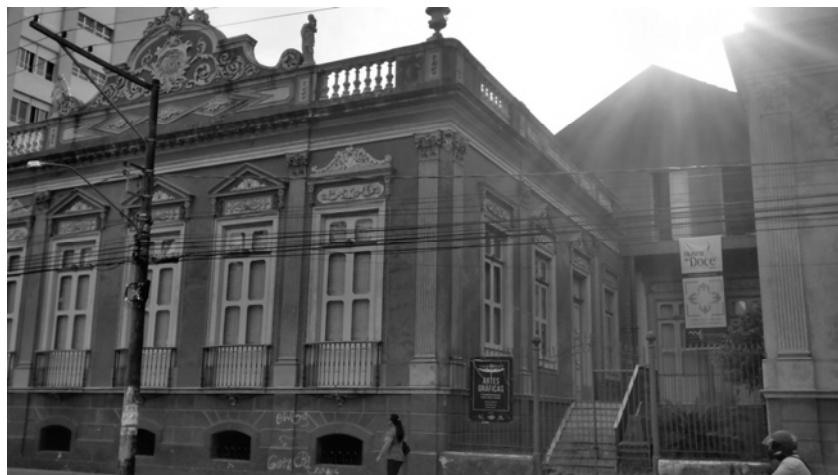
**Fig. 4 Casarão 8.**  
Source: the authors.

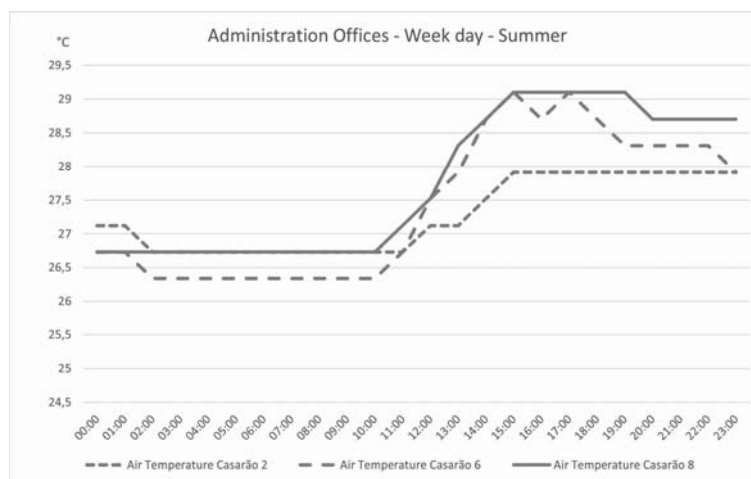
**Fig. 5 Thermal behavior on a summer week day—administration offices.**

With Tables 4 and 5, it is possible to notice that in week days in summer internal temperatures in environments used as administration offices began to rise only by the end of the morning in all buildings, due to the walls' great thickness.

In winter, temperatures did not vary significantly, the same way they did not rise along the day outside either, as seen on Figs. 5 and 6.

Number 2 presented a different curve from the others. In this environment, air temperature values were milder than in the others during summer, since users operated windows searching to block solar incidence and thus, the heat inside. Curve was also different during winter, since there were more users compared to the other buildings and solar incidence was no longer controlled, increasing the production of heat inside the environment. Casarão 8, even having users, has more depth regarding windows, allowing them to be open without causing thermal discomfort.

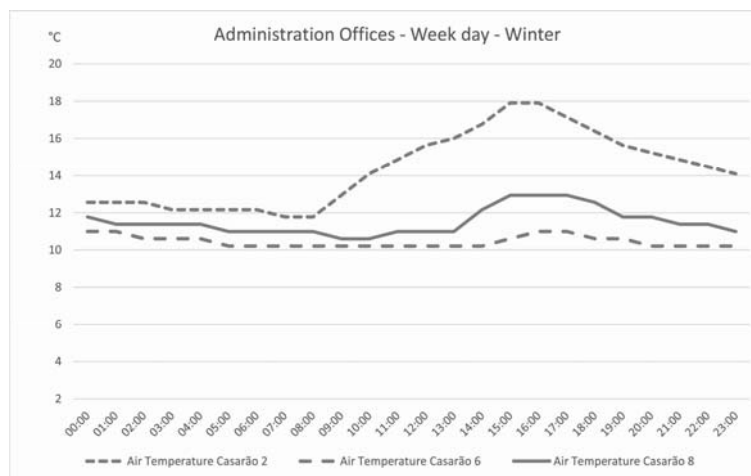
**Fig. 6 Thermal behavior on a winter week day—administration offices.**

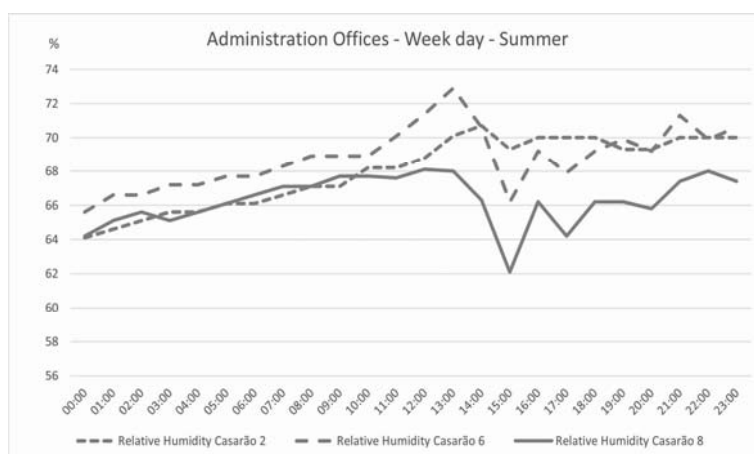
**Fig. 7 Hygroscopic behavior on a summer week day—administration offices.**

Besides these results, it was also noticed that the unused building, Casarão 6, presented higher values for relative humidity in both periods—Figs. 7 and 8. In summer, there were no pathological manifestations related to filamentous fungi. On the other hand, in

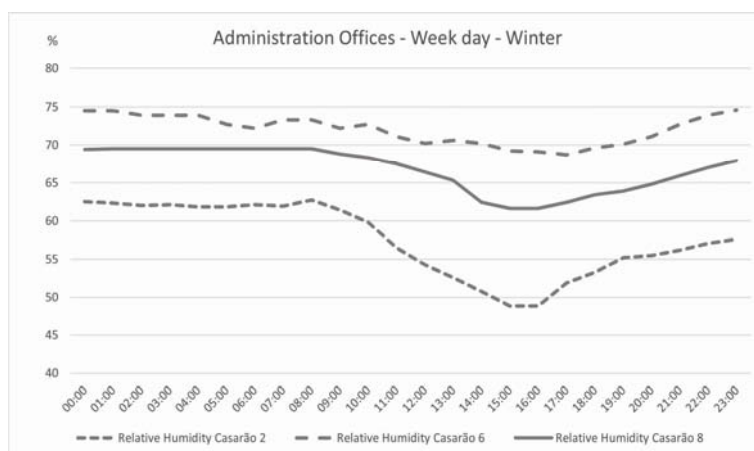
**Fig. 8 Hygroscopic behavior on a winter week day—administration offices.**

winter, there was a higher incidence of filamentous fungi than in the other buildings. In the administrative environment of House Number 2, incidence of filamentous fungi was low in both periods. In Casarão 8, there were no pathological manifestations.

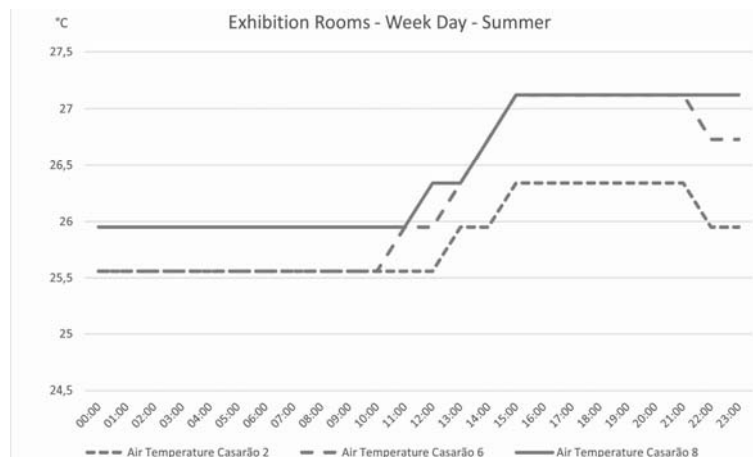
**Fig. 9** Thermal behavior on a summer week day—exhibition rooms.

In a week day with the exhibition room usage, environments of all the buildings presented the same behavior of the ones used as administration offices, regarding thermal delay—Tables 6 and 7. That means that, in the same way, in summer, internal temperatures began to rise by the end of the morning and in winter, they did not change in a significant way—Figs. 9 and 10. In this use, curves are equivalent and so is the hygroscopic behavior—Figs. 11 and 12—as exhibitions rooms do not present internal sources of humidity. Even though they are

equivalent, the highest internal temperature levels in summer were registered in Casarão 8, while in winter, the highest values were found in Casarão 2. This happened due to the thermal changes of the construction in contact with the ground. The environment in Casarão 2 also presented a high incidence of pathological manifestations by fungi in both periods. It is important to remind that this is the only one of the three buildings that does not have a high cellar, which means the ground floor does not have a source of ascending humidity. In Casarão 6, pathological manifestations were only registered during winter and in Casarão 8 no filamentous fungi were found.

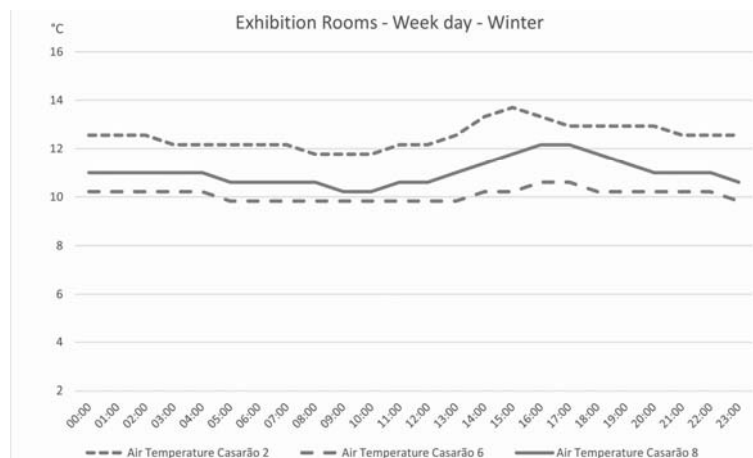
**Fig. 10** Thermal behavior on a winter week day—exhibition rooms.

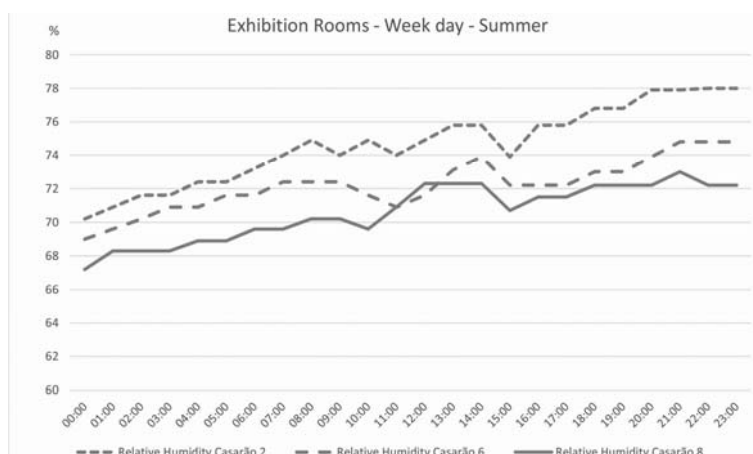
**Fig. 11** Hygroscopic behavior on a summer week day—exhibition rooms.

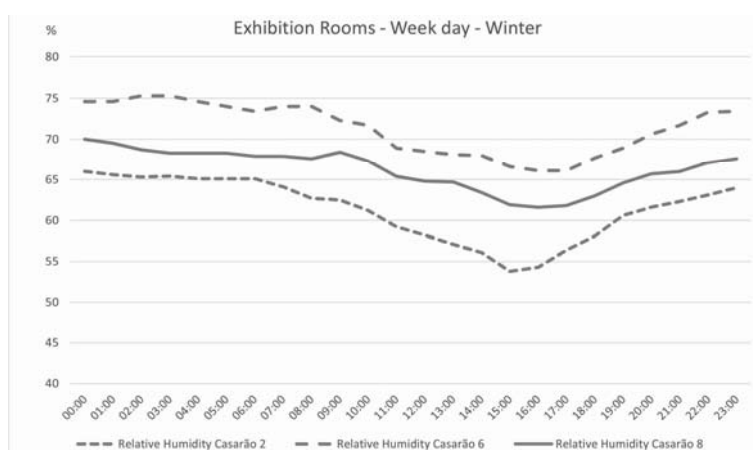
**Fig. 12** Hygroscopic behavior on a winter week day—exhibition rooms.

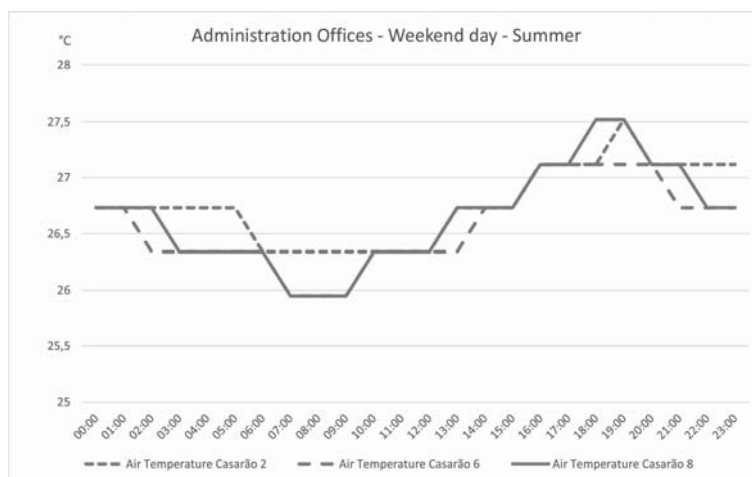
**Fig. 13 Thermal behavior on a summer weekend day—administration offices.**

Since the three buildings are closed and present the same construction characteristics, behavior should be similar. That was confirmed during summer, when temperature and relative humidity curves were equivalent and values were close. However, in winter, Casarão 2 presented higher temperatures (Figs. 13 and 14) and lower relative humidity levels (Figs. 15 and 16), differing from the others.

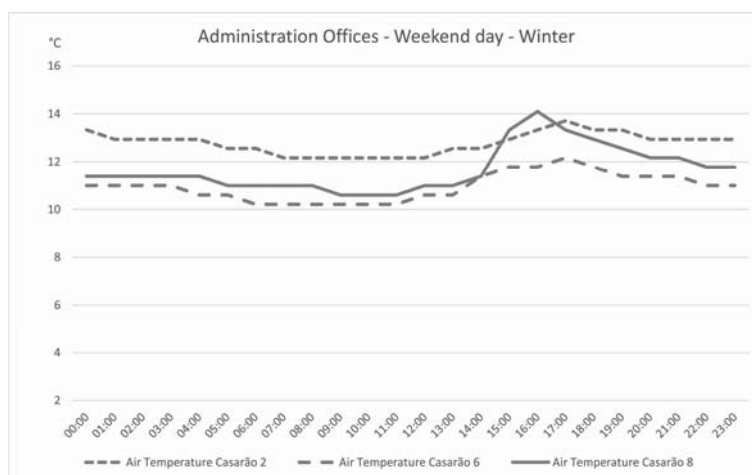
**Fig. 14 Thermal behavior on a winter weekend day—administration offices.**

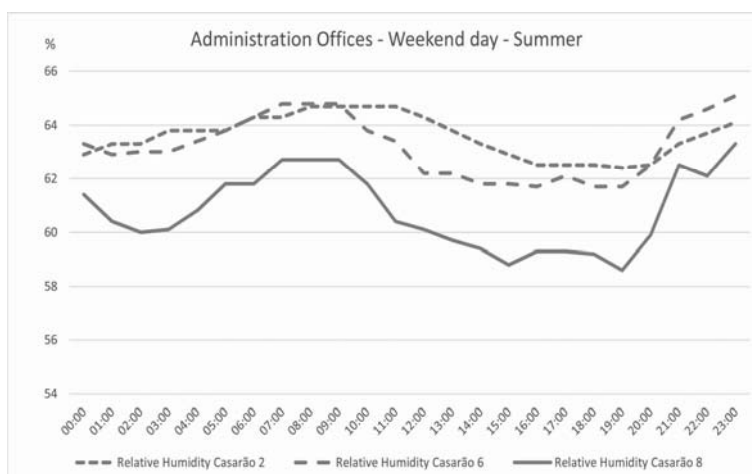
**Fig. 15 Hygroscopic behavior on a summer weekend day—administration offices.**

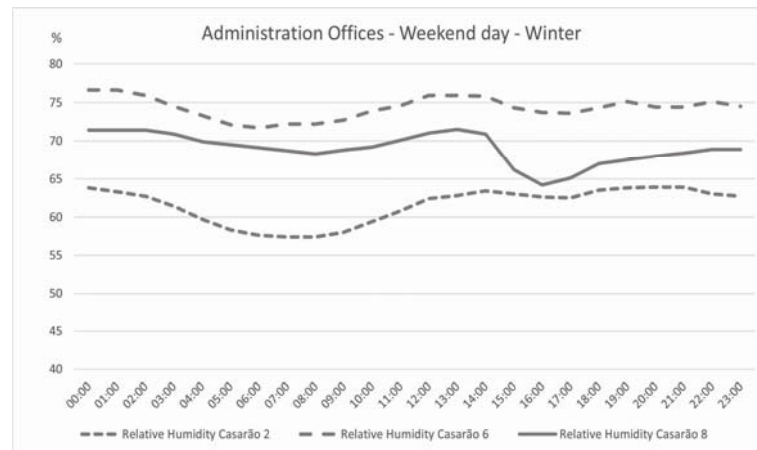
**Fig. 16** Hygroscopic behavior on a winter weekend day—administration offices.

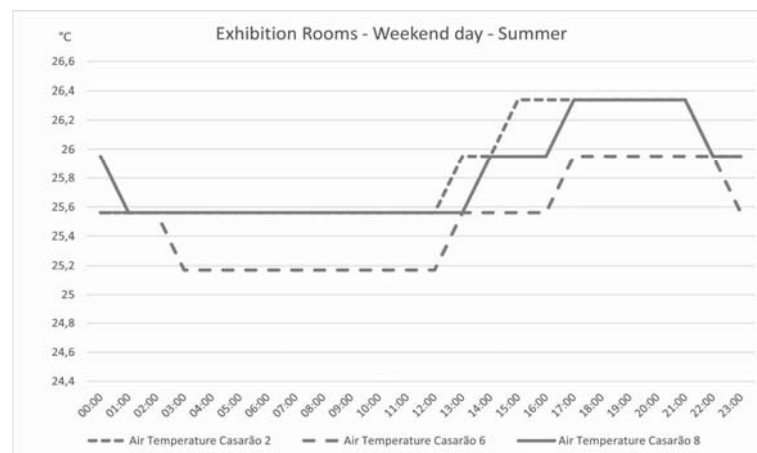
**Fig. 17** Thermal behavior on a summer weekend day—exhibition rooms.

In the exhibition room usage, behavior was similar to administration offices in both seasons, as seen in Tables 10 and 11. That is because the three buildings presented the same conditions of use for the ground floors, too. Nonetheless, in this use, temperature (Figs. 17 and 18) and relative humidity (Figs. 19 and 20) remained close and equivalent also during summer, in the three buildings.

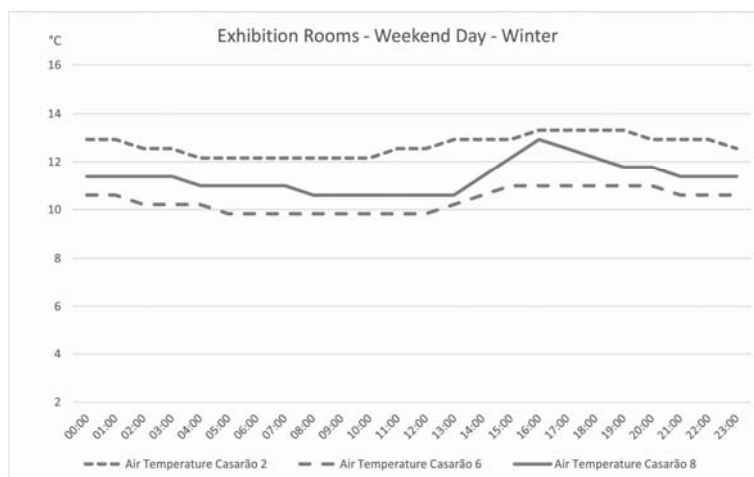
**Fig. 18 Thermal behavior on a winter weekend day—exhibition rooms.**

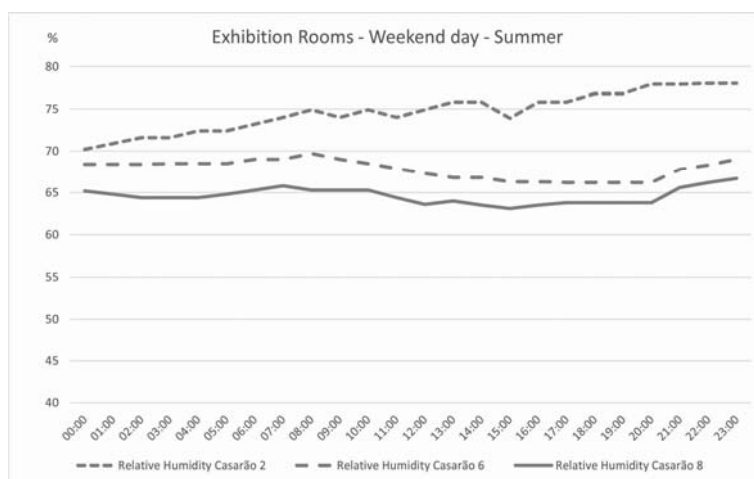
**Fig. 19 Hygroscopic behavior on a summer weekend day—exhibition rooms.**

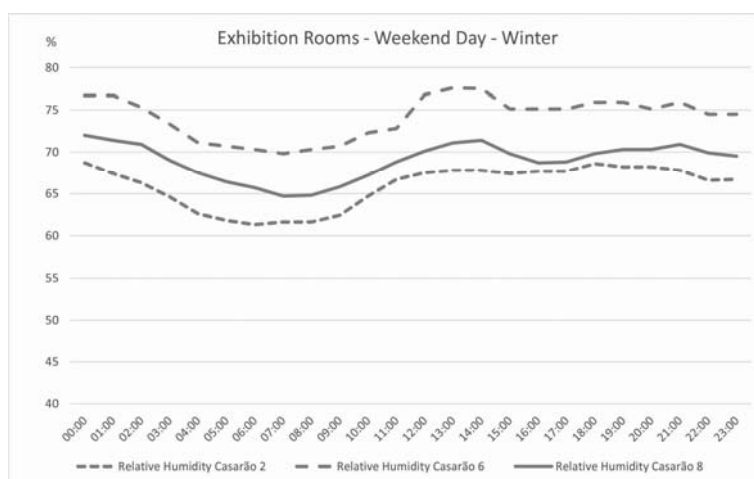
**Fig. 20 Hygroscopic behavior on a winter weekend day—exhibition rooms.**
