# Onsite Testing of Ammonium Oxalate Treatment Applied to Historical Salt-Infested Limestone

Tabitha Dreyfuss and JoAnn Cassar

Department of Conservation and Built Heritage, Faculty for the Built Environment, University of Malta, Msida, MSD 2080, Malta

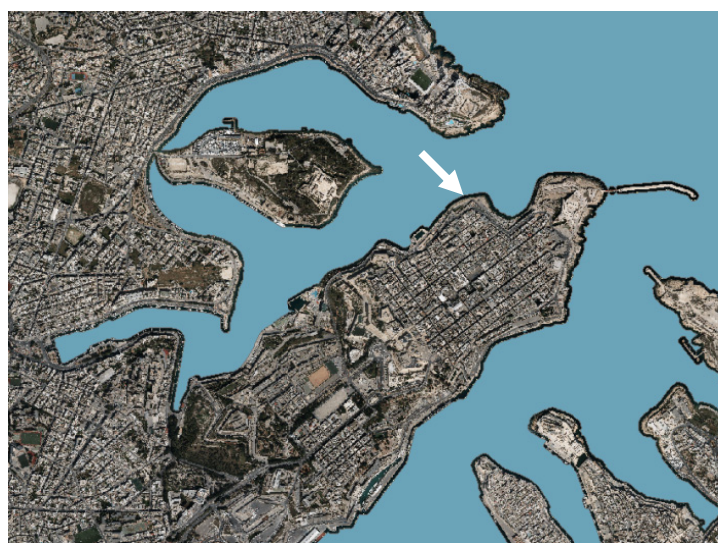
**Fig. 1** Ortho map showing area studied and its proximity to the sea

This current research includes three distinct sites—coastal, rural and urban—representing three typical site scenarios with respect to the soluble salts expected to be present. This paper discusses the results from onsite testing from the first site, St. Sebastian Bastion, Marsamxett Harbour, Valletta (Figs. 1 and 2). This is coastal bastion wall with high levels of sodium chloride.

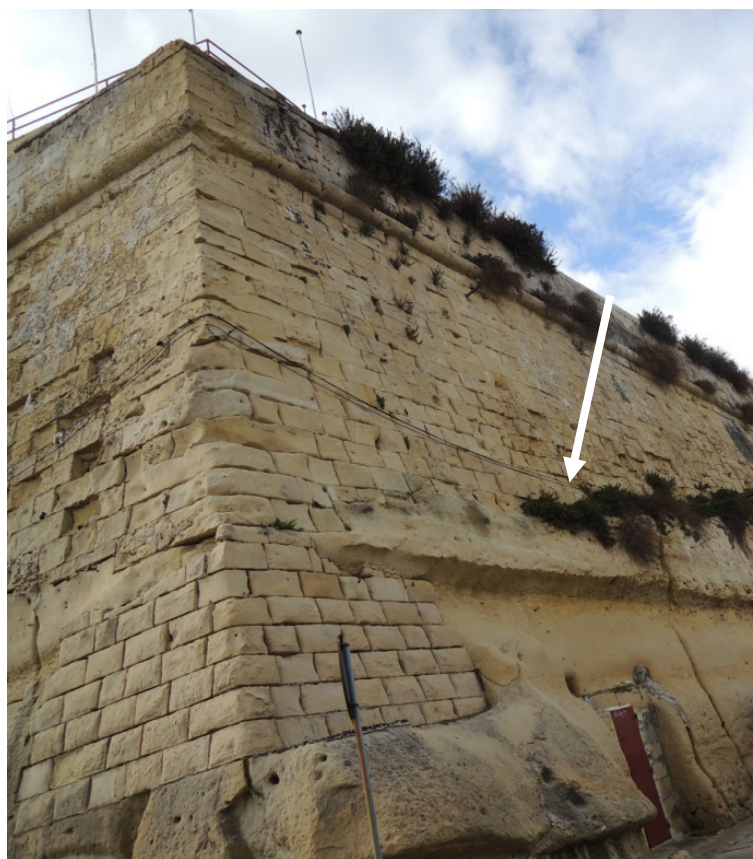
Fig. 2 St. Sebastian Bastion, Marsamxett Harbour (arrow indicates the area studied).

Both poultices included a cellulose pulp (300  $\mu\text{m}$ ). The blank poultice consisted of deionised water and the treatment poultice included a 5% ammonium oxalate monohydrate solution. Both poultices were applied *in situ* at approximately 7 m above street level (Fig. 2). The area included in the testing is illustrated in Fig. 3. The mean ambient temperature during application was 26 °C and the mean relative humidity was 72%. The two poultices were applied for 24 hours and left uncovered. Following application, the still-damp poultices were manually removed and the excess pulp was brushed off with a dry, soft nylon brush. In both cases, the stone was left to air dry for 3 days at ambient conditions (22–40 °C temperature and

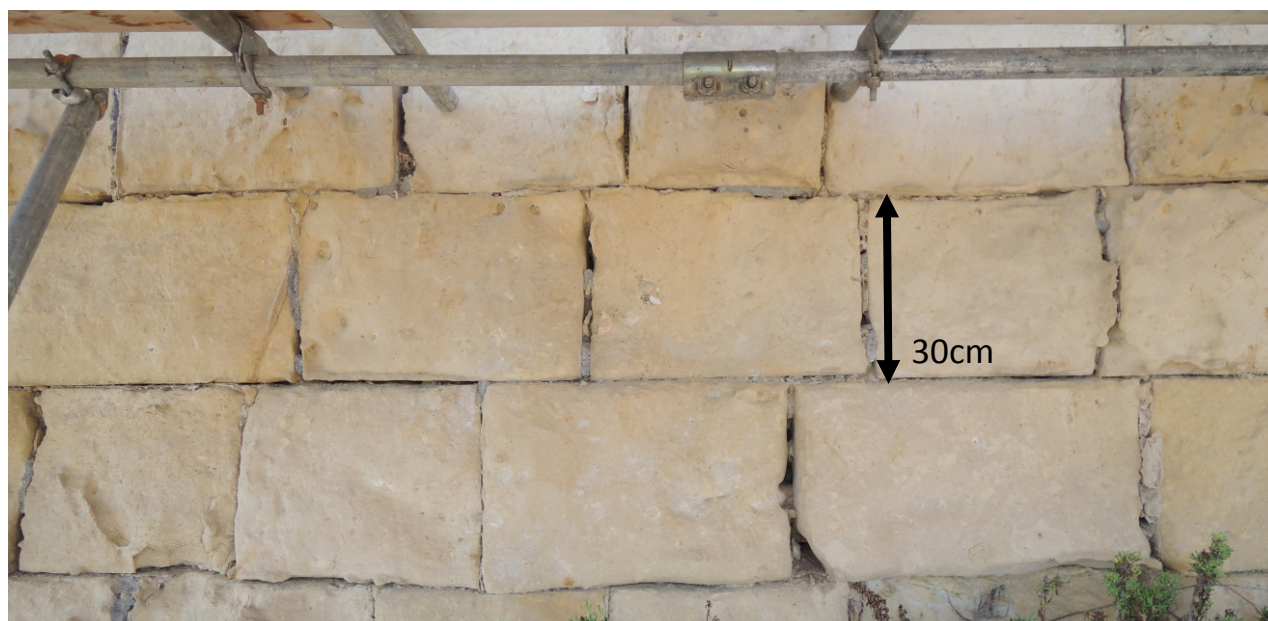
Fig. 3 Area tested; arrow in Fig. 1.
