Ultrasonic Phased Array Inspection of Electrofused Joints Implemented in Polyethylene Gas Piping Systems

Abstract: PE (polyethylene) is a widespread material for the manufacturing of gas and water distribution pipelines and a large number of PE electrofusion pipe joints can be found over the thousands of kilometers of PE pipelines all over the world, thus generating an increasing interest in checking the quality of both these pipes and joints. Within the last few years it has been proved that—among the available concepts—the PAUT (phased array ultrasonic technique) was one of the most promising candidates for non destructive analysis of PE welds and pipes. No current operational NDE (non destructive examination) Technique to date has been adapted to inspect the small diameter electrofusion joints (OD from 20 to 63 mm) which are frequently encountered in particular on the French gas distribution networks. In the present paper, the acuity of PAUT to detect and size both poor weld quality (e.g. cold weld) and calibrated faults has been evaluated on 63 mm electrofused welds by ENGIE Lab CRIGEN jointly with Institut de Soudure Industrie. Moreover the results of the PAUT evaluation and

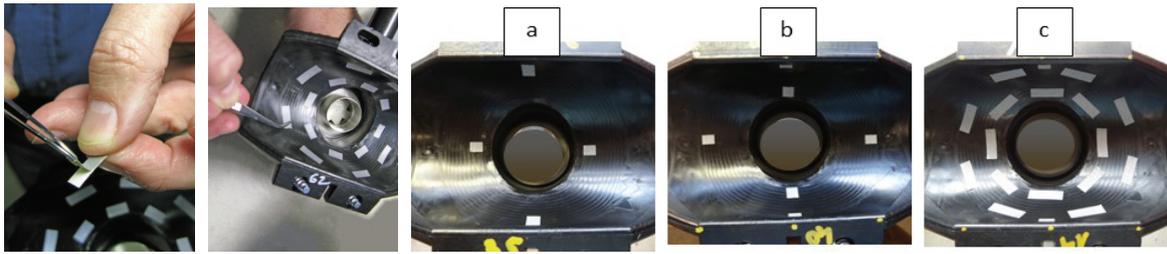
Fig. 1 Application of adhesive strips on the theoretical weld zone for the saddle (“cross” configuration T1 (a); “cross” configuration T2 (b); “mass” configuration (c).

strips—0.08 mm thick, placed regularly at the theoretical weld zone of the saddles in order to design three different configurations, as illustrated in Fig. 1. Both pipe and saddles were made of an ethylene-butene copolymer PE 100 grade currently used and complying with the NF EN 1555 standard for gas distribution piping systems [35]. The pipe was a standard gas pipe with a nominal diameter of 63 mm and a nominal thickness of 5.8 mm.

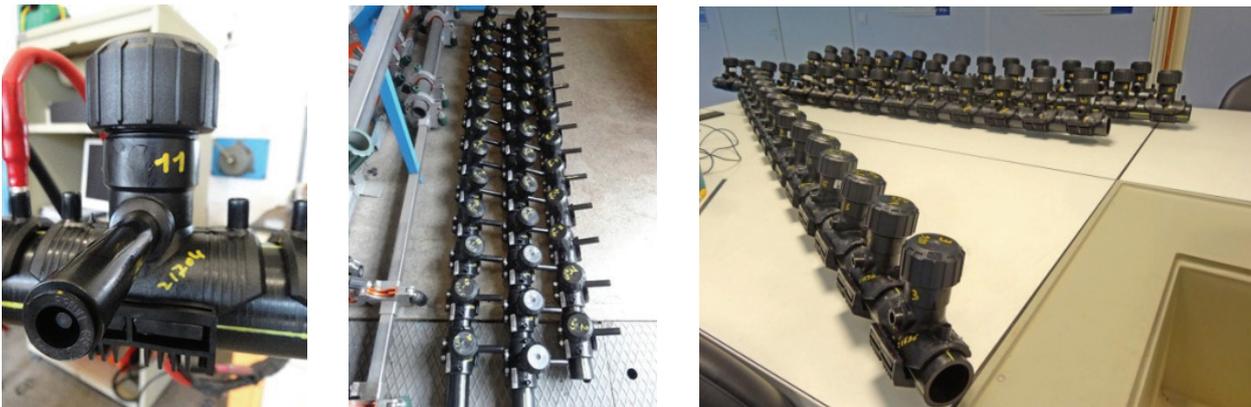
Fig. 2 Welding of the pipe-saddle assemblies.

The 56 welds at the nominal heating time were processed automatically at room temperature, by reading bar codes using an electrofusion welding machine. The 28 welds at 80% of the nominal heating time were processed manually at room temperature programming the reduced heating time on the welding machine. All the welds were carried out leaving a minimum space of around 20 mm between each saddle in order to avoid any disturbing heat transfers between neighbors, as illustrated in Fig. 2.

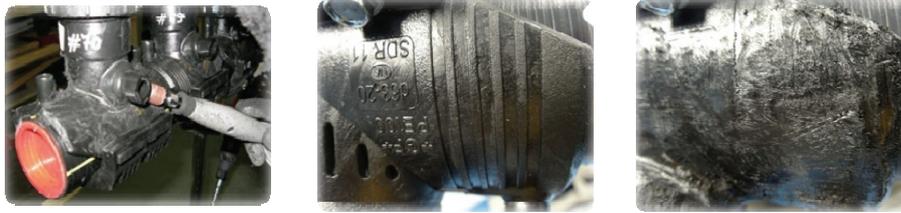
Fig. 3 Mechanical grinding and resulting state of the external surface of the saddle.

In order to improve access for the ultrasonic probe during the inspection of the assembly, half of the saddles were subjected to surface grinding using a mechanical tool. This operation, while rather coarse, made it possible to locally eliminate bumps or thicknesses on the accessory, as illustrated in Fig. 3.

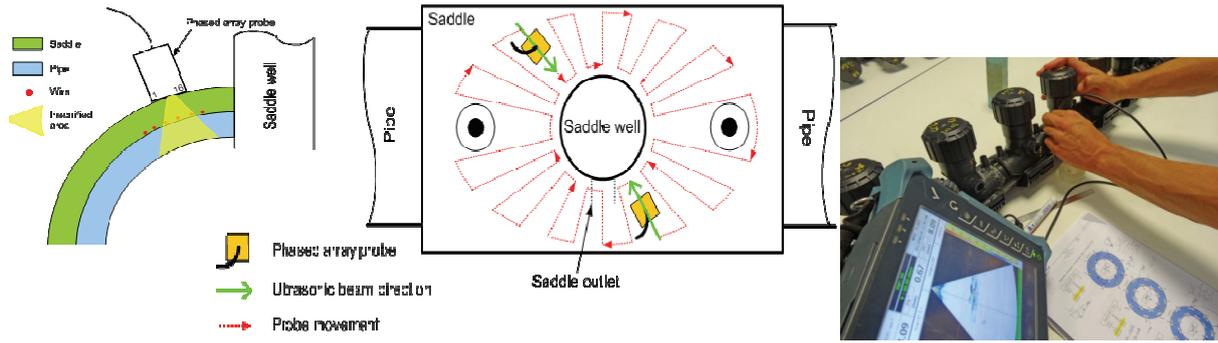
Fig. 4 PAUT inspection of a saddle that can be electrofusion-welded.

The electrofusion fitting was inspected by sweeping the part as evenly as possible. Regularity was better for a sleeve fitting than for a saddle, due to the more complex geometry of the latter, linked to the presence of connectors, outlet, fusion indicators, and stamps, as illustrated in Fig. 4.

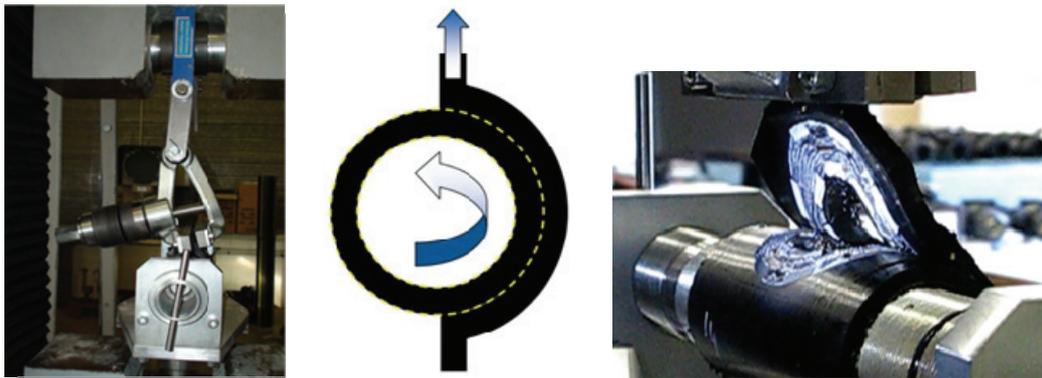
Fig. 5 Destructive peeling of an EF saddle revealing the calibrated non-welded zones.

Destructive testing of assemblies was performed as per ISO 13956 standard according to configuration A2 (peel) at ambient temperature, with a tensile rate of 20 mm/min [19, 25], as illustrated in Fig. 5.

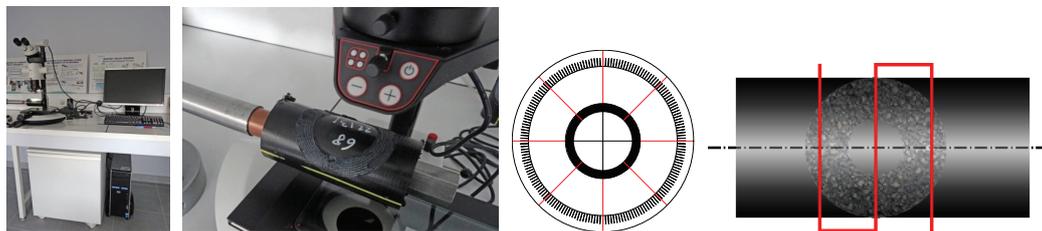
Fig. 6 Optical microscopy bench for mapping of the peeled surfaces of the welded assemblies. The complete scanning of the surface is made by rotating and translating the specimen. A “flattening” of the scanned surface is computed afterwards and the computed analysis of the different areas is done by means of dedicated image analysis software with the help of a specific scaled gauge.

In order to quantify the non-welded zones after the destructive tests, a mapping of the peeled surfaces has been done by means of a specific mechanical device installed on a LEICA MZ_{12.5} microscope associated with an image processing system, as illustrated in Fig. 6.

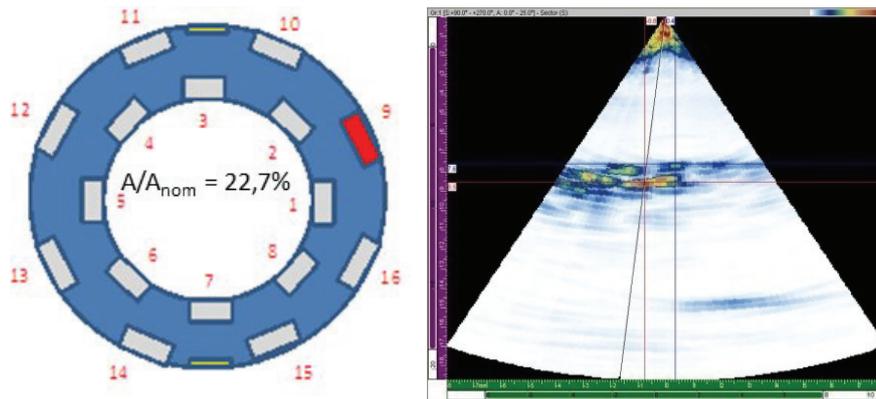
Fig. 7 PAUT detection of strip 9 applied in the periphery of the heating zone of saddle #11 ($A/A_{nom} = 22,7\%$ “mass”).

Within the framework of a first test campaign, 256 strips and 160 strips were researched respectively for the “mass” configuration and for the “cross” configuration. Fig. 7 gives by way of example the S-Scan of the detection of one of the strips placed in the periphery of the heating area of saddle referred to as #11 ($A/A_{nom} = 22.7\%$).

The strip is perfectly detected (intersection of red lines) at depth corresponding to the position of the pipe-saddle interface (distance between the top and the horizontal red line) and at a 1 mm distance from the wires (distance between blue and red horizontal lines). The 256 strips in “mass configuration” are detected by PAUT, hence a POD of 100%. However, for a gain increased by +6 dB (normal conditions +6 dB), the surface condition of the saddles influences the PAUT response, specifically the presence of striations or the presence of the fusion indicator or the

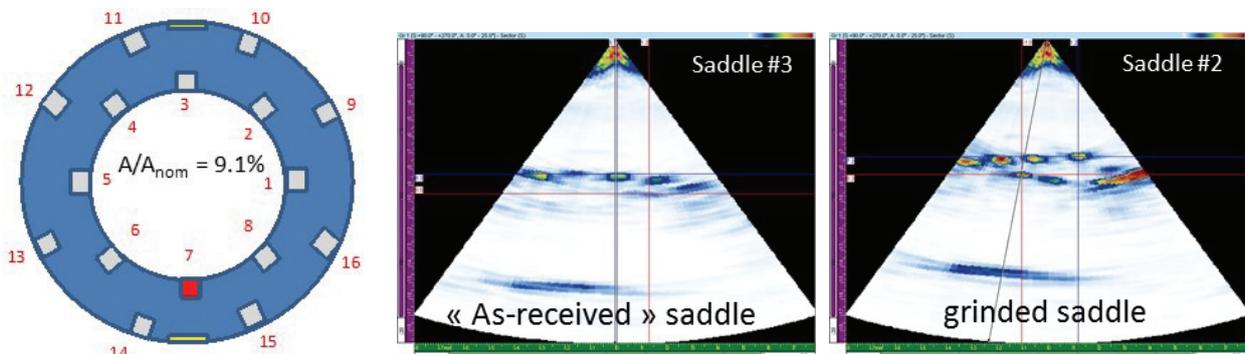
Fig. 8 PAUT detection of strip 7 on the rough saddle #3 ($A/A_{nom} = 9.1\%$) (middle) and on the grinded saddle #2 ($A/A_{nom} = 9.1\%$) (right).

existence of local instances of excess thickness. In this case, the grinded saddle presents a better foundation for the analysis of the welded assembly, as illustrated by way of example in Fig. 8.

The grinding of the saddle then leads to detection rates that always exceed those obtained from an as-received one. In addition, the transition to a gain augmented by +12 dB for around 60 strips (i.e. around one quarter of the total number of strips implemented)

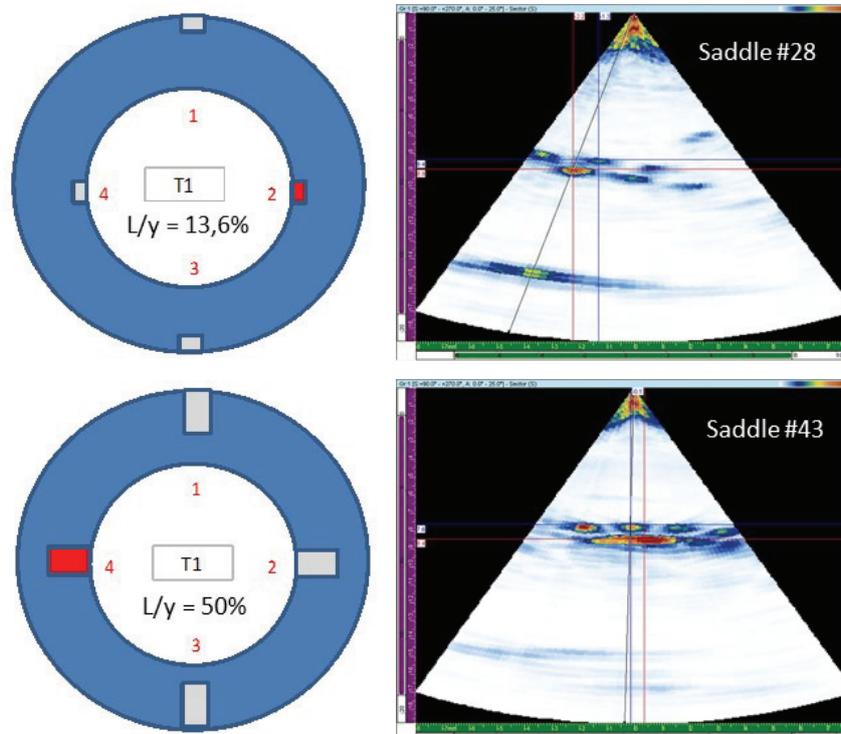
Fig. 9 PAUT detection of strips 2 (top) and 4 (bottom) applied in the interior periphery of the heating zone of Saddles #28 ($l/y = 13.6\%$) and #43 ($l/y = 50\%$) (“cross” configuration T1).

Fig. 9 shows the S-Scans for a strip placed in the interior periphery (T1) of the heating zone of saddles referred to as #28 ($l/y = 13.6\%$) and #43 ($l/y = 50\%$). The S-Scans show the excellent level of detection of two strips having very different dimensions (3 mm- and 11 mm-long, respectively) located at relatively

inaccessible positions (near the saddle well). Detection is easier since the impact of the ultrasonic beam is maximal (Saddle #43, strip 4). If the cross configurations (T1 and T2) are below 27.3%, the POD remains very low. On the other hand, once this experimental value is reached, the POD is close to 100%, enabling correct detection at the ISO standard requirement threshold transition (50% “cross”).

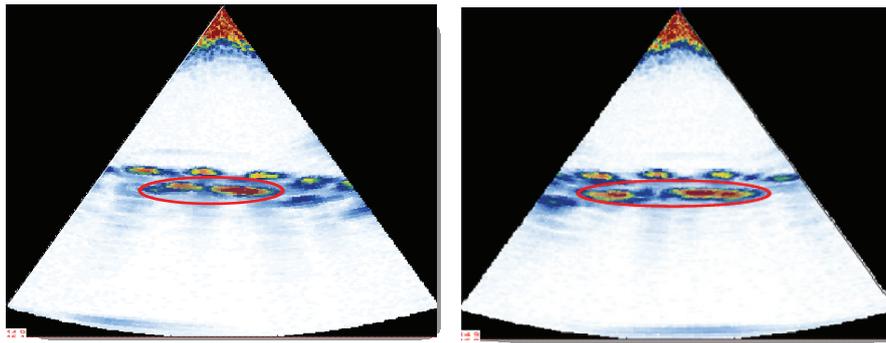
Fig. 10 S-Scans of two Saddles (#60 & #63) revealing the calibrated defects and additional anomalies.

measure both the calibrated faults and the zones improperly welded as a consequence of the reduced heating time. In these welded assemblies, 128 strips and 80 strips were researched respectively for the “mass” configuration and for the “cross” configurations (T1 and T2). Fig. 10 gives an example of the S-Scans obtained on saddles with calibrated faults in “mass” configuration.

For “mass” faults, the 128 strips are detected, even for the lowest proportion (9.1%), hence a POD of 100%. Moreover, PAUT reveals additional anomalies with some saddles located mainly on the external “ring” materialized by the outermost strips. From the data obtained on 8 assemblies, an attempt for sizing the overall faults is presented in Table 4. PAUT sizing is possible for 126 strips on 128 (98.5%). The estimated widths, between 4 mm and 6 mm, are very close to the real ones, even if these dimensions are also very close to the focal spot of the UT beam. The estimated lengths are greater than the real ones. Considering a 30% error on the measurement (as for the widths), it is possible to reveal about 50 cases for which additional disorders, other than those of the non-weldable striped areas, do exist (some of them circled in Table 4, as a way of an example).

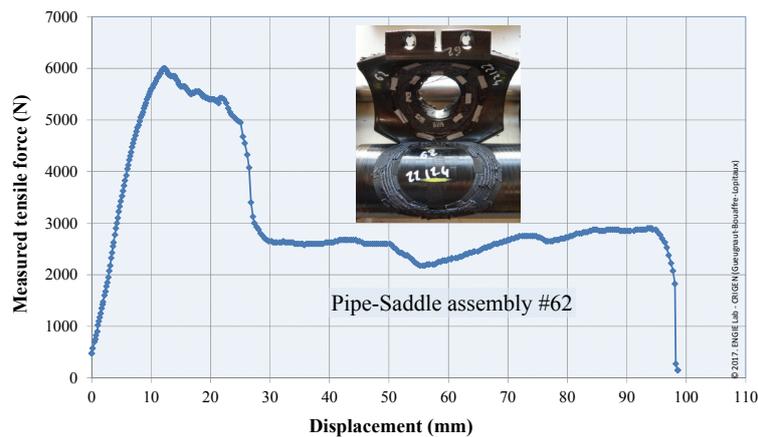
Fig. 11 Revelation of the position of the strips after the destructive peel test (Saddle #62).

The peel energy was calculated on the basis of the “Force-Displacement” curves recorded by the tensile machine during the peel test as illustrated in Fig. 11.

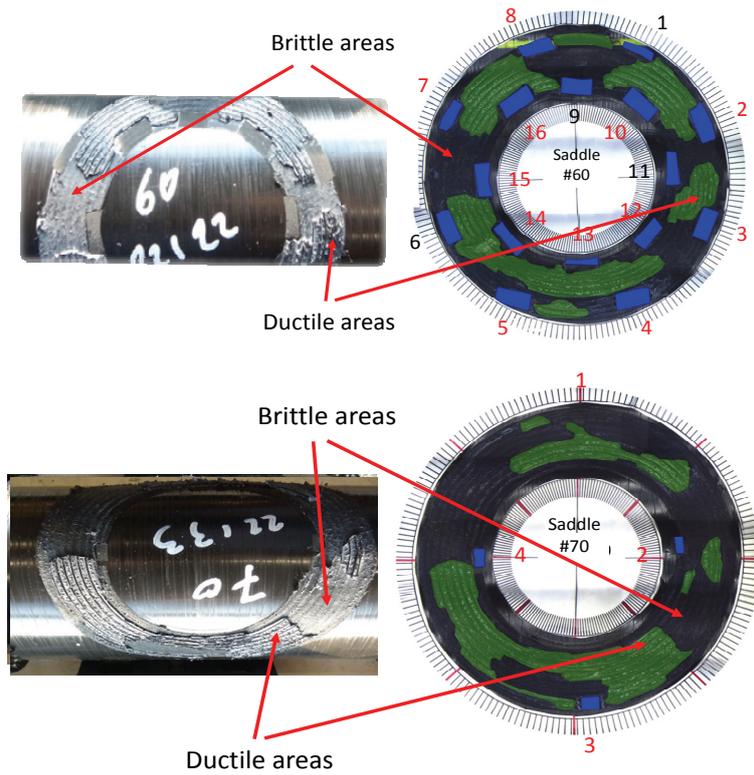
Fig. 12 Localization of the anomalies on the peeled specimens for the “mass” configuration (top) and the “cross” configuration (bottom). Strips come in blue color. The so-called “ductile” zones (good weld) appear in green color. The black zones correspond to the additional non-welded zones. The numbers in red color correspond to the strips where additional disorders were detected and sized by PAUT.

The results of the PAUT inspection were then compared with those obtained after computation of the peeled surfaces. Fig. 12 displays, as a way of an example, the localization of the different revealed areas corresponding to both the welded zones and the non-welded zones including the non-weldable zones of the strips, for the “mass” configuration and the “cross” configuration.

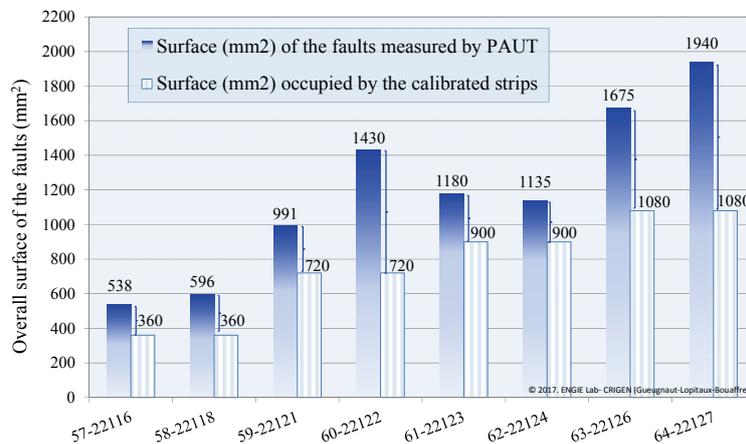
Fig. 13 Improperly welded zones in the saddles with calibrated defects in “mass” configuration.

a fairly good way a significant number of additional disorders corresponding to the non-welded areas due to the insufficient heating time on the 28 assemblies. As a way of an example, Fig. 13 displays the overall surfaces of the defects (calibrated strips in “mass” configuration + non-welded areas) calculated from the PAUT sizing for 8 welds with regard to the total surface occupied by the strips. The gap between both measurements gives a clear indication of the additional non-welded zones due to the insufficient heating time.
