# The Stava Valley Tailings Dams Disaster: A Reference Point for the Prevention of Severe Mine Incidents

**Abstract:** On July 19, 1985, at Stava near Tesero (Italian Alps), two reservoirs collapsed, causing the death of 268 people and the destruction of many buildings. The two adjacent basins were constructed for the decantation and storage of fine-grained waste material, which was pumped from a nearby fluorite mine. The consequence of the failure was a vast flowslide that found its way downstream along the Stava valley destroying many houses in the village of Stava, eventually reaching Tesero, where more property was wrecked or severely damaged. The Stava valley disaster was one of the most tragic of its kind. This paper aims to give a contribution on the technical aspects related to the causes of this catastrophic event. It also describes alternative technical solutions for the proper management of mining waste disposal and environmental protection proposed by the Stava 1985 Foundation for disseminating knowledge and awareness on how to make these geotechnical structures safer and more profitable and avoid other similar disasters that still keep occurring every year around the

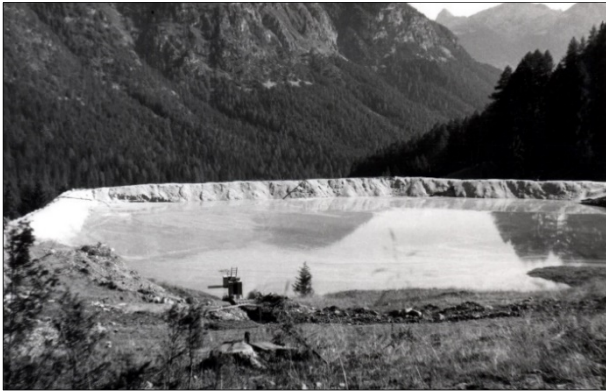
Fig. 2 View of the Stava lower basin in 1969.

Access to the seam was given by means of four tunnels, excavated on the slope of the mountain at different levels. The tunnels were on either side of the mining areas in which the working panels were developed. The mineral was exploited in horizontal slices, backfilling the foot of the excavation with the waste material produced during excavation. The raw mineral was dumped into vertical shafts and arrived at the bottom hauling level by gravity. From there, it was transported to the washery by means of a ropeway, where a beneficiation process extracted the fluorite, concentrating the mineral at the acid grade of 97% and eliminating the rock waste by sending it to purpose-built basins (Fig. 2).

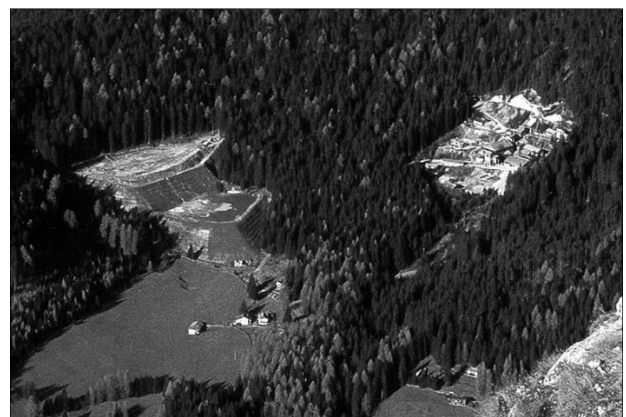
Fig. 4 The two Stava tailings dams and the Prestavèl mine facilities (October 1981).

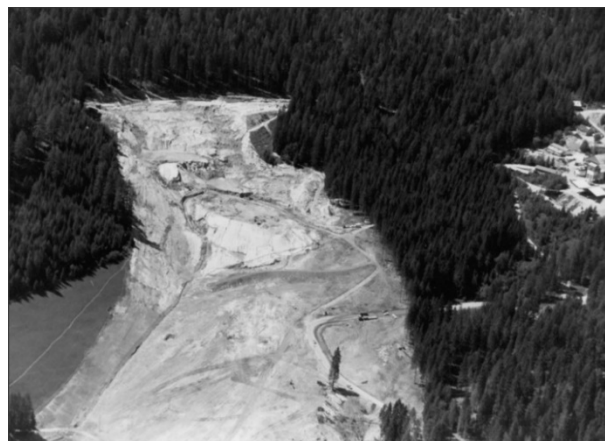
**Fig. 5** The failed dams and the devastation of the Stava valley (July 1985).

In the end, unnoticed and persisting high-pond conditions weakened the foundations of the upper dam with a progressive increase of pore water pressure, leading eventually to its collapse and causing also the failure of the lower dam. Consequently, 180,000 m<sup>3</sup> of liquefied mud and water spilled out of the failed dams

plus nearly 50,000 m<sup>3</sup> of material resulting from soil erosion, destruction of buildings and uprooting of trees. The entire Stava valley was completely devastated (Fig. 5).

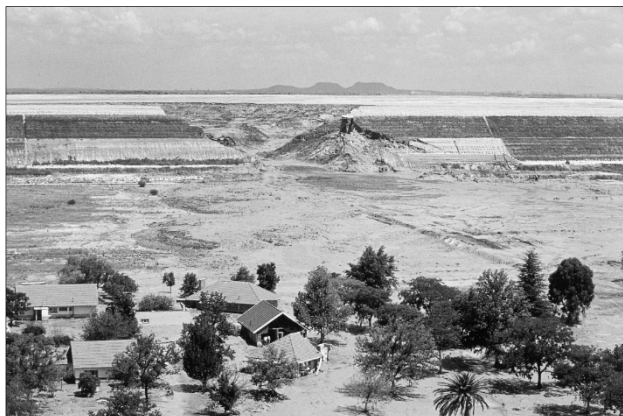
**Fig. 6** The devastation of the mudflow following the Merriespruit tailings dam failure, South Africa (February 1994).

<sup>3</sup> This incident took place on February 22, 1994 when, following heavy rains, 1,500,000 m<sup>3</sup> of polluted mud overflowed the embankment of a tailings dam. Seventeen persons lost their lives, 80 more were injured and many houses were destroyed in the suburb of Merriespruit, Virginia, Free State.
