Characteristics of the Architectural Structures Belonging to the Transition Period in Beirut (1840-1920)

Youssef Hamze and Jad Hammoud

1. Faculty of Engineering, Lebanese University, Hadath Campus, Beirut 961, Lebanon

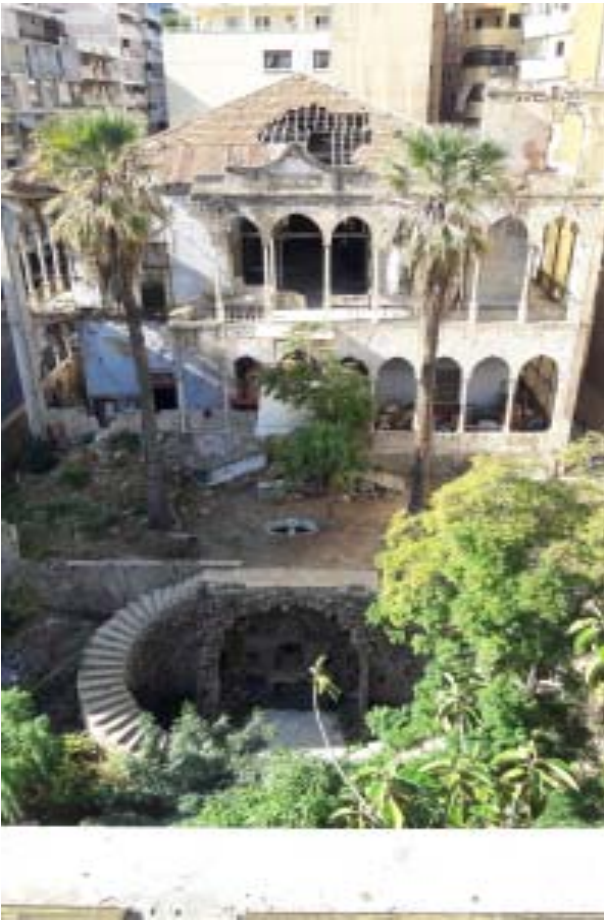
Fig. 2 Main elevation (Hammoud J. 2016).

mansion, named as its longtime owner family. It is currently used as workshop for carpenters at the ground floor while the second floor is abandoned. Seen from outside Bchara el-Khoury mansion is a quite imposing load-bearing structure. The plaster which must have been ochre color in early days is now weathered and bullet pocked. In many windows are missing their glazing. The building is surrounded by an elevated open gallery at the two floors with pointed arches on marble columns. The mansion has a red tiled hip-roof. The mansion is built by plastered sandstone masonry and is consisting of two floors, a ground and first floor with space around 600 m² each, making it one of the biggest surviving mansions in Beirut. Typologically, this mansion can be classed with the type of late 19th century Beirut upper bourgeois mansions. At the ground floor, the ceiling is almost five meters high and has iron girders with stone fills in between. The floors of the rooms are tiled with colored cement tiles with geometric pattern, framed by a line of cement tiles with floral pattern. The ceilings are carried by long iron girder with I-shape supported at the stone walls. The spaces above the girders are screened with substrates. Between the iron girders run vaulted stones. At the western end is the vaulted kitchen and two small inbuilt rooms with the toilets. Several double wing doors in

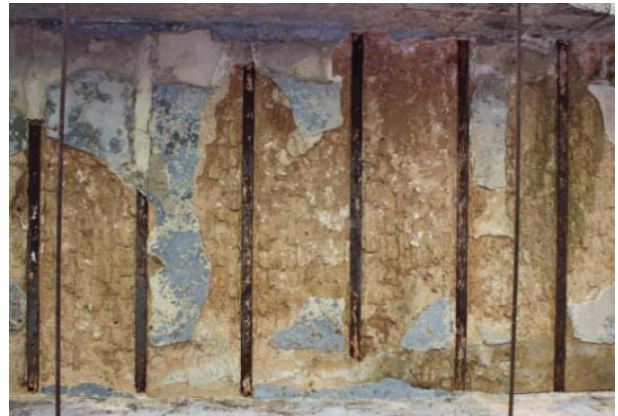
Fig. 4 Jack arch slab at the ground floor.

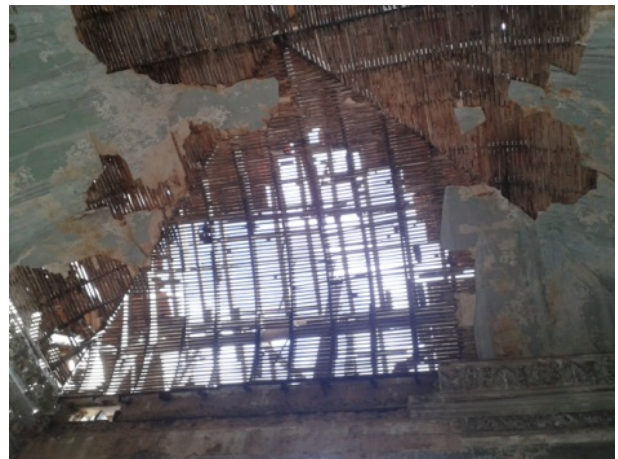
Fig. 5 Span queen post roof truss (idem).

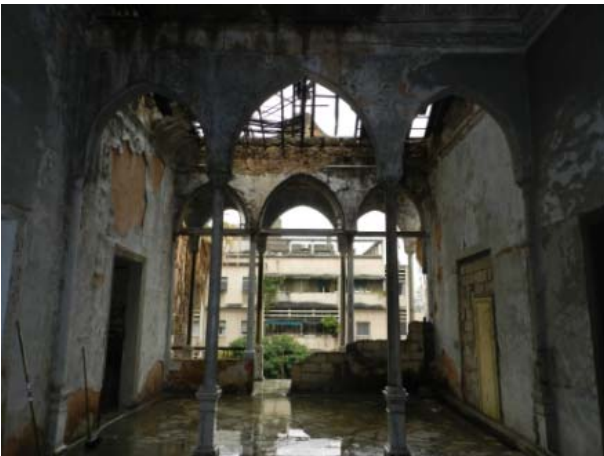
Fig. 3 Triple arcades at the central hall.

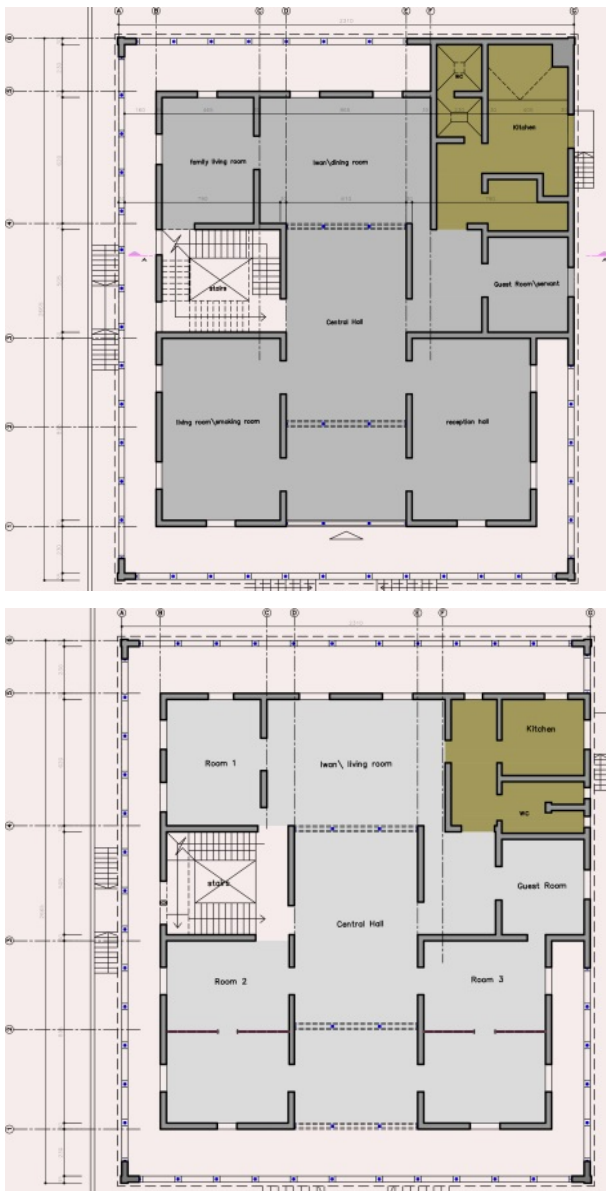
Fig. 7 Ground and first floor plans (*idem*).

the central hall open to the rooms and to the staircase that leads to the first floor. The first floor is in bad condition due to water infiltration from the damaged hipped roof which is carried on wooden beams that are closed by wooden fillings from below.

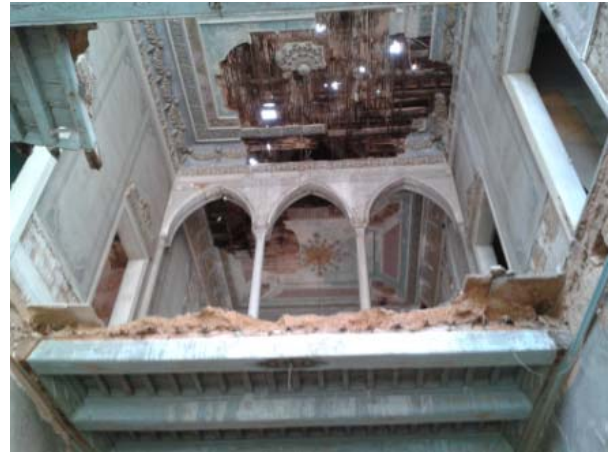
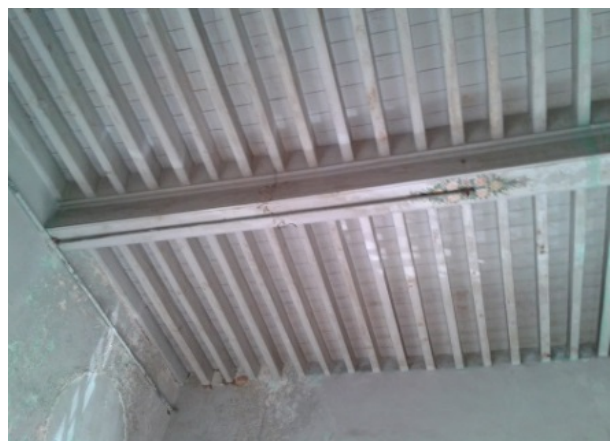
Fig. 8 Timber cut beam in the central hall with adorned ceiling (idem).

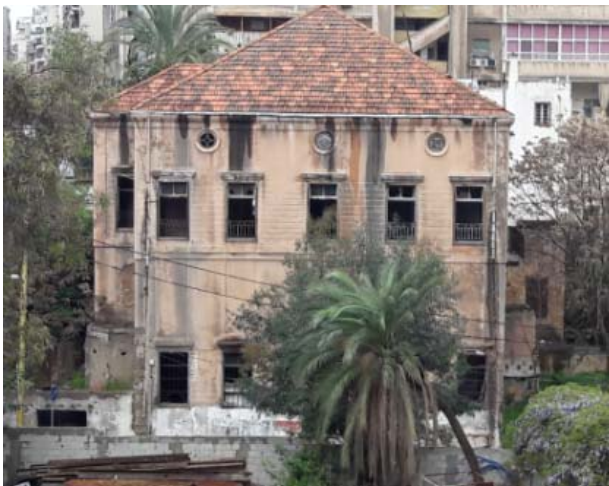
Fig. 9 East elevation.

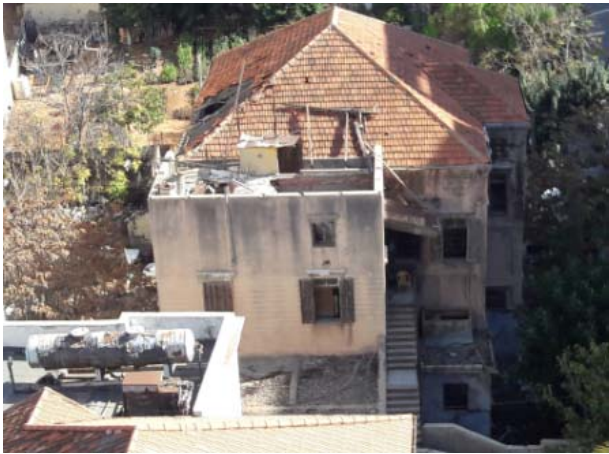
Fig. 11 West elevation (idem).

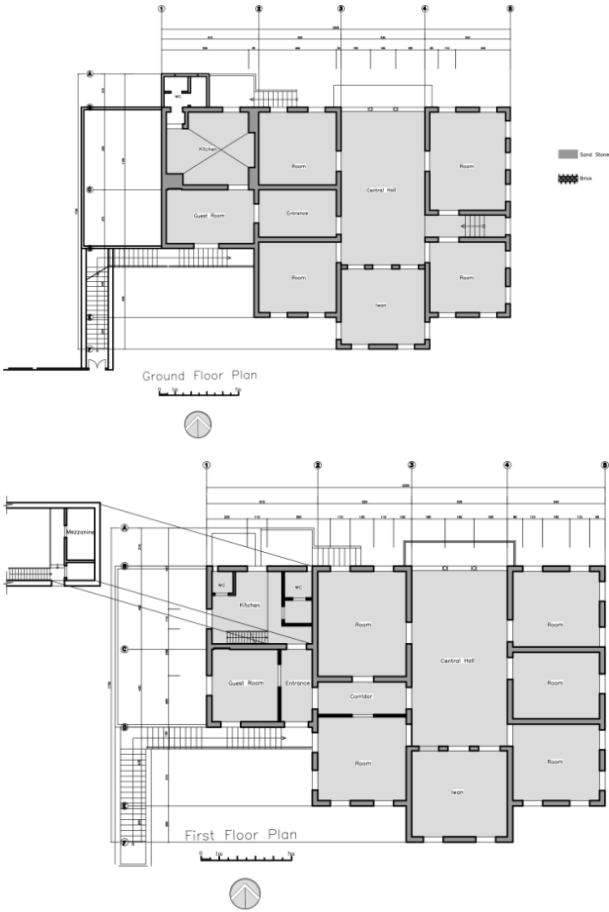
Fig. 12 Ground and first plan (idem).

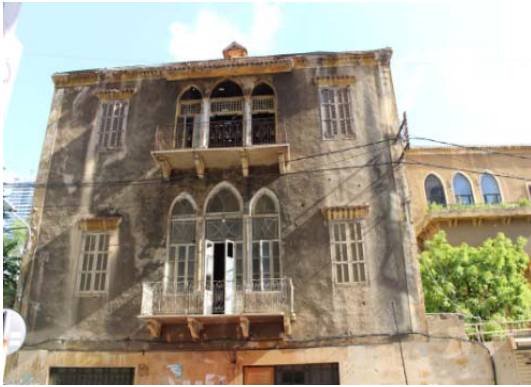
Fig. 14 East elevation (idem).

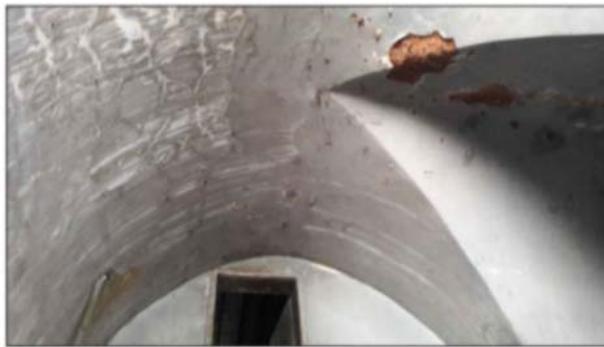
Fig. 18 The arched vaulted floor in kaaki house (idem).

The ground floor of some central hall houses in Beirut was arched vaulted. The vaulting cannot be built of uncut stones. The kind of vaulting is like the half spherical dome which requires rotational symmetry depending on whether it is a real or blind arcade. The vaulting starts from the plane of the upper part of the windows. This is the level of the second stage of the scaffolding. The possible techniques of building need to be weighed up, considered very carefully. For

functional reasons the support for the forces in the knee walls, stability of the vaulting, has roles in the building process as well. As shown below, scaffolding is erected inside the building, but the vaulting can only be built from the top of the load-bearing wall. At the same time the half wall provides a helpful position for the masonry work for the vaulting. As the first step, the half walls are built up to the possible height. Following this, it is moulded and built the lower part of the rotational symmetric vaulting. The wall filling is required for the continuation of the building process, because it serves as the support for the half way scaffolding. From the wall filling we finish the knee wall, and from this we finish the vaulting. We must not forget that the building of the vaulting is happening in greater height (Fig. 18).

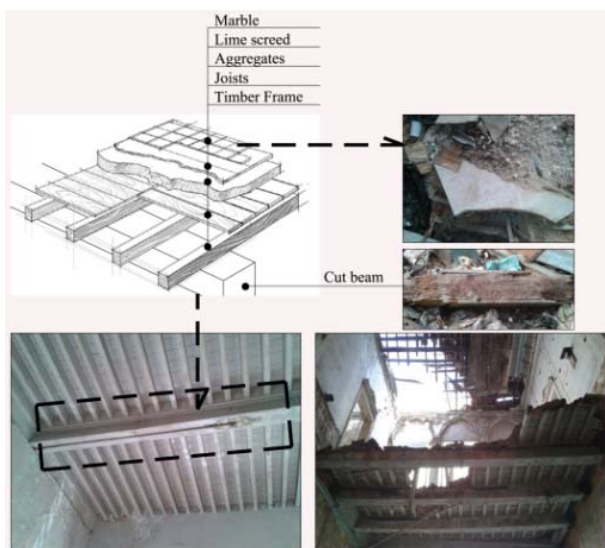
Fig. 19 Construction of intermediate ceiling in kaaki house before 1880s (idem).

In regard to intermediate floors built in Beirut, it was found two kind of roof constructed between one generation and another. At the beginning of the nineteenth century, the intermediate floors consisted of a timber frame with machine-cut beams carried on a large spanned timber beams linked to the walls. Tiling is applied at the top of this surface by adding a layer of aggregates with lime screed below the marble tiling (Fig. 19). This is present in Kaaki house. This kind of ceilings ended by 1880s, where the I-beam slabs were replaced instead of large spanned timber beams lifting small timber beams & joists (Fig. 20).

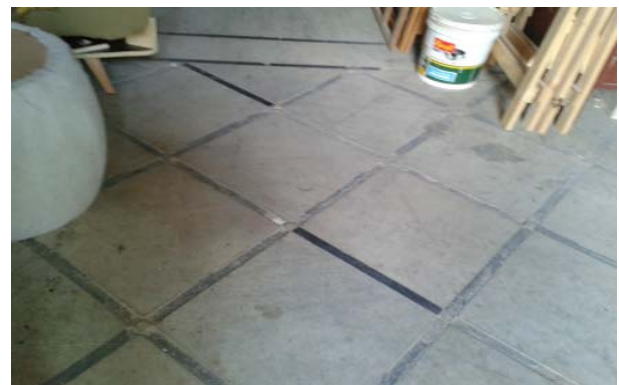
Fig. 21 Poured lime cement tile used in late Ottoman period in Bchara el-Khoury mansion (idem).

In the late Ottoman period, neo-traditional buildings, cement tiles appeared in non-reception areas next to the central hall. Tiles were made from clay (often locally sourced), or poured lime cement always having a square edge. This square edge is significant and is the key to the flat surface that these floors have, unlike some modern reproductions. A layer of coarse, cheap clay about 10 mm thick was installed between two layers of clay, each about 3 mm thick, the top layer containing the imprinted as they became known, design. Imprinted pattern making remained essentially a hand-crafted operation, patterns were impressed into the wet clay with the use of machine presses, but pouring the colour “slip” (slip is the term given to wet clay mixed to the consistency of cream) into the impressions was a hand skilled job, which after two or three days drying, would be scraped flat by hand, revealing the pattern with sharp clear edges. The tile was then left to continue to dry slowly, as speeding up the drying time too much could also result in warping. Drying time for plastic clay was up to three weeks before firing, resulting in a slow production time (Fig. 21).

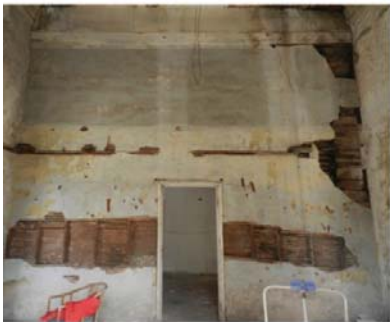
Fig. 24 Baghdadi construction (idem).

Type 2: Wooden frame wall (Composite Construction): This construction is a composite application of timber frame and massive stone techniques. It is a partition between one space and another in the house and not considered as bearing wall.

The filling of timber frame is local rubble limestone, earth and lime mortar. The total thickness of the wall is 15 cm whereas the outer surfaces were either plastered or non-plastered or wooden plastered. This wooden structure consists of wooden sections (10×8 cm) and wooden laths (2×1.5 cm) which is called *bagdadi* construction (lath technique) (Fig. 24).

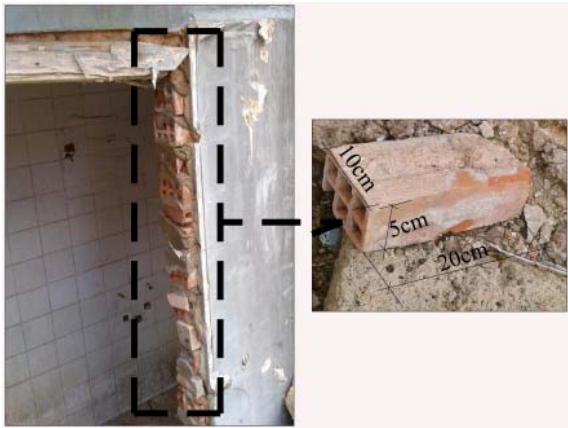
Fig. 25 Showing the brick construction in kitchen and toilet area in Kaaki building (idem).

Type 3: Brick masonry is construction in which uniform units (bricks), small to be placed with one hand, are laid in courses with mortar joints to form walls. Bricks are kiln baked from various clay and mixtures. The chemical and physical characteristics of the materials vary considerably. These characteristics and the kiln temperatures combine to produce brick in a variety of colours and harnesses. In brickwork, those bricks laid lengthwise in the wall are called stretchers and the course in which they occur, a stretching course. Bricks laid across the wall thickness are called headers and the course in which they occur, a heading course.
