Morphological Changes Induced by Coastal Protection on the Coast of Maputo City, Mozambique

Elisa Eda Nhambire, Celso Alexandre Vidigal Chivale, Zacarias Alexandre Ombe and Bernardino Bernardo
Pedagogical University of Maputo, Zipcode 3276, Mozambique

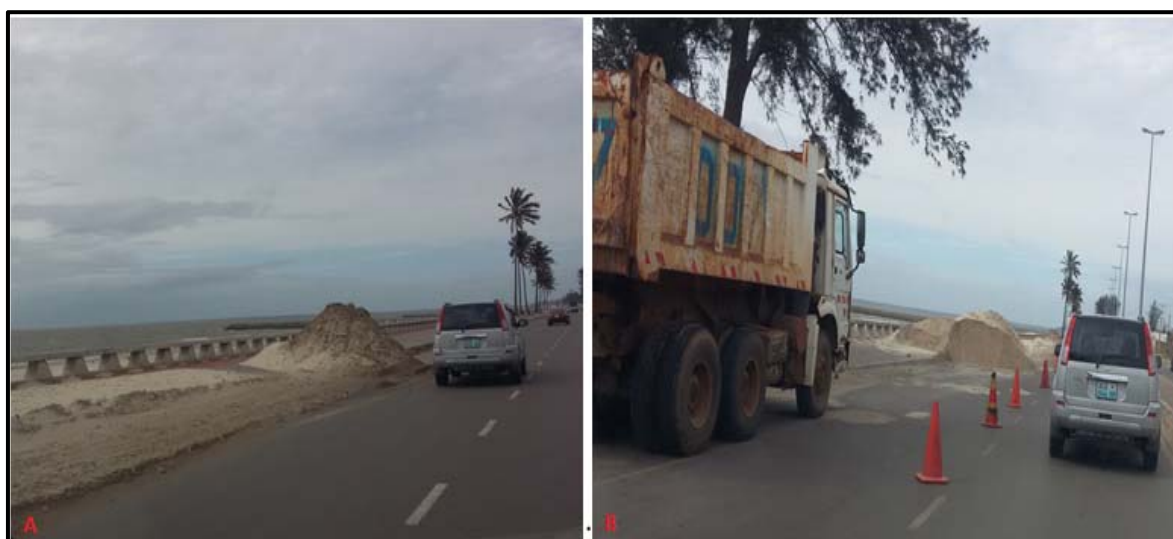
Fig. 3 Sand deposited by the wind on Marginal Avenue.

It was found that artificial feeding increased the width of the beach and the number of sediments moved by the wind by deflation (Fig. 3).

The accumulation of beach sediments on the sidewalk and along the road disturbs the normal movement of pedestrians and vehicles, a situation that is aggravated on rainy days when water accumulates on the road because of clogging of rainwater runoff channels.

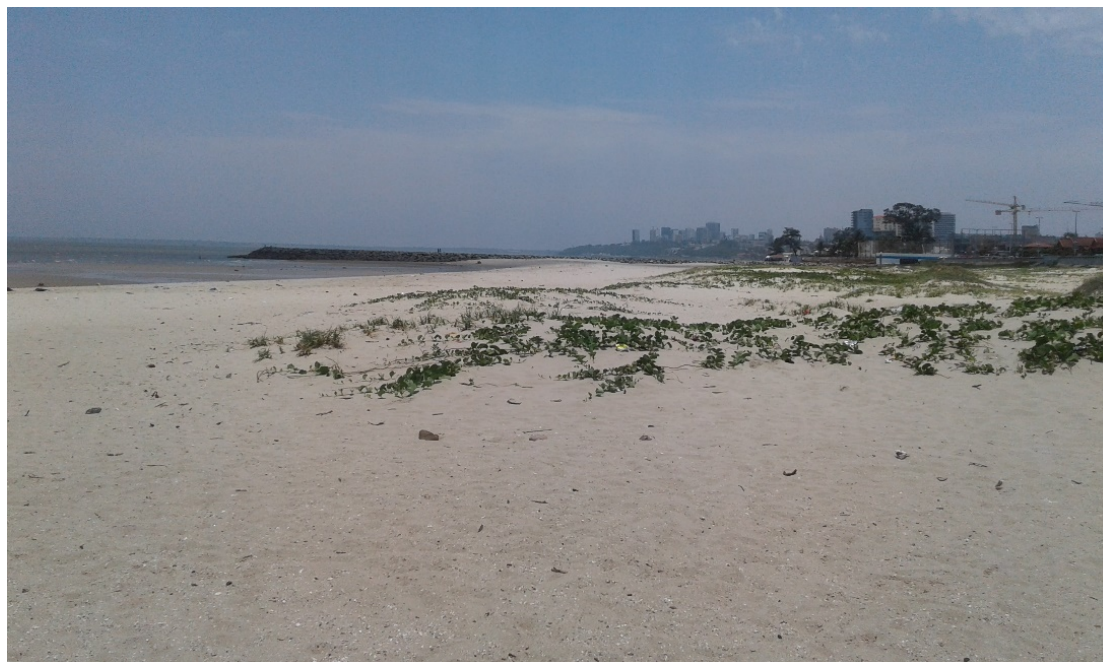
Fig. 4 Embryonic dunes.

Despite the situation described above, there was evidence of embryonic dunes in some stretches of the coast. This is a sign of balance in the coastal system between the first and second groyne, in the South-North direction of the area under study, as illustrated by the image in Fig. 4.

The embryonic dunes, if not disturbed by trampling, may develop and reduce the impact of the wind on the beach sand and become a source of sediments to the beach system.

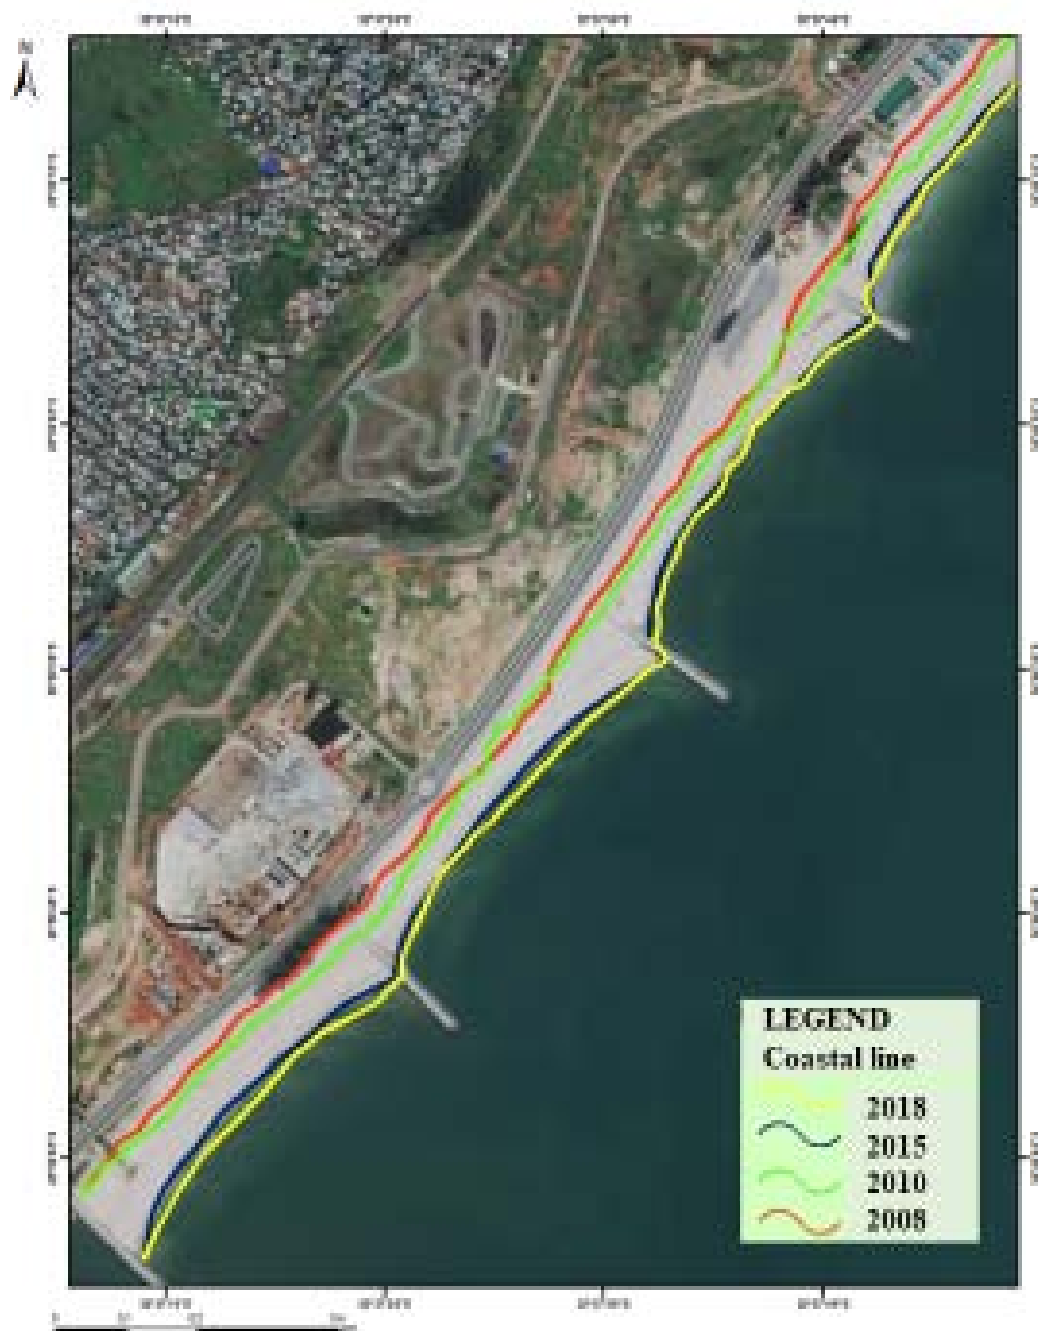
Fig. 5 Dynamics of Costa do Sol line (2008-2018).

As previously mentioned, the coastal area is quite dynamic, as evidenced by the 2008 and 2010 coastlines, before the intervention, 2015 coastline, at the project completion year, and 2018 coastline in Figs. 5 and 6 below.

The coastline layout, in 2008, shows a retreat. In 2010, the coastline continued to retreat and in some points, which were already critical, the situation worsened even more. This is the situation that led to coastal protection.

In 2015, the coastline advanced towards the sea by artificial feeding. However, the line layout, in 2018, was quite worrying given the investment made and the time-lapse of only three years. The slimming of the beach in the entire study area is clear. The situation is exacerbated in the downdrift, in the left margin of each of the groynes, which takes us to agree with Ref.

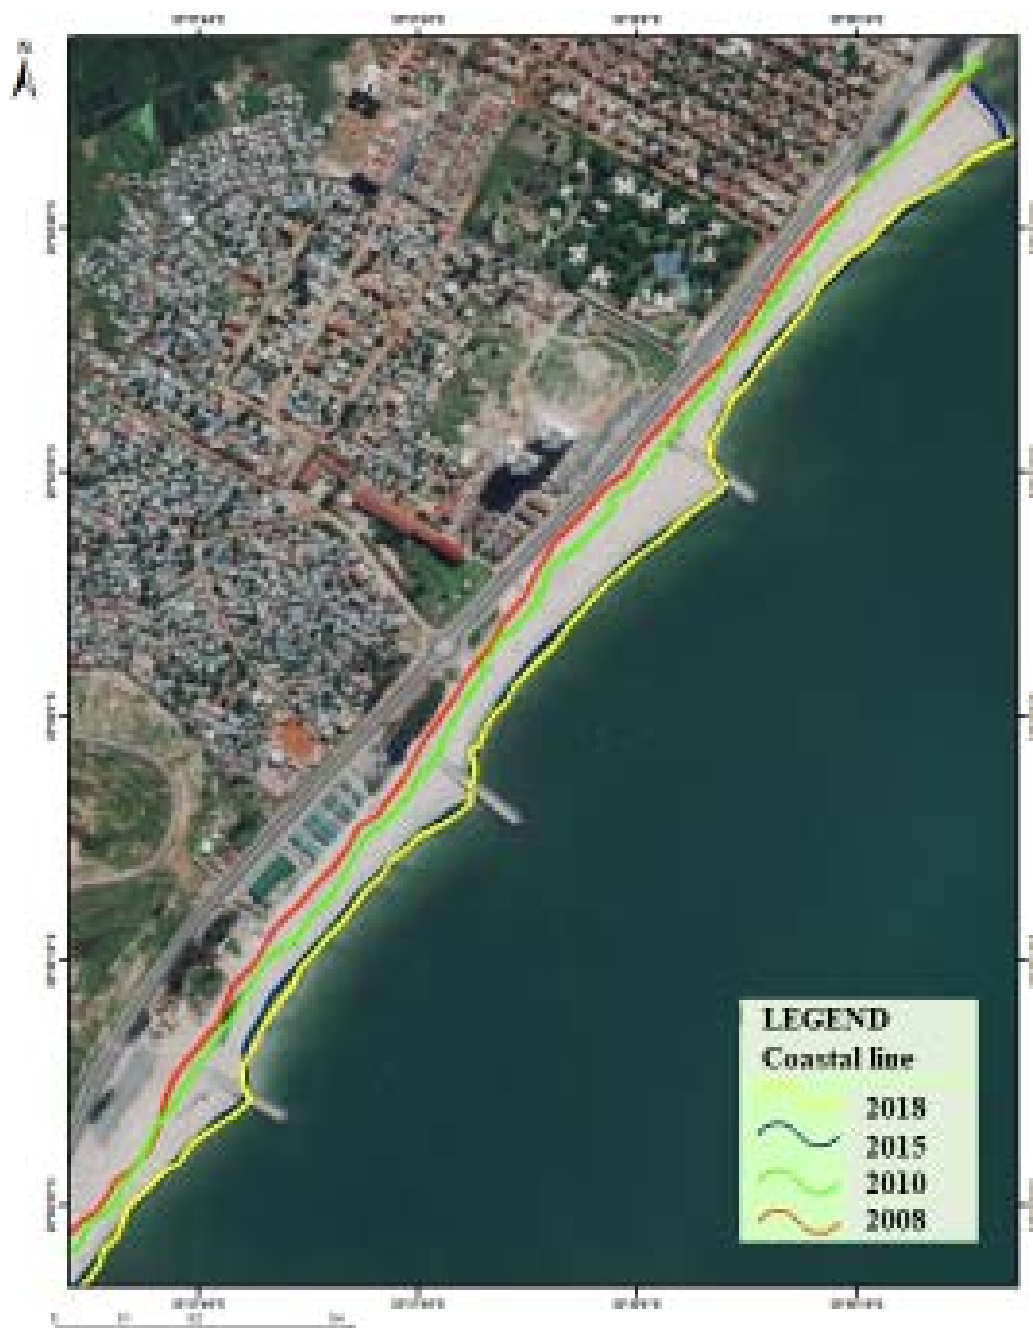
Fig. 6 Dynamics of Costa do Sol line (2008-2018).

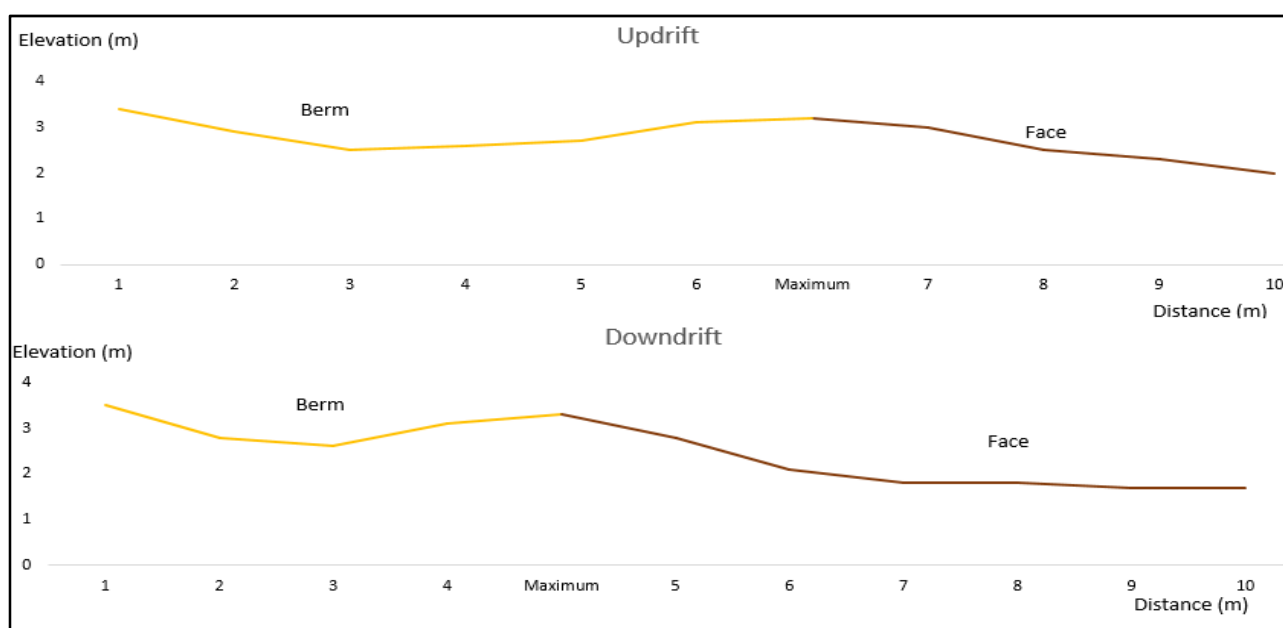
Fig. 7 Transversal beach profiles on updrift to downdrift of the second groyne.

Besides the longitudinal variation, a topographic survey of the transversal profile of the beach at the second groyne, just apposite *Baía* Mall, was conducted (Fig. 7).

The outcomes showed significant morphological differences on the beach face and berm. Fig. 5 shows the profiles of the beach at low tide on both sides of the groyne.

The Beach berm is the immersed part of the beach; It is the place where beach users sunbathe. The Beach face is the part affected by the swash and backwash [1, 10]. Fig. 7 shows morphological differences in the berm and beach face.

(1) The beach berm is more extensive in the updrift than it is in the groyne's downdrift.

(2) The beach face is less steep in the updrift than in the downdrift.

The existing differences are a result of the hydrodynamics, i.e., the action of waves and especially longitudinal currents.
