Spatial Quality Evaluation of Pedestrian Streets

Renata Cardoso Magagnin, Maria Solange Gurgel de Castro Fontes and Rosio Fernandez Baca Salcedo

Architecture, Arts and Communication Faculty, UNESP—Univ Estadual Paulista, Bauru 17033-360, Brazil

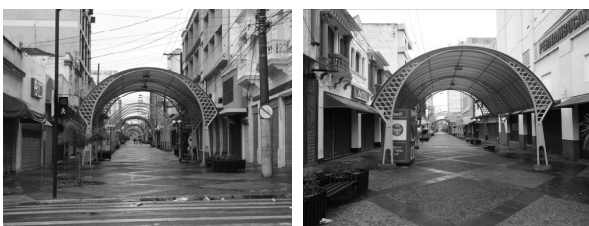
Fig. 2 Pictures of the area under study.

The pedestrian street analyzed is known as “Calçada” of Batista de Carvalho Street. It is located in the central area of Bauru (latitude 22°35' S and longitude 49°31' W), medium-sized city located in the center west region of São Paulo (Figs. 1 and 2).

the following characteristics: Portuguese stone and concrete slab as pavement; gantries of metal framework, some of which have coverage of polycarbonate; benches, planters, payphones, mailboxes, trash cans and lampposts.

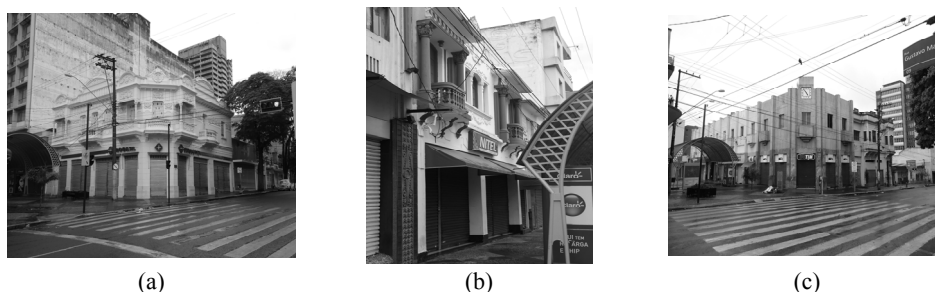
Fig. 3 Buildings listed by CODEPAC: (a) Palace Pagani; (b) Older Commercial House; (c) Lusitana House.

The pedestrian street consists of several buildings dating from the early 20th century in Art-Deco and Eclectic style. However, only three buildings were listed by the board of preservation of local heritage (CODEPAC): Lusitana House, Older Commercial House and Pagani Palace (Fig. 3).

Lusitana House and Older Commercial House suffered interventions on the facades. The former had its original color changed and the latter suffered alterations that mischaracterized the original building, such as enlargement of the doors at the ground floor of the facade and change of its original color. The Pagani House was restored keeping its original features, therefore, its conservation status is good (Table 2).
