Elimination of ESD Events and Optimizing Waterjet Deflash Process for Reduction of Leakage Current Failures on QFN-mr Leadframe Devices

Back-End Manufacturing & Technology, STMicroelectronics, Inc., Calamba City, Laguna 4027, Philippines

Abstract: This technical paper presents the resolution of high leakage current failures on QFN-mr (Quad-Flat No-leads Multi-Row) LF (leadframe) devices by optimizing the waterjet deflash process and eliminating the ESD (electrostatic discharge) events. ESD damage to units can cause permanent or latent product failures which results in low final test yield, and worse, possible external customer complaints. The use of CO₂ (carbon dioxide) bubbler was able to reduce the DI (deionized) water's equivalent resistivity from 17 MΩ to 0.30 MΩ, minimizing the tribocharging effect produced during the waterjet deflash process. Moreover, ESD events were eliminated by grounding the floating assembly equipment parts and installing appropriate ESD controls. It is of high importance to reduce or eliminate the leakage current failures to ensure the product quality, especially as the market becomes more demanding. After the optimization and implementation of the co

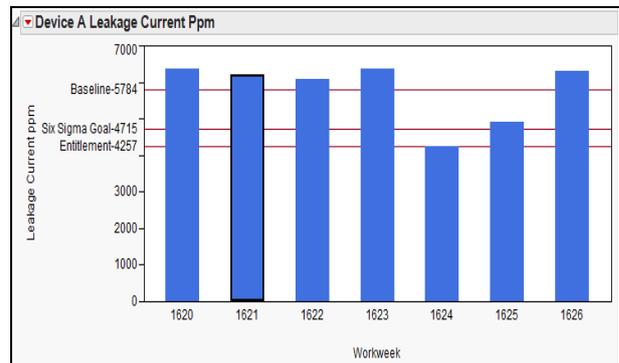
With a baseline of 5,784 ppm and an entitlement of 4,257 ppm, the calculated Six Sigma Goal is at 4,715 ppm (70% improvement), as illustrated in Fig. 4.

Fig. 4 Baseline and six sigma goal.

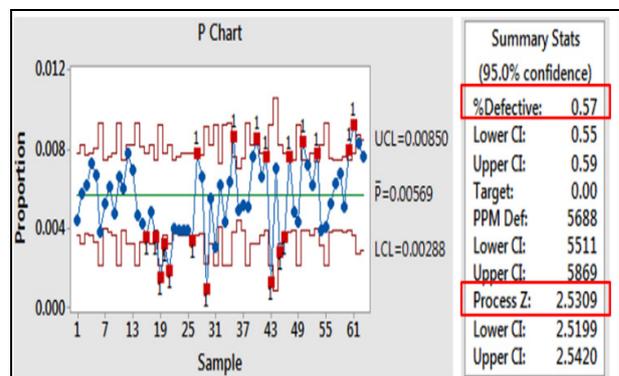
The lots processed for the workweek 1620-26 showed that most of the defectives lie on 0.57% and the long term sigma (current process capability) was calculated at 2.5309, see Fig. 5.

Fig. 5 Current process capability.
