Mosul Dam: Geology and Safety Concerns

Abstract: Mosul Dam is an earth fill dam located on the River Tigris northern part of Iraq. The capacity of its reservoir is 11.11 billion cubic meters which makes it the fourth biggest dam in the Middle East. From geological perspective, the dam is located on double plunging anticlines. The rocks of the site are mainly composed of highly jointed and karstified alternating beds of limestones, gypsum and marls, since the impoundment of the reservoir seepage of water was recognized under the foundation of the dam. To stop or minimize the seepage, intensive grouting operations were conducted. Recent investigations and evaluation of the conditions of the dam indicate that it is in a critical situation. In this paper, consequences of the dam failure are discussed and possible solutions are given.

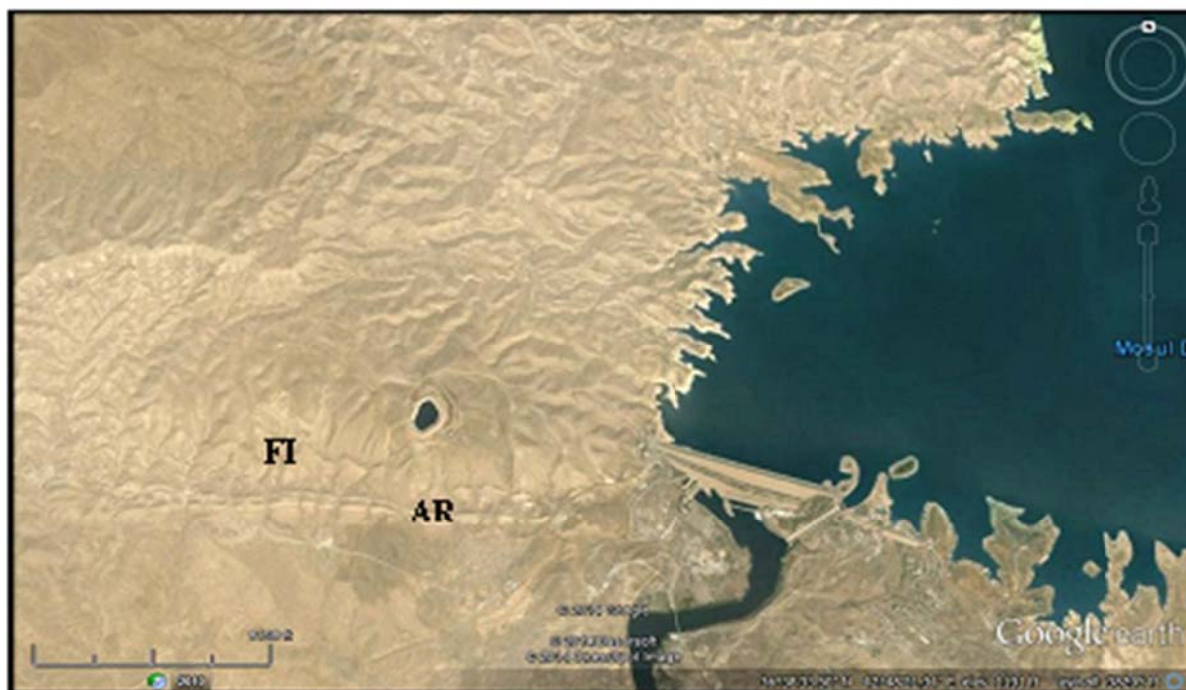
The geology of the dam area belongs to the Pleistocene to recent age alluvial deposits overlaying rocks of the Lower to Middle Miocene age Lower Fars Group (Fatha Formation) which is formed of highly karstified layers of limestone and soluble gypsum, followed by Oligocene to Lower Miocene age Jeribe limestone formation. The geomorphology of Mosul dam area is characterized by hilly terrain that rises to low mountainous area. The mountain anticlines trend NW-SE direction and change to almost E-W direction. Fig. 5 is a Google image of the dam and surrounding area.

Fig. 5 Google Earth image of the Mosul Dam site, located within Butma east Anticline. AR = anticlinal ridge, FI = flat iron [5].

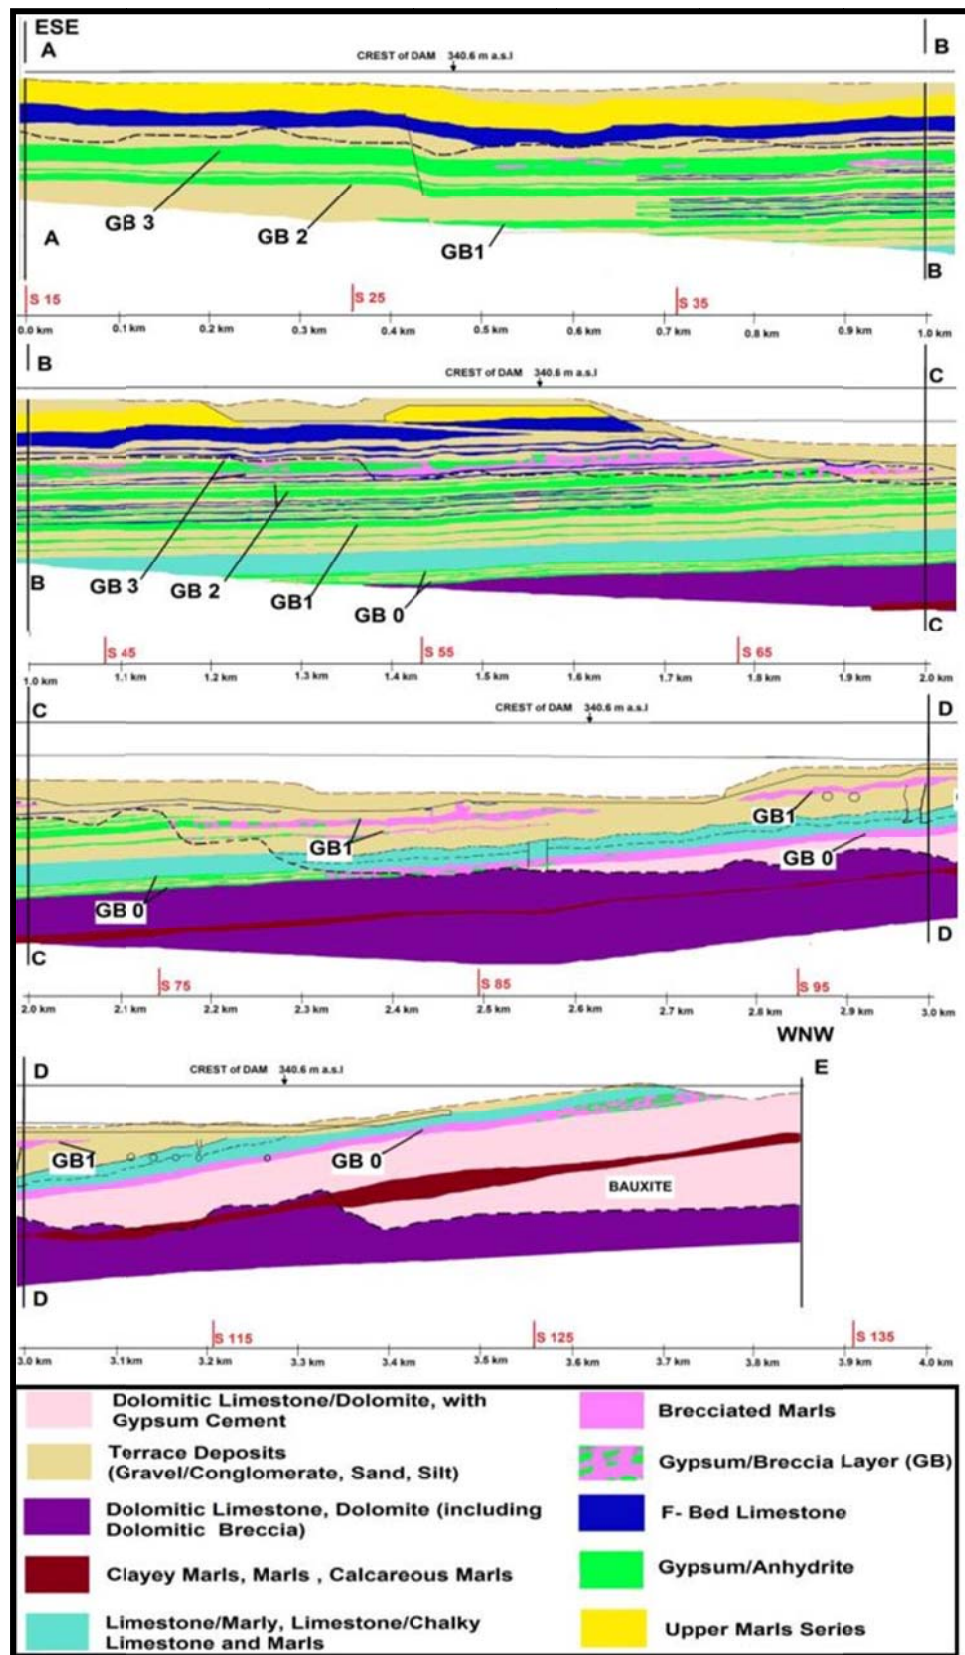
formation of highly developed conduits and caverns which form easy passages to the flow of ground water and the reservoir water. This had caused extensive dissolution of gypsum and gypsum anhydrite rocks present above and below these limestone layers. These dynamics had caused the collapsing of whole layers of clayey marls and gypsum anhydrite into the underneath cavities forming beds of brecciated gypsum particles and anhydrite blocks embedded into a loose clayey matrix. Four such layers were discovered during the geological investigations and they were termed as the Gypsum-Breccias layers which had thickness ranging between 8 meters and 16 meters. The first layer was found at a depth of 80 meters in the river section and it was marked as the GB0 layer. The other three layers were at higher levels. The last one i.e. the GB3 was discovered at the foundation of spillway chute ski jump. The GB layers proved to be very dangerous due to their erratic behavior during the grouting of the deep grout curtain under the dam. Fig. 11 shows the geological cross section under the dam.

Fig. 11 Geological long section under dam axis (the long extending from east to west shown has been divided in parts from east to west which are stacked together in the above figure) [4].

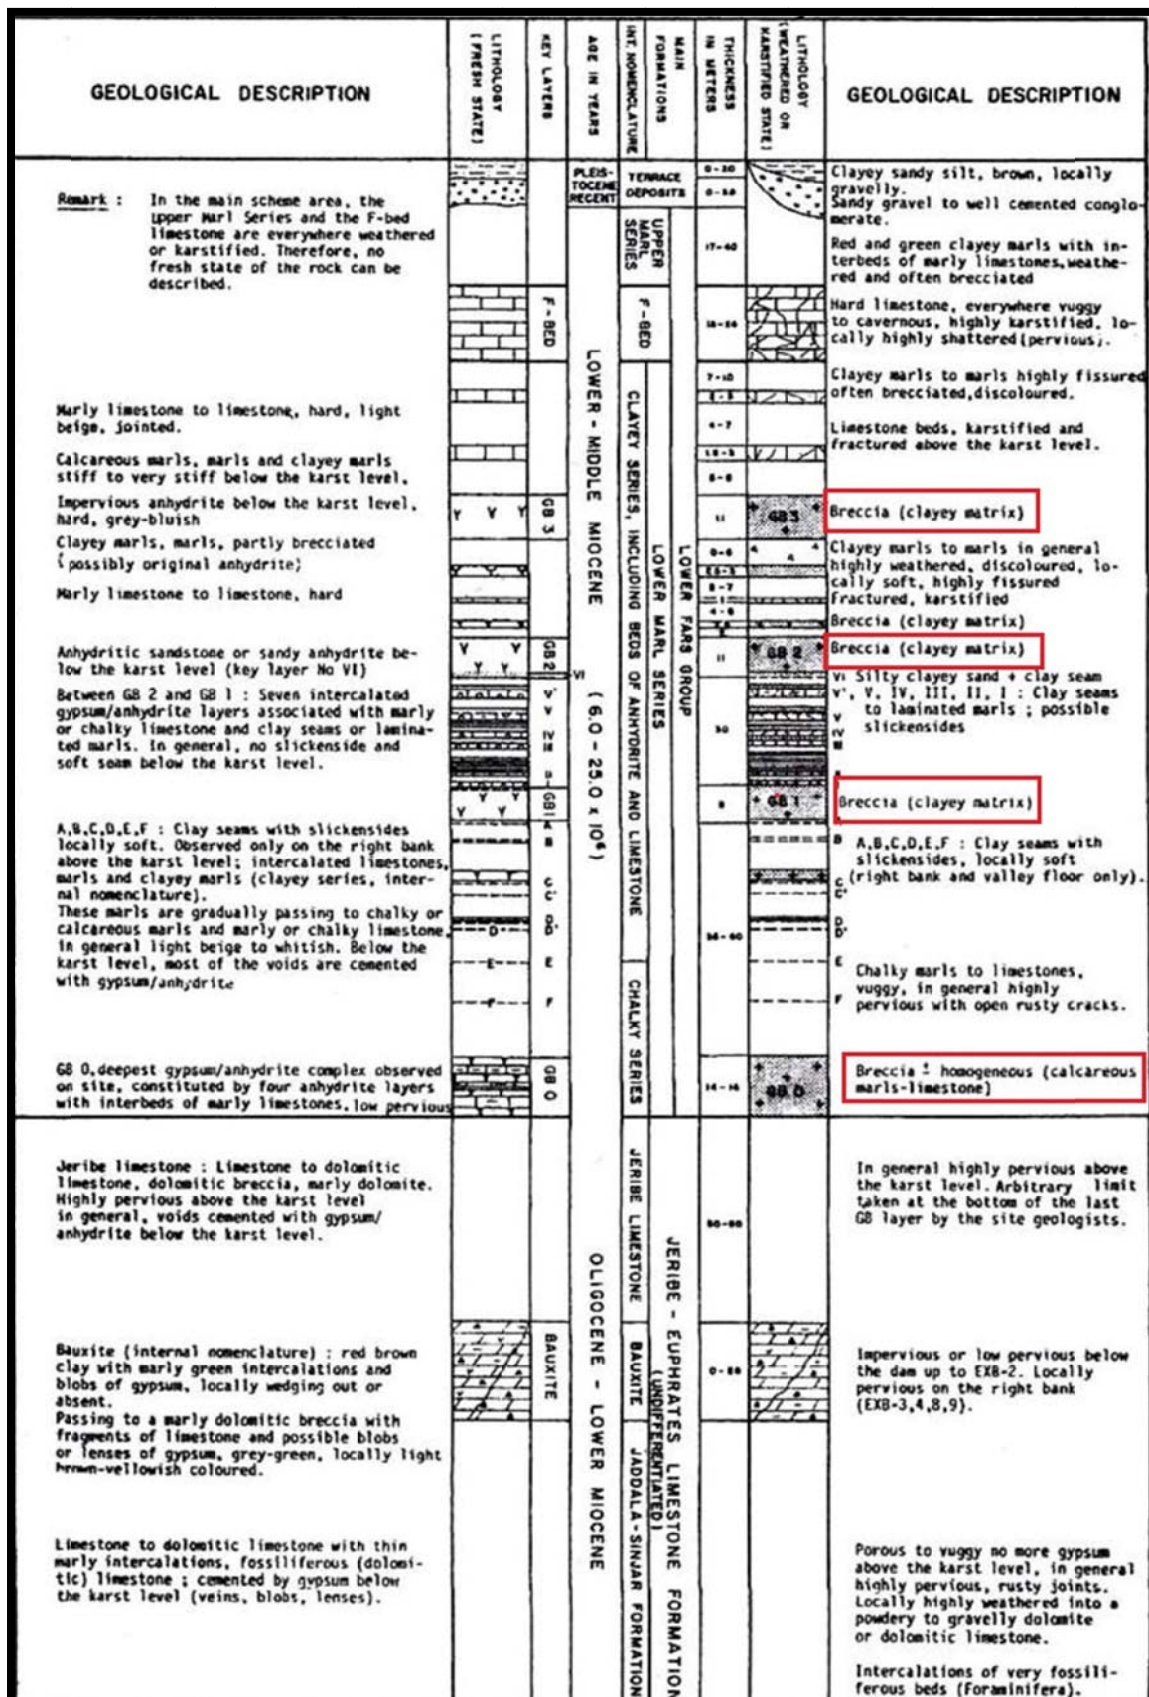
Fig. 12 gives the lithological column under the Mosul Dam central part.

Fig. 12 The lithological column under the Mosul Dam central part (red rectangles indicate the Gypsum Breccia layers) [4].

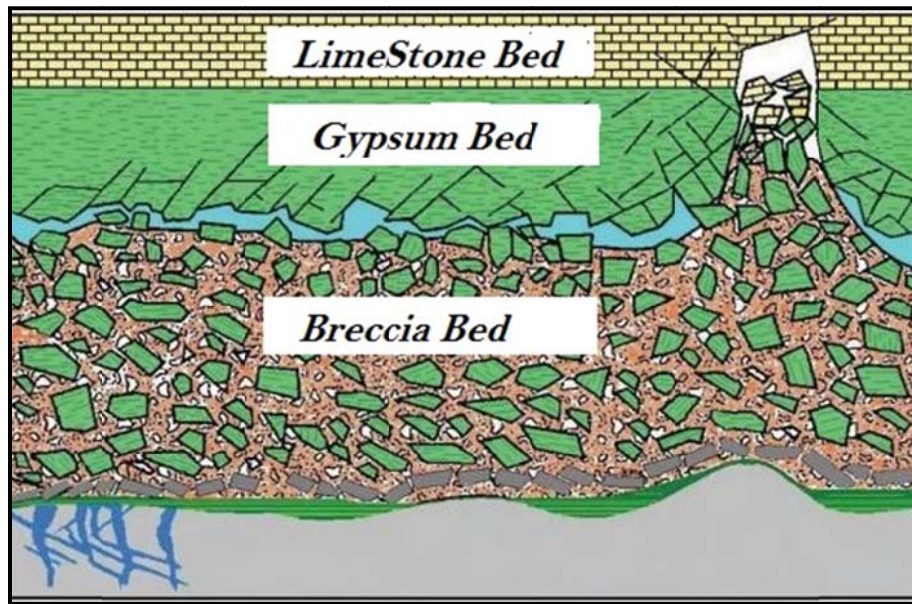
The schematic diagram Fig. 15 shows the mechanism of the gypsum/breccias layer formation. Groundwater flowing through cavernous limestone can wash the Marley clay from above into cavities already formed in gypsum/anhydrite layers and causing the collapse of more gypsum/anhydrite into these cavities forming continuous layers of the breccias.

Fig. 15 Schematic diagram showing the formation of a breccias layer.

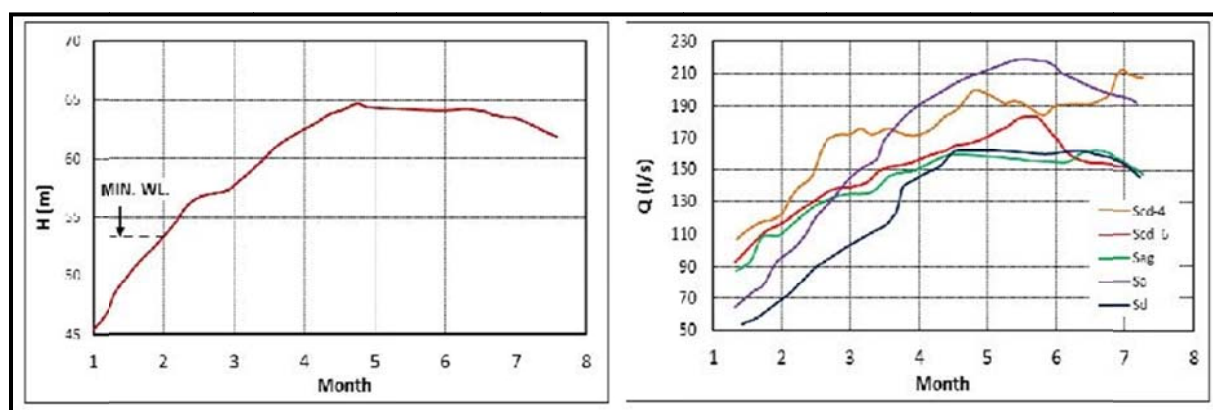
which corresponded with a reservoir level of 304 masl. This could yield, if extrapolated to 2 cubic meters per second at full reservoir elevation of 330 masl. Chemical tests showed an increase in salts content indicating leaching of gypsum at a rate of 30 tons/day. This is equivalent to void volume of 10-15 cubic meters. Fig. 17 shows the obtained test results of water seepage from the most important five springs as the water level was raised during the period February-August 1986 [12].

Fig. 17 Chemical test results of water seepage from the most important five springs vs. water level was raised during the period February-August 1986 [12].

Further hydro geological investigations by installing more open pipe piezometers and use of tracers to discover seepage paths showed the need for extending the depth of the grout curtain at certain sections and adding another line of grouting holes in others. Arrangements were made to catch some springs by pipes to discharge away the water safely and others were covered by filter material. A new deep curtain was also constructed along the left side of the spillway's chute to stop seepages flowing underneath the chute and across it from the upstream direction. An extension to the left bank grout curtain along dam axis was performed also to protect the left bank from being outflanked by water seeping around the executed curtain.

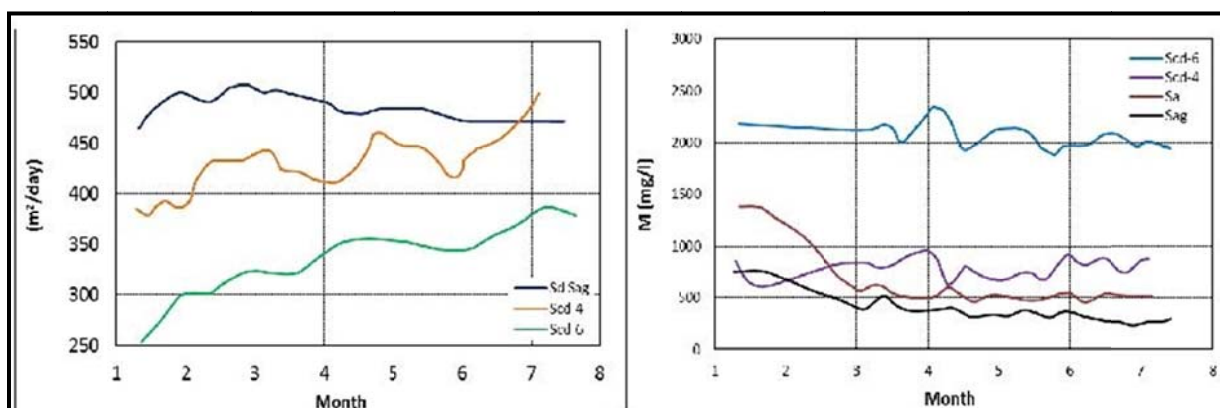
Similar measurements of seepage water quantity and quality from under the dam at the river channel section, which was collected from the pond created by the coffer dam no 6 used during river diversion, showed alarming dissolution of gypsum and increased transmissibility during the same period [12], as indicated in Fig. 18.

The increase in seepage quantity was accompanied by reduction of the grout curtain efficiencies in many sections in the river channel and could be attributed to the increased size of the aforementioned windows due to increased dissolution. Grout curtain efficiencies at various parts were measured by observing the difference in the hydraulic head between the upstream and downstream piezometers that were installed in pairs in the grouting gallery. These piezometers were and still are up till today as the only means to discover the formation of cavities in the foundation and to indicate the need for filling grouting as a maintenance procedure.

Fig. 18 Increased transmissibility vs. time (February-August 1986), and continuous dissolution of gypsum in the same period for the increased head shown in Fig. 17. (Dissolution had leveled off after the initial increase in the first three months which was due to the washing away of gypsum particles fillings in the cracks and joints of the rock formation) [12].

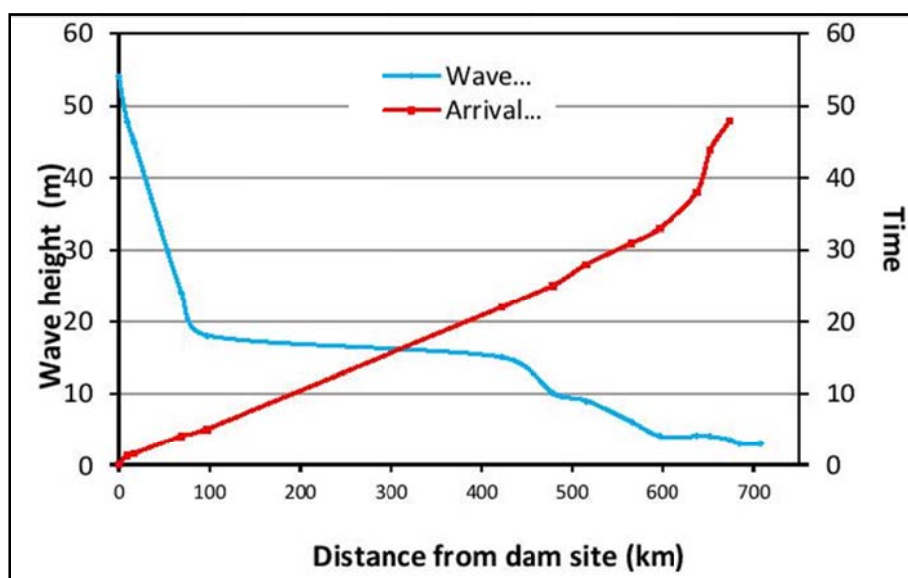
result in such an event to both human lives and material properties and infrastructures with its impact reaching beyond Baghdad. The main conclusions of the study showed that: (1) if failure would occur at all, the most probable cause would be the foundation geology; (2) for the various scenarios of the reservoir water levels at failure, the initial wave hydrograph would be as shown in Table 2, with peak discharge of 551,000 cumecs can be expected (Scenario A); (3) the calculated travel times to various cities on the river, max height of wave, and flooded areas are shown in Table 2 and Fig. 24 [13].

Fig. 24 Wave height at various distances downstream of dam and time of travel time of arrival.

Irrigation, when it was clear that the dam presented a grave hazard on the population, to design and start construction of a protective dam 40 km downstream from Mosul Dam to contain the full volume of Mosul Dam flood wave in case of its failure. This is the dam called Badush Dam which is probably a unique case of this size in the history of dam construction. Unfortunately the works were suspended in 1991 after completing 30-40% of the works, which was due to the UN economic sanctions imposed on Iraq after its invasion of Kuwait.

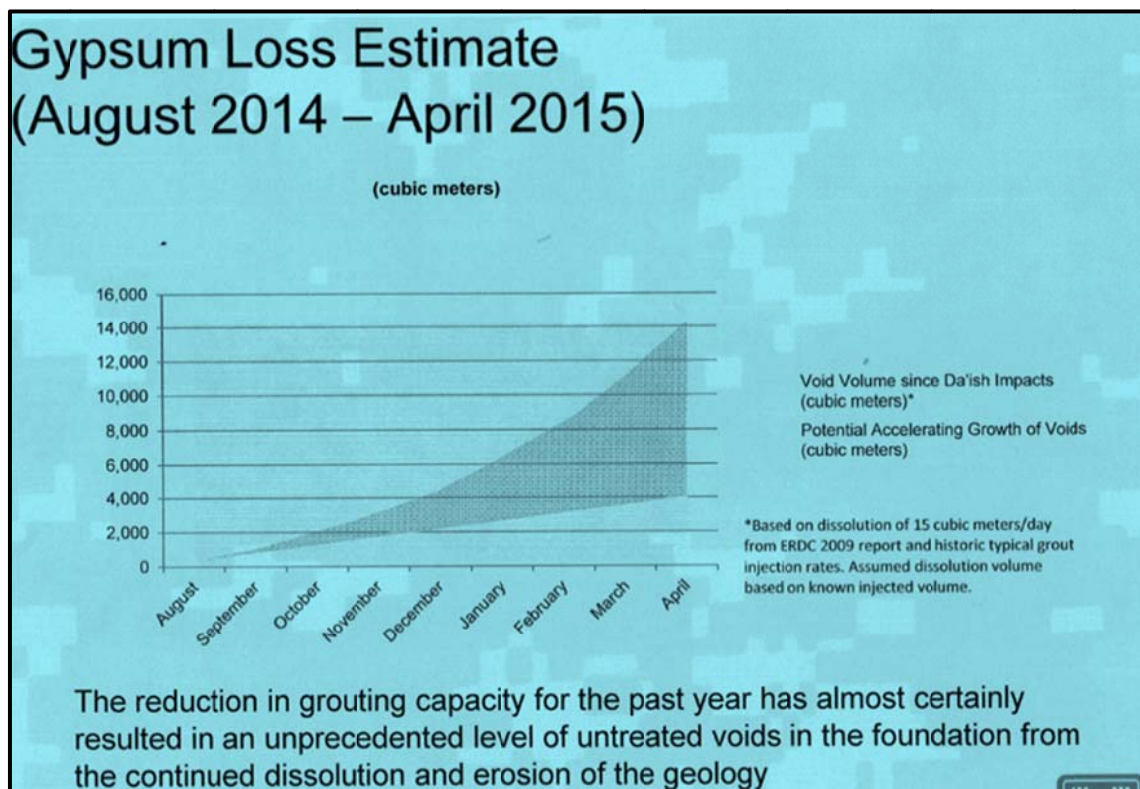
10,000 cubic meters more than what normally would have happened with the continuation of grouting shown in Fig. 25.

Fig. 25 Dissolution of gypsum without grouting (lower curve: estimated and without grouting; upper curve: measured) for the period (August 2014-April 2015).

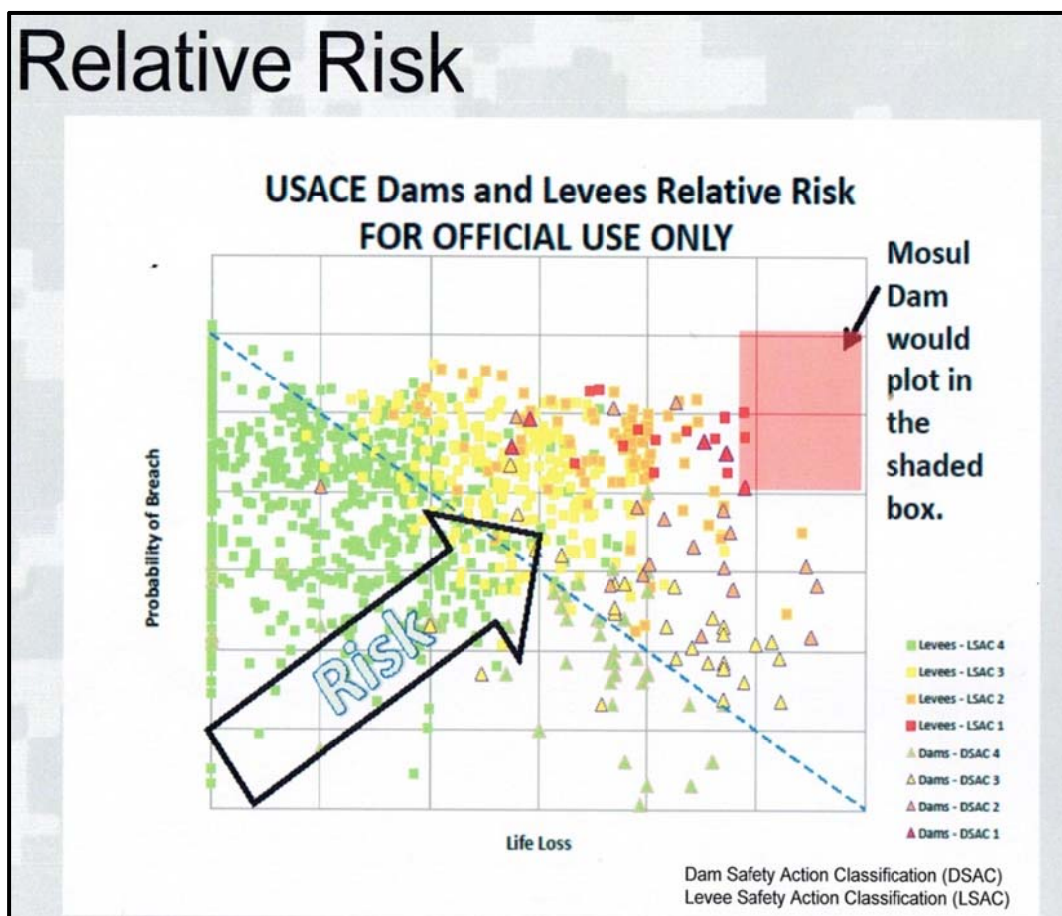
(4) A SPRA (screening portfolio risk analysis) was performed to obtain the relative risks imposed by Mosul Dam relative to large dams in USA. The screening process considered loading frequency, an engineering rating to estimate a relative probability of failure, and both human life loss and economic. The evaluated risk results were compared to the risks in a total of 563 dams and 108 other with separate consequence structures which belonged to the USACE portfolio of dams. This ranking showed Mosul Dam to be in a state of extreme relative risk as shown in Fig. 27. In fact it shows that Mosul Dam is in a state of extreme and unprecedentedly high relative risk.

Fig. 27 Plot showing the severe relative risk of Mosul Dam.
