# Discussion on Maintenance Cases of Wind Turbine Components

Huang Ren-Jen

Central Branch, Department of Power Equipment Repair and Maintenance, Taiwan Power Company, No. 643, Sec.2, Jinma Rd. Changhua city, Taiwan, Email address: u592749@gmail.com

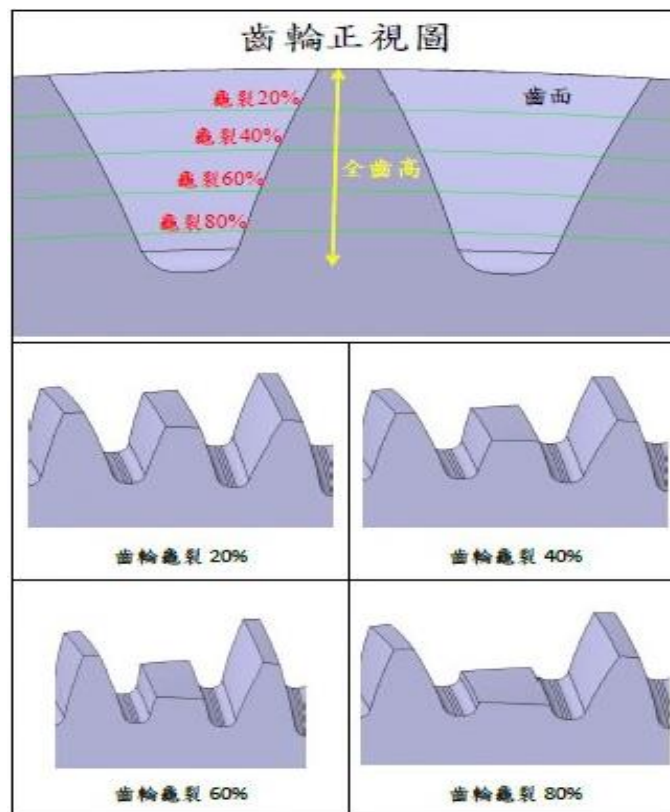
**Fig. 9 Schematic diagram of the percentage of missing teeth.**

The force condition of the surrounding gear teeth and the most appropriate load calculation in the case of gear teeth missing, calculate the allowable load during operation after the teeth of gearbox of the wind turbine is broken. For this calculation, first it is assumed that the proportions of broken teeth are 20%, 40%, 60%, 80% respectively, as shown in Fig. 9.

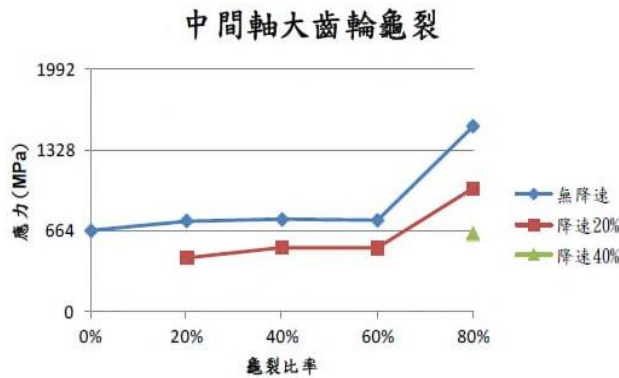
**Fig. 13** The relationship between the percentage of missing tooth depth and force.

Entrusted by the Ship and Ocean Research Center, to calculate the proportion of broken teeth with 20%, 40%, 60%, 80%, the calculation result shows the relationship between the rotational speed and the force during operation, as shown in Fig. 13, comparing the load of the defective tooth and the non-defective tooth, when the depth of the defective tooth is less than 60%, the load has little relationship with rotation speed of the shaft. But when the depth of missing teeth is greater than 60%, the force on the tooth surface will increase sharply when running without speed reduction or load reduction. At this time, if the speed or load is reduced by 20% and 40% respectively, it can be seen that the force on the tooth surface will decrease as the speed decreases.

齒龜裂比重	最大應力 (MPa)		最大應力增加比率 (%)	
	無降速	最大應力增加比率 (%)	降轉速 20% (限載 400kW)	降轉速 40% (停機)
0%	664	-	-	-
20%	745	12.2%	442	-
40%	757	14.0%	526	-
60%	750	13.0%	523	-
80%	1527	130.0%	1012	642

The result of this calculation can be used as a reference for the operation of gears with broken teeth.

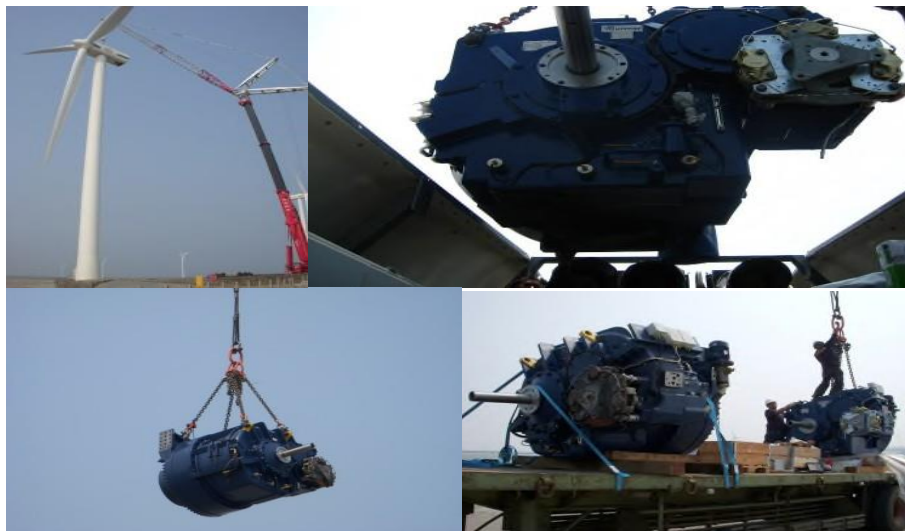
**Fig. 14** Wind turbine gearbox hanging project.

and maintenance technology of wind turbines in Taiwan, it has taken the first step. For the repair and maintenance of the broken tooth gearbox, the first thing to overcome is the hanging project. It is necessary to ensure that personnel and equipment can be carried out under safe conditions, and the work is completed as scheduled and with quality. Therefore, the establishment of SOP and the training of personnel must be strictly required before they can be achieved. Fig. 14 shows the hanging project of the wind turbine gearbox.

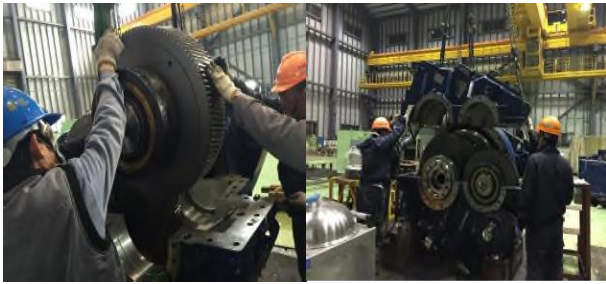
**Fig. 15 Gearbox maintenance project.**

The repair of the gearbox includes the replacement of broken gears and the replacement of damaged bearings, as shown in Fig. 16. After the assembly is completed, the gear lubricant should be filtered and monitored, and perform 30% (600 rpm), 65% (1,300 rpm), 100% (2,000 rpm).

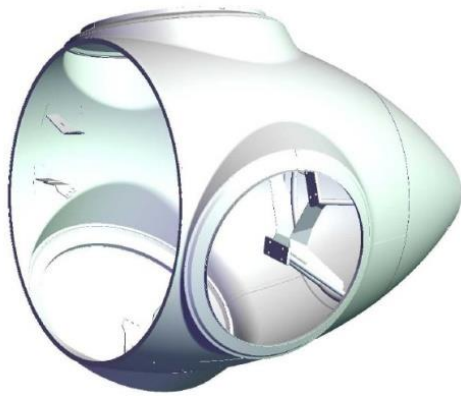
**Fig. 21** Vestas V80 Hub.

The function of hub is to join the structure of three blades, as shown in Fig. 21. The failure situation is that the support frame used to fix the component is broken. Therefore, in the routine inspection, the integrity of all supporting members must be checked in detail. If cracks or fractures are found in the supporting members, a repair plan shall be adopted, because the entire hub has to support the dynamic and static loads of the three blades, if the support frame breaks, it will cause soft feet, resulting in unbalanced support and affecting operational safety.

Regarding the repair of cracks or breaks in supporting members, firstly remove the defects, fix them with stiffening plates, and then repair them by welding. Since the wind turbine nacelle and blades are made of flammable FRB, the surrounding area must be covered with a fire-resistant blanket before welding. The welding process must avoid welding slag splashing, and all safety protection measures must be taken. The whole process is shown in Figs. 22-25. Because the wind turbine is in operation, its related components are subjected to an amplitude stress, so the wind turbine components often suffer from fatigue. As fatigue is a failure mode without warning,
